## Safety Recall Launch Notification

<b>Campaign #</b>	<b>NHTSA ID</b>	<b>Campaign Codeword</b>	<b>Reinforcement of Longitudinal Frame Member</b>
2025090008	25V609	VS3LAENGST

<b>Total Recall Population</b>	4	<b>Model(s)/ Platform(s)</b>	Sprinter (907)
<b>Vehicles in Dealer Inventory</b>	0		
<b>Model Year(s)</b>	2024		
<b>Issue</b>	Mercedes-Benz AG, the manufacturer of Mercedes-Benz vehicles, has determined that on certain Sprinter (907 platform) vehicles, the longitudinal frame members of the Body in White might not meet specifications. In the event of a frontal collision, the deformation behavior of the Body in White might be impaired. As a result, the risk of injury for the occupants might increase.		
<b>What We're Doing</b>	MBUSA is conducting a voluntary recall. Authorized Mercedes-Benz Sprinter dealers will check the longitudinal frame members on the affected vehicles. Depending on the findings, the necessary measures will be carried out.		
<b>Remedy</b>	The inspection process is available.		
<b>Launch Date</b>	Affected VINs will be flagged in VMI as “ <b>OPEN</b> ” on Tuesday, December 2 <sup>nd</sup> , 2025. The campaign will be visible on the <a href="http://www.NHTSA.gov

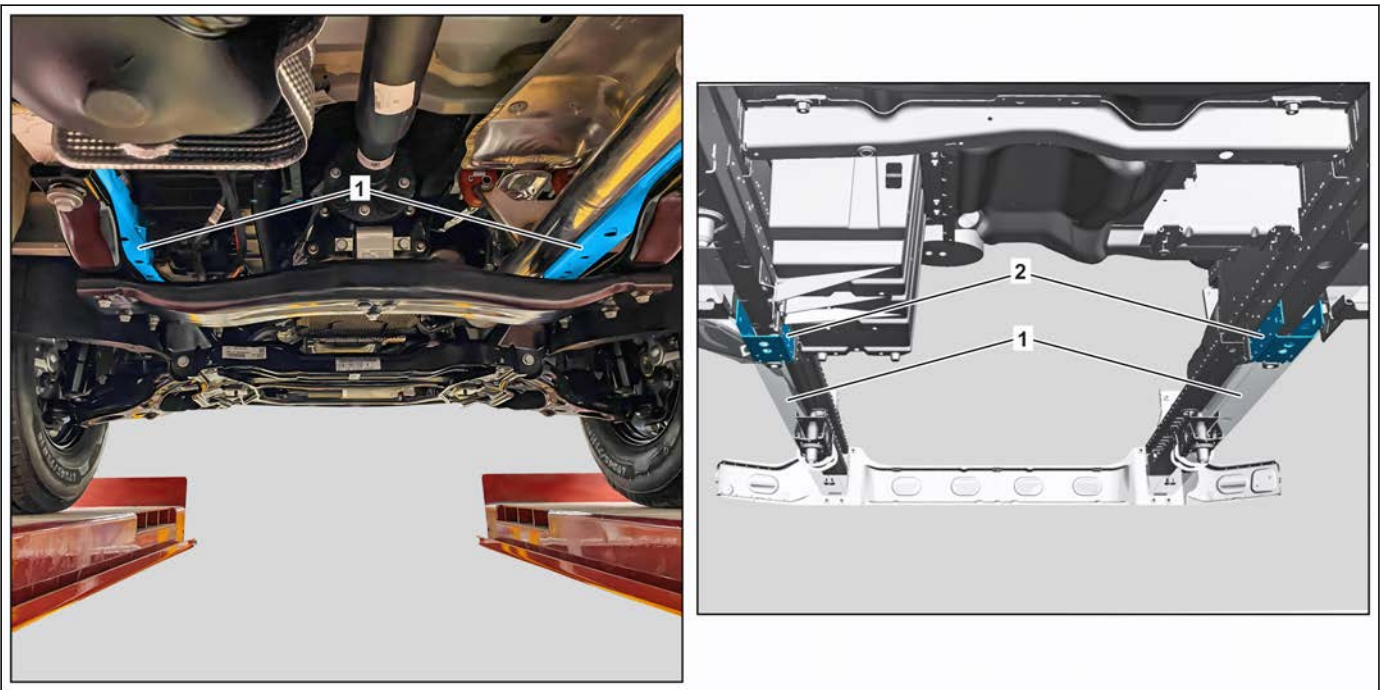
D62.20-A040-79

1 Front longitudinal member

2 Reinforcements

If reinforcements (2) are missing in the longitudinal members (1), representative pictures of the test must be created and filed in a tamperproof manner with the repair order.

Vehicles in which the reinforcements (2) are missing must be decommissioned.

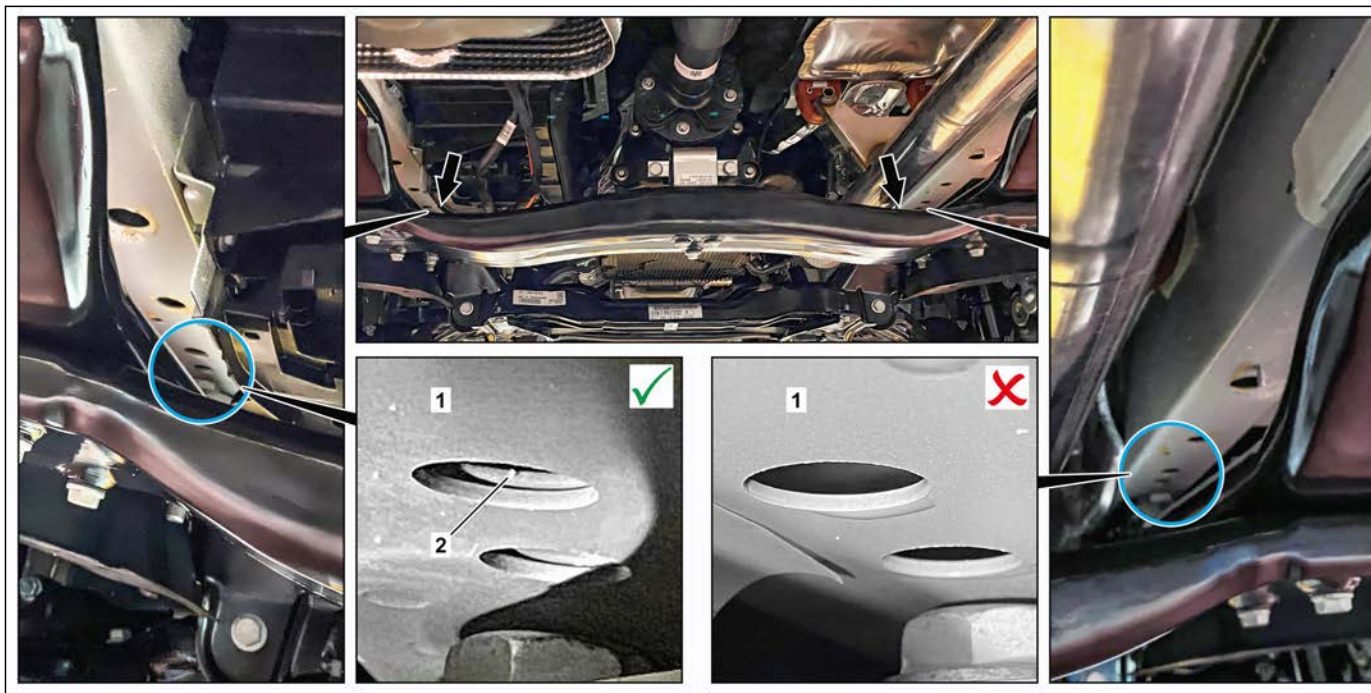
D62.20-A041-79

1 Front longitudinal member

2 Reinforcement

<p><b>⚠ Danger</b></p>	<p><b>Risk of death</b> caused by vehicle slipping or toppling off of the lifting platform.</p>	<p>Align vehicle between vehicle lift columns and position the four support plates at the vehicle lift support points specified by the vehicle manufacturer.</p>	<p>AS00.00-Z-0010-01A</p>
<p><b>🔍</b></p>	<p><b>Check</b></p>		
<p>1</p>	<p>Check whether vehicle is affected by measure.</p>		
<p>2 <b>📢 Notice</b> 🔧 AR 🔧 WS 🔧 WS 🔧 WS</p>	<p>Raise vehicle. Special instructions for lifting and supporting vehicle  000 588 26 80 00 Adapter 000 588 41 80 00 Adapter 000 588 27 80 00 Adapter</p>		<p>AH00.60-P-0100-01TS AR00.60-D-1000-04TS WS00.00-Z-0067KOB WS00.00-P-0321B WS00.00-P-0068B</p>
<p>3</p>	<p>Check that reinforcements (2) are present in front longitudinal members (1).</p>	<p><b>i</b>  If reinforcements (2) are present, ↓ end the measure. If reinforcements (2) are not present, ↓ Please contact CCC to have a case created</p>
