# Campaign Service

**BULLETIN NUMBER:**  
CB25-J-001

### F-SERIES FUEL HEATER REPLACEMENT SAFETY RECALL 25V-630 (Transport Canada 2025-493)

- 2022-2026MY Isuzu F-Series Vehicles Wholesaled Prior to 9/13/2025

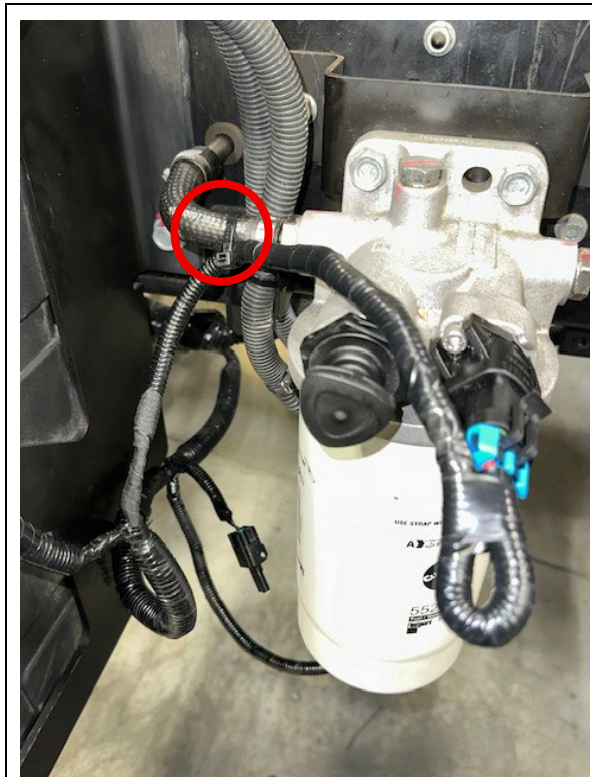
Figure 1

3. Remove the one (1) zip tie. (See Figure 1.)

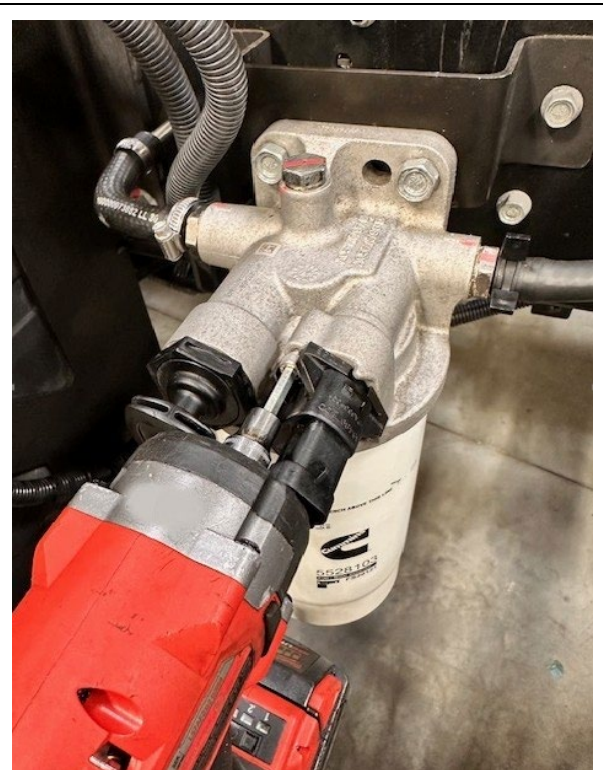
5. Using a 3/8" impact on the lowest setting, remove the two (2) screws securing the fuel heater to the fuel filter assembly. (See Figures 3 and 4.)

**Important: Do not use hand tools to remove the two (2) screws.**

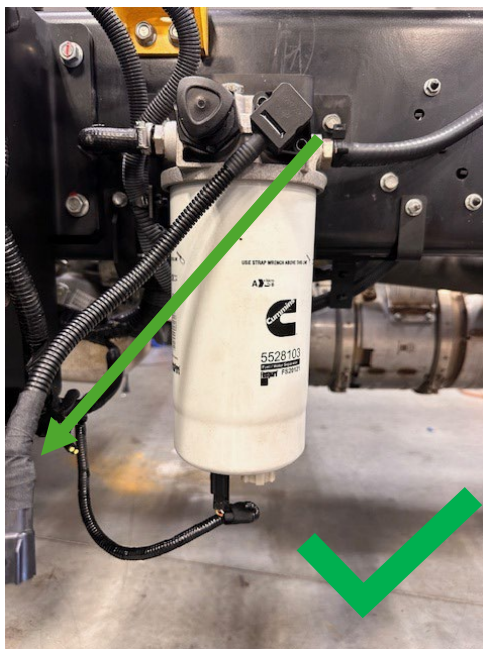
**Figure 6 – Correctly Installed Fuel Heater**

8. Install the new fuel heater with the harness pointing down into the fuel filter assembly. Ensure that the new fuel heater is fully seated into the fuel filter assembly. (See Figures 6 and 7.)

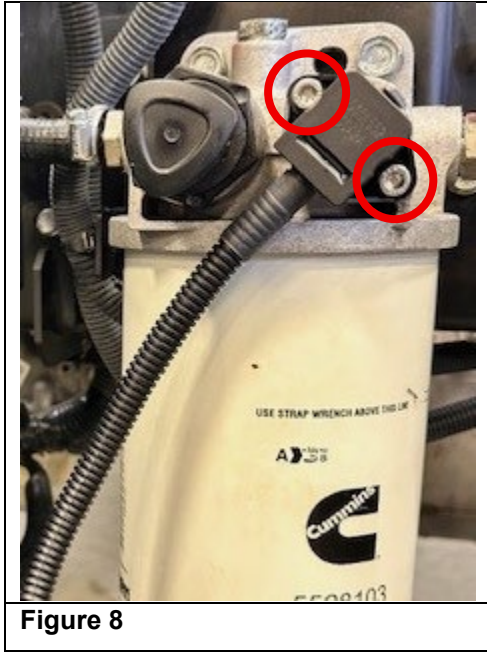
9. Install and torque the two (2) new screws. (See Figure 8.)

<b>Tightening Torque:</b>	<b>9 N·m (80 in/lbs.)</b>
---------------------------	---------------------------
