SERVICE PROCEDURE

SUBJECT: SAFETY RECALL

Wiper Module in certain 2026 IC Bus™ CE Series school buses built 03/11/2025 thru 08/26/2025

VEHICLE RECALL 25515

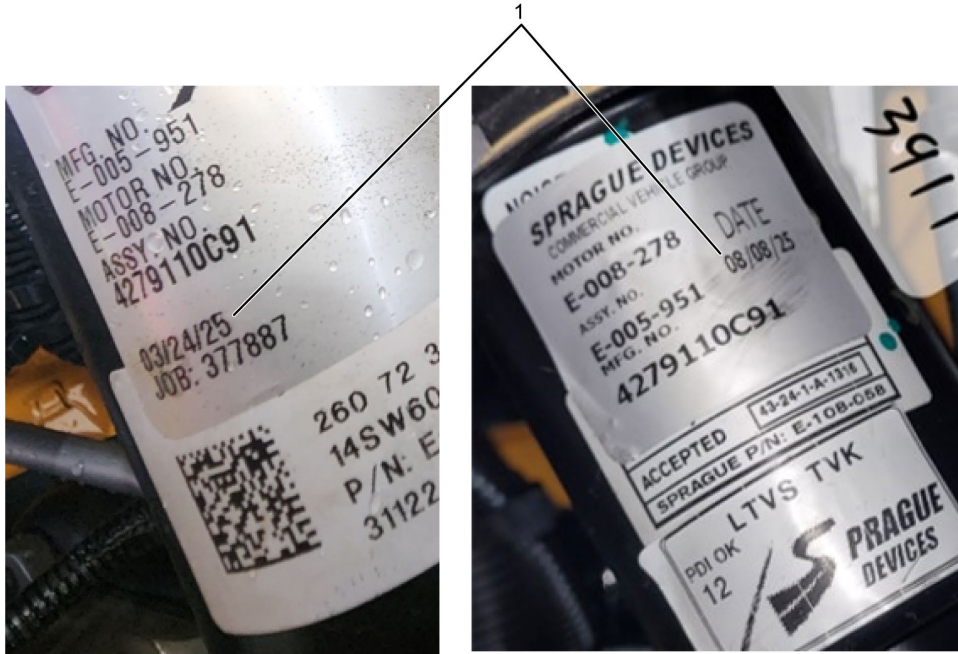
Figure 1. Wiper Motor Date Code Location

1. Date code

7. Inspect and compare date code (Figure 1, Item 1) on wiper motor to Table 2 Suspect Wiper Motor Date Code:
 - a. If date code (Figure 1, Item 1) on wiper motor is not listed in the suspect wiper motor date code table, go to Step 30.
 - b. If date code (Figure 1, Item 1) on wiper motor is listed in the suspect wiper motor date code table, continue to Step 8.

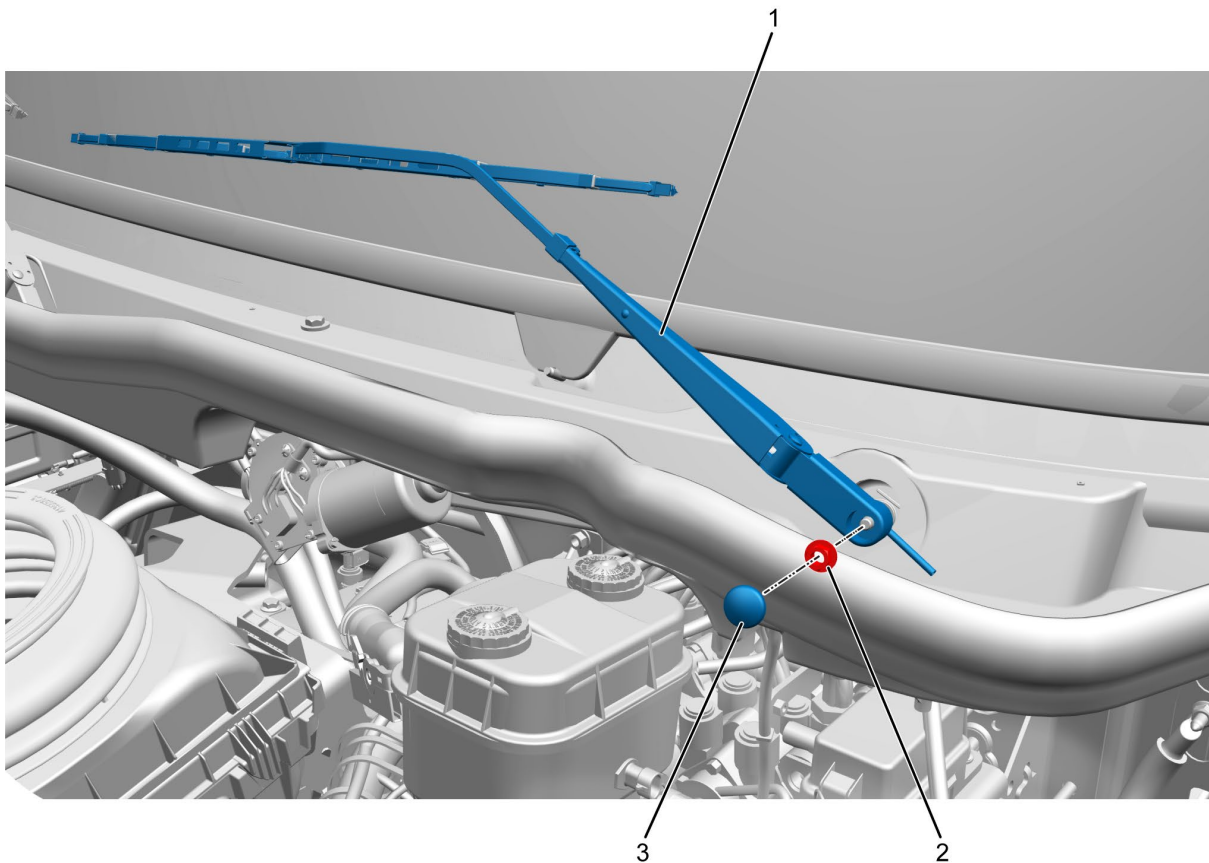
Figure 2. Windshield Wiper Arm

1. Wiper arm
2. M10 nut
3. Cap

8. Remove cap (Figure 2, Item 3) from windshield wiper arm (Figure 2, Item 1) and save for reuse.
9. Remove M10 nut (Figure 2, Item 2) and save for reuse. Remove wiper arm (Figure 2, Item 1) and save for reuse.
10. Repeat Steps 8–9 for opposite side.

19. Connect electrical connector (Figure 3, Item 3) to linkage assembly. Install tie straps as needed.
20. Reinstall cowl tray lid with fasteners saved during disassembly.
21. Reconnect washer fluid hose.
22. Using a soft wire brush, clean wiper motor pivot shaft knurls.
23. Position wiper arm (Figure 2, Item 1) on motor pivot shaft.
24. Install M10 nut (Figure 2, Item 2). Using torque wrench, tighten M10 nut to 11–12.5 lb-ft (15–17 N·m).
25. Install cap (Figure 2, Item 3).
26. Repeat Steps 22–25 for opposite side.
27. Turn vehicle ignition to Key ON, Engine OFF (KOEO) position.
28. Verify proper operation by cycling the windshield wiper for two cycles, turn OFF wipers, and verify the arms are parked in the correct location.
29. Turn vehicle ignition to Key OFF position.
30. Close and latch hood.
31. Remove wheel chocks.

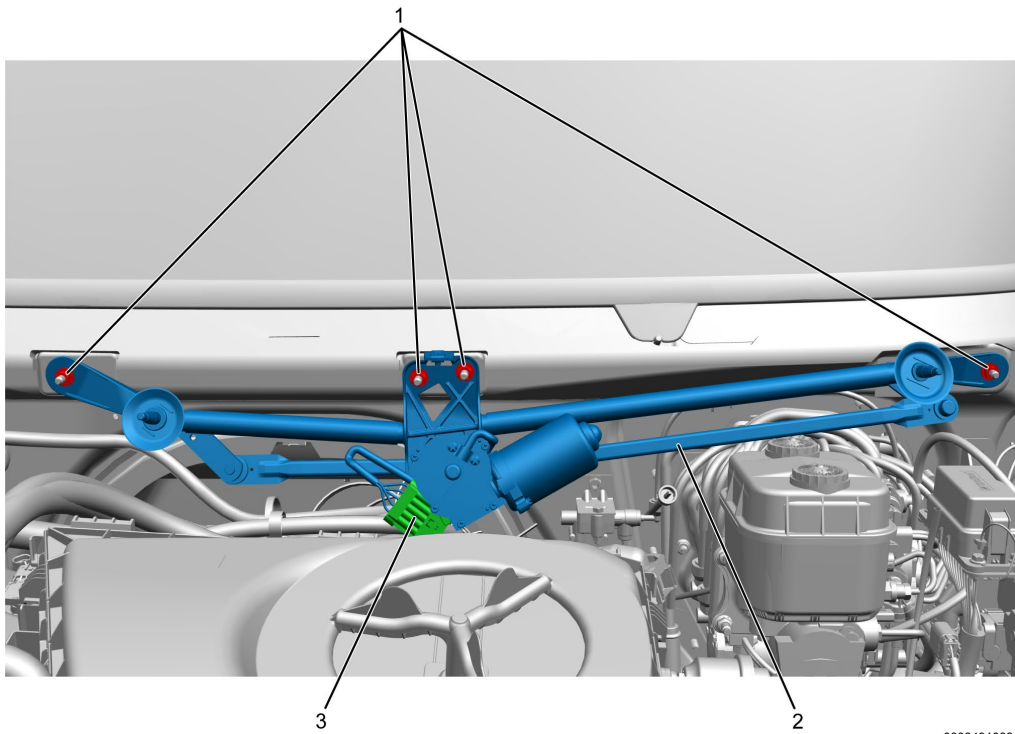
Figure 3. Linkage Assembly

The wiper module crank-shaft assembly is not welded properly which can cause the left-side windshield wiper to not wipe the windshield.

1. M8 mounting nut (4)
2. Linkage assembly
3. Electrical connector

14. Disconnect electrical connector (Figure 3, Item 3). Remove any tie straps as needed.
15. Remove four M8 mounting nuts (Figure 3, Item 1) from mounting studs and save for reuse.
16. Remove windshield wiper linkage assembly (Figure 3, Item 2) and discard.
17. Align new linkage assembly (Figure 3, Item 2) to mounting studs. Loosely install previously removed four M8 mounting nuts (Figure 3, Item 1).
18. Using torque wrench, tighten four M8 mounting nuts to 16–18 lb-ft (22–25 N·m).
