SERVICE PROCEDURE

25516R1
October, 2025

SUBJECT: SAFETY RECALL

**Wiper Module in certain 2026 IC Bus™ CE Series
commercial buses built 03/27/2025 thru 05/13/2025**

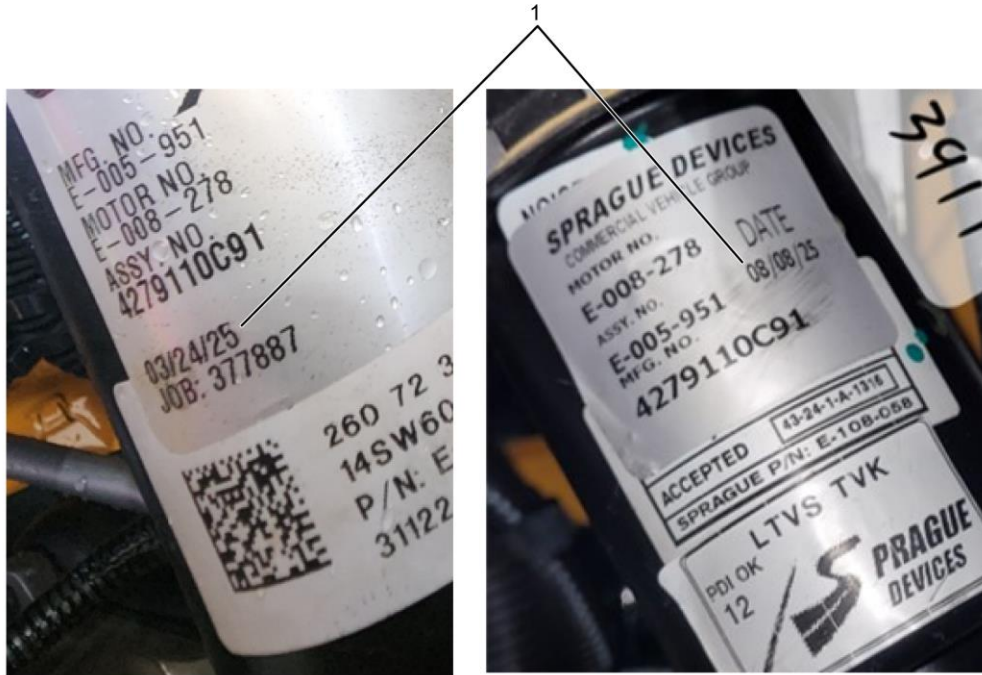
Figure 1. Wiper Motor Date Code Location
1. Date code

7. Inspect and compare date code (Figure 1, Item 1) on wiper motor to Table 2 Suspect Wiper Motor Date Code:
 - a. If date code (Figure 1, Item 1) on wiper motor is not listed in the suspect wiper motor date code table, go to Step 30.
 - b. If date code (Figure 1, Item 1) on wiper motor is listed in the suspect wiper motor date code table, continue to Step 8.

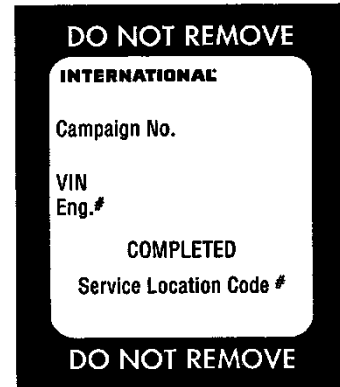
Each vehicle corrected in accordance with this campaign must be marked with a CTS-1075 Campaign Identification Label.

Complete the label and attach on a clean surface next to the vehicle identification number (VIN) plate.
