SERVICE PROCEDURE

25518
November, 2025

SUBJECT: SAFETY RECALL
Air dryer discharge in certain 2025 thru 2026 IC Bus™ CE Series commercial buses built 04/16/2024 thru 05/13/2025 with air brakes (feature code 0004091) and an air dryer location mounted inside the engine compartment, right side (feature code 0004VLE)

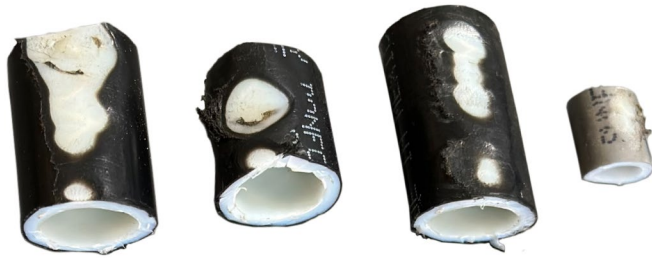
Figure 1. Rubs and Chafe Marks

9. Inspect for rubs and chafe marks (Figures 1 and 2).
10. Cut and remove the section of damaged air line tubing.

NOTE: Ensure air line tubing going into the coupler is cut at a 90-degree angle. A diagonal cut may increase the risk of a leak at the coupler.

11. Repair the air line installing two air line couplers and bulk air line.
