Tesla, Inc. Service Bulletin		<h2>Replace Rear Fascia Harness and Rear Fascia Taillight Assemblies</h2>	
SB-25-17-011 October 10, 2025			
Classification		Section/Group	Mobile Service
Recall Bulletin		17 - Electrical	Cannot Perform
Configuration			
		All	
Model	Model Year	Country/Region	Build Location
Model Y	2026	North America, Europe, Asia Pacific	Fremont, Giga Berlin, Giga Shanghai, Giga Texas
<small>The model(s) and model year(s) listed are a general approximation of the affected VIN list. Refer to the VIN/Bulletin Tracker or Customer/Vehicle profile to determine applicability of this bulletin for a particular vehicle.</small>

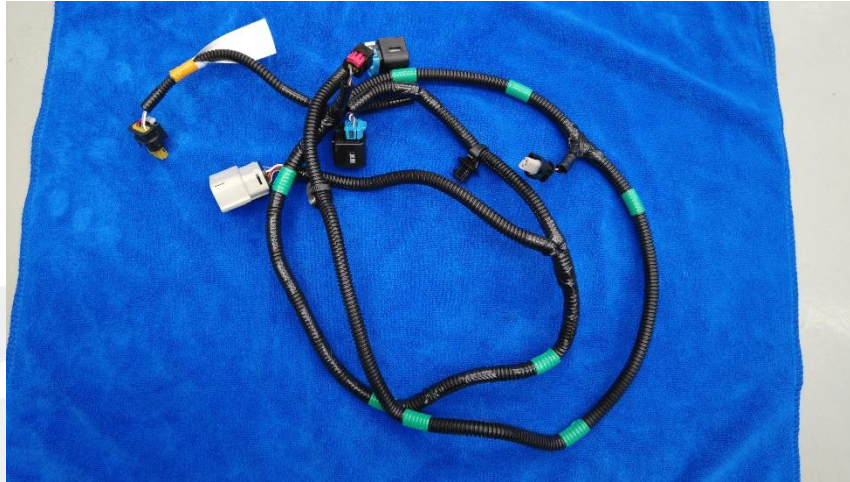
Figure 1

1. Remove the rear fascia and diffuser assembly (refer to Service Manual procedure [10010501601](#)).
2. Replace the rear fascia harness (Figure 1) (refer to Service Manual procedure [1710070102](#)). Do not reinstall the rear fascia assembly yet.

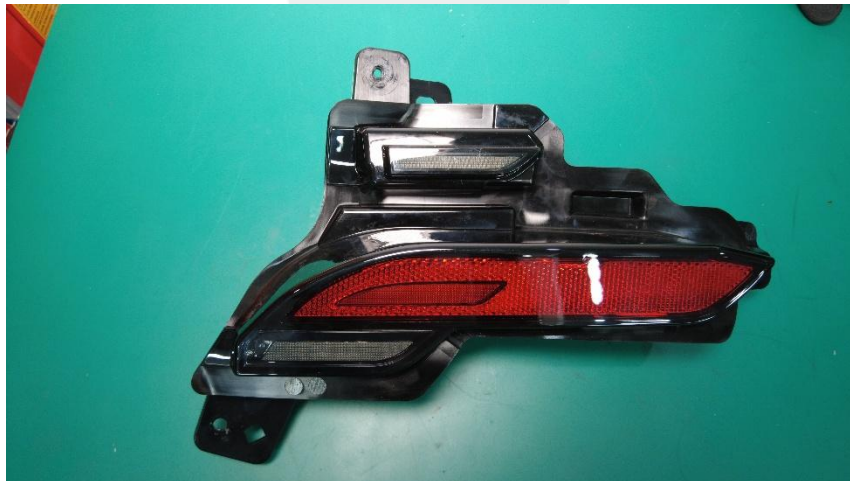
Figure 2 – LH shown; RH similar

3. Replace the LH and RH rear fascia taillights (Figure 2) (refer to Service Manual procedure [1740030702](#)).
