**TECHNICAL INSTRUCTIONS**

**SAFETY RECALL 25TA12**

**SECOND ROW SEAT RAIL REPLACEMENT ON BRAUN REAR ENTRY**

**CERTAIN 8 PASSENGER 2025 MODEL YEAR SIENNA**

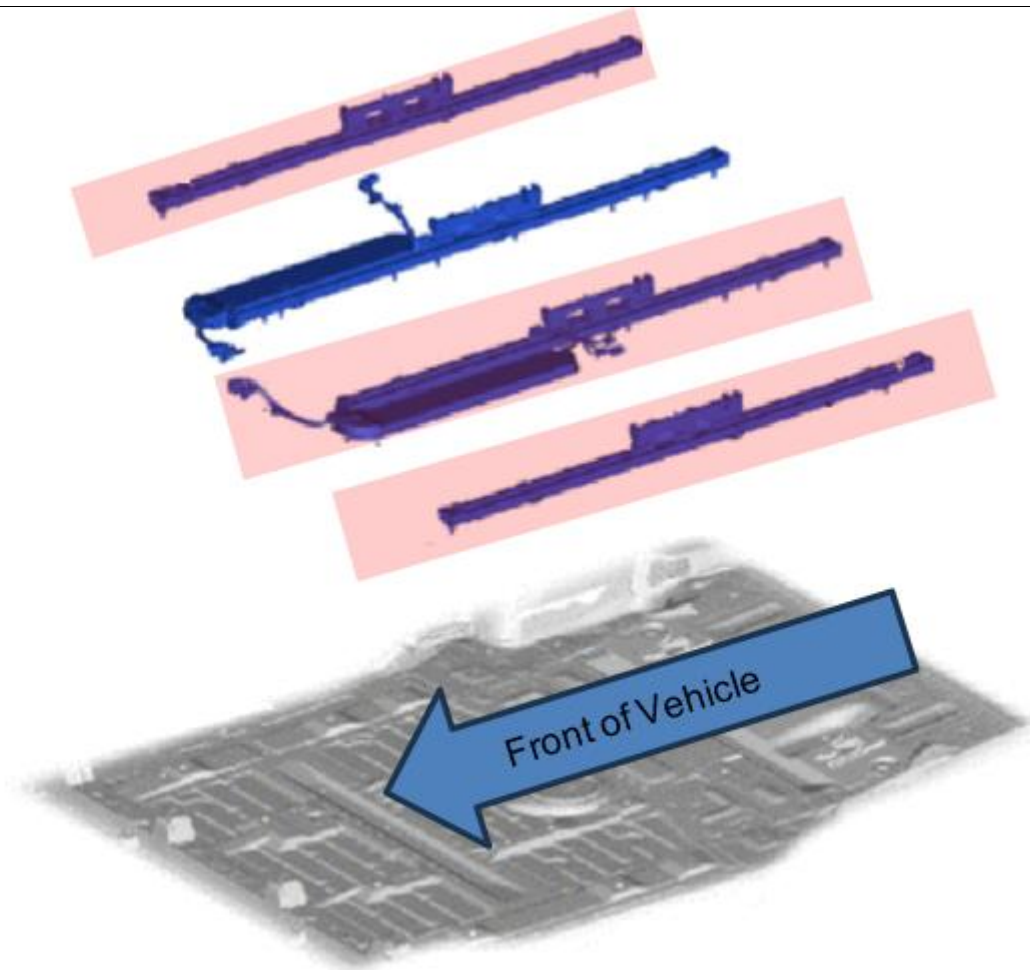
The subject vehicles contain second-row seats that are mounted on seat rails that may have been improperly welded

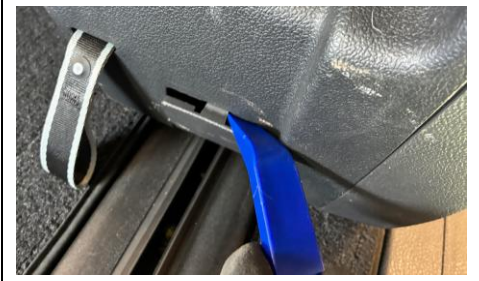
- a. Adjust the passenger side 2nd row seat to its forward-most position.

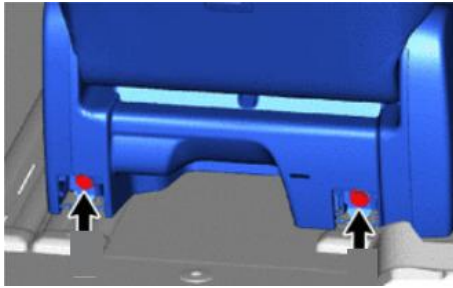
- b. Open the (2) passenger side rear bolt access covers.

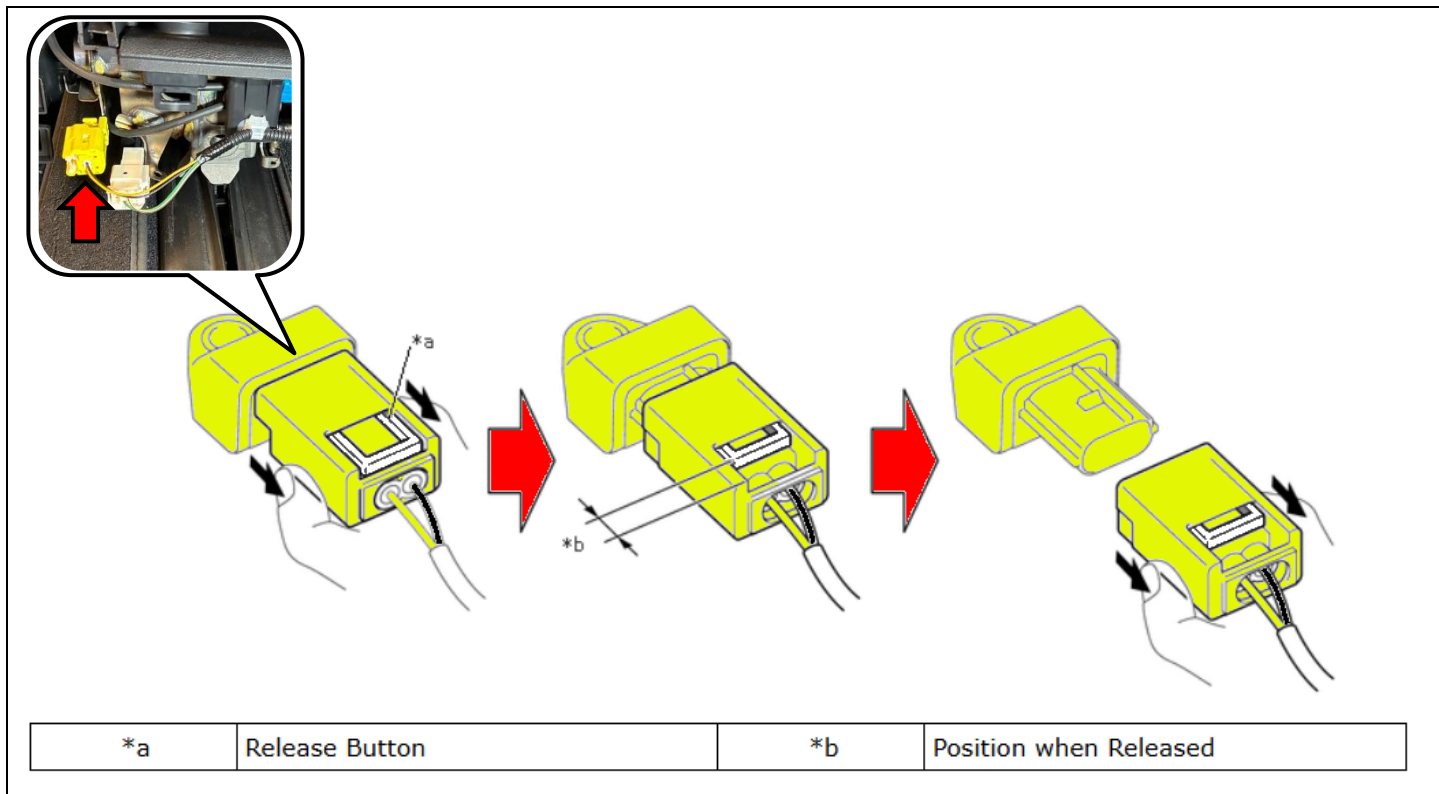
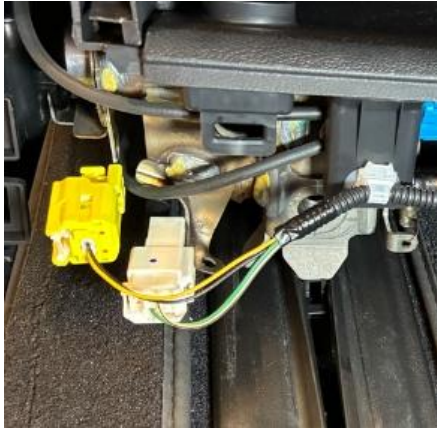
- f. Disconnect the yellow rear seat airbag assembly connector under the passenger side rear No. 1 seat assembly
- I. Push down the release button and slide the sides of the connector in the direction shown by the arrows in the illustration below. (**At this time, the connector cannot be disconnected yet.**)
- HINT: Check that the position of the release button is as shown in the illustration below.
- II. Push down the release button and slide the connector again to disconnect the airbag connector.

- When disconnecting any airbag connector, take care not to damage the airbag wire harness.
- Pushing down on the top of the connector will prevent the lock from being released, so hold the sides of the connector.

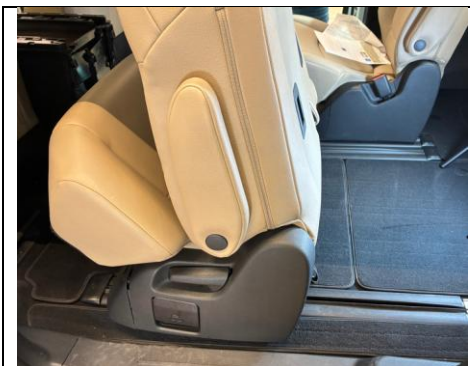
- i. Remove the (2) bolts on the front side of the passenger side rear No. 1 seat assembly.

**NOTE:** Be sure not to damage the airbag connector or harness when removing the seat bolt.

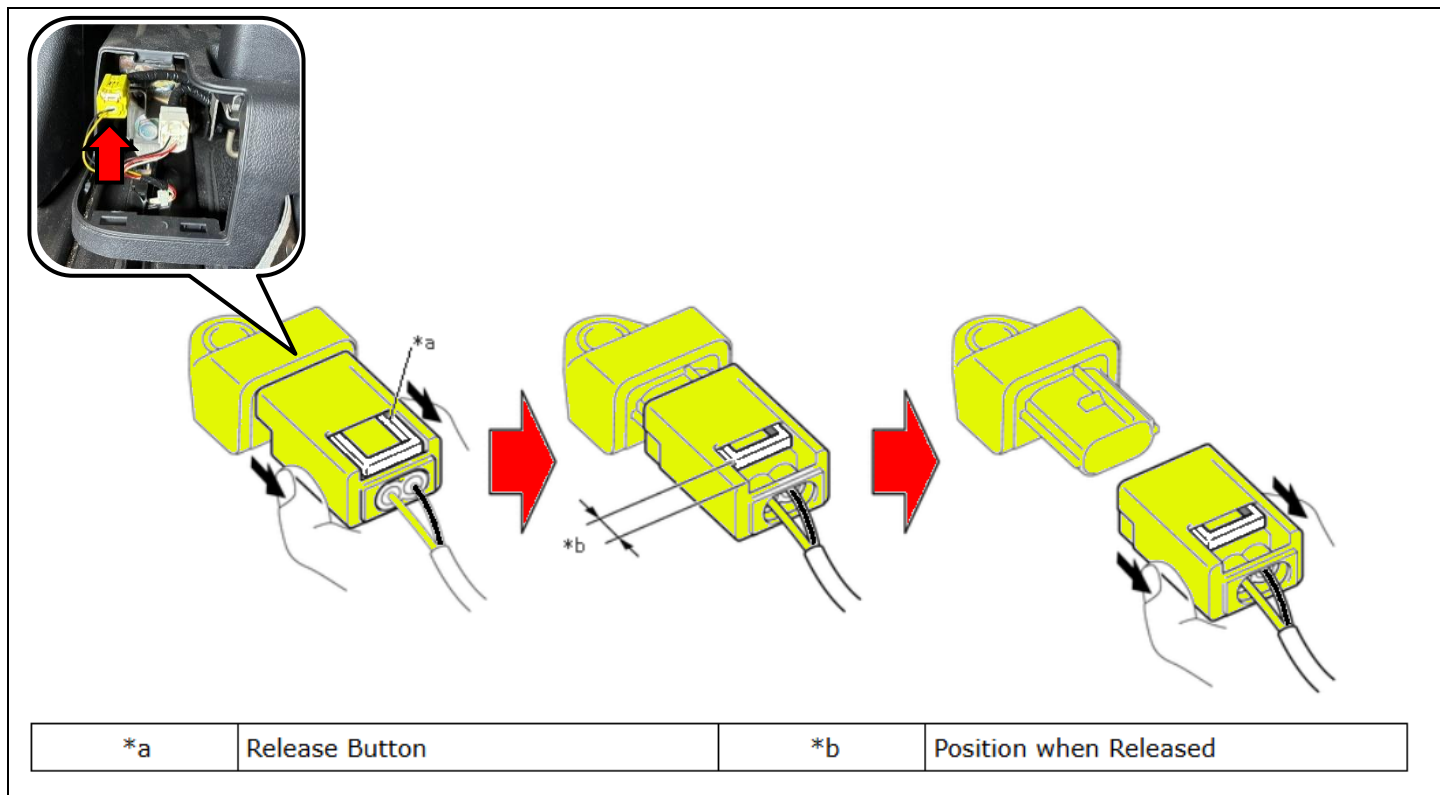
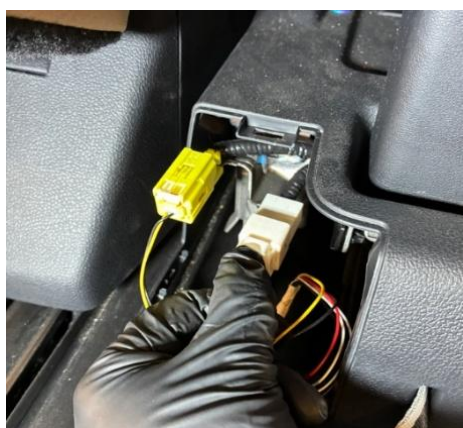
- g. Disconnect the yellow rear seat airbag assembly connector under the driver side rear No. 1 seat assembly
- Push down the release button and slide the sides of the connector in the direction shown by the arrows in the illustration below. **(At this time, the connector cannot be disconnected yet.)**

HINT: Check that the position of the release button is as shown in the illustration below.

- Push down the release button and slide the connector again to disconnect the airbag connector.

- When disconnecting any airbag connector, take care not to damage the airbag wire harness.
- Pushing down on the top of the connector will prevent the lock from being released, so hold the sides of the connector.

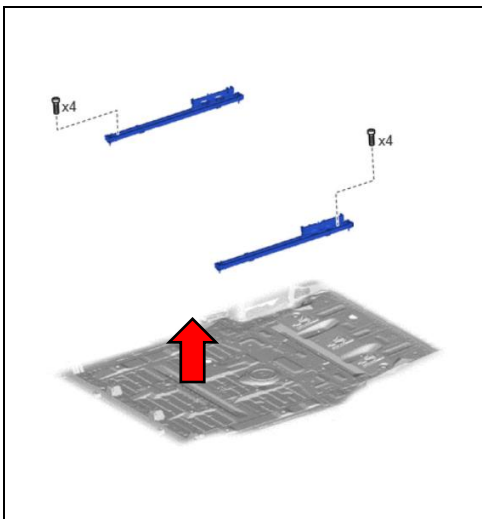
- f. Slide the rail so that its position allows for access to all four bolts.
- g. Using a T50 "TORX" socket and hand ratchet, remove the driver side outboard seat track lower rail assembly bolts, then remove the rail assembly from the vehicle.

**NOTE: "T50 TORX" bolts must be removed by hand to avoid damage to the cage holding the nut under the rail.**

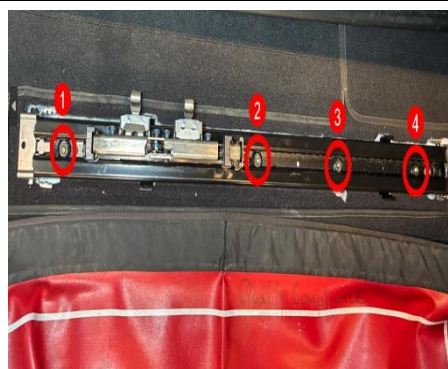
- j. Install the **NEW** driver side outboard seat track lower rail assembly.
- k. Slide the rails so that all four bolt holes are accessible.
- l. Hand-tighten the bolts.

**Note: Do not use an impact wrench while tightening the rail bolts as this will result in damage to the nut cage under the floor.**

m. Torque the bolts in sequence, starting from the front, working towards the rear (1-4).

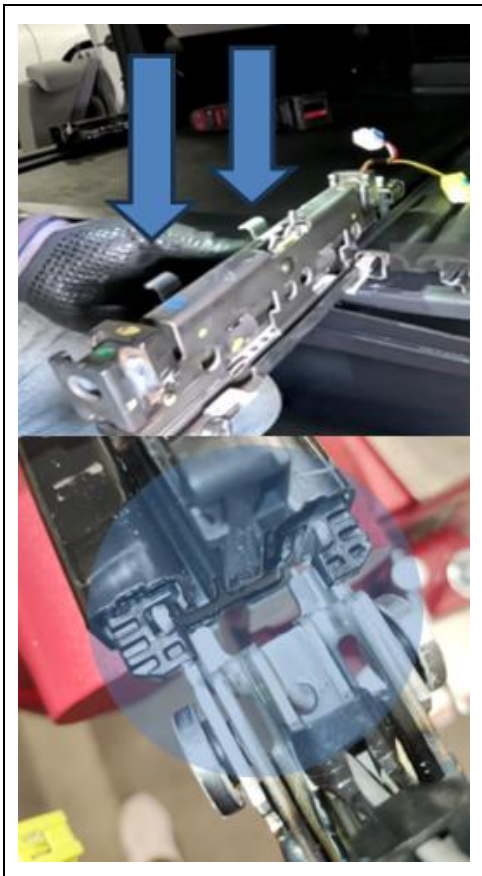
g. Pushing down on the 2 side tabs of the upper rail ,slide the rail towards the back and stop once you see the two hooks of the rail at which point you can push down and out to separate from the wiring harness.

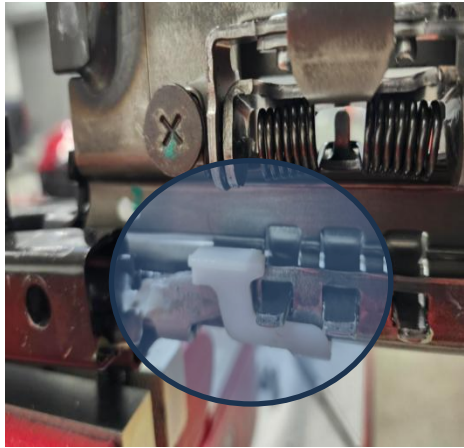
- a. Push wiring harness slightly to attach as shown on the picture, once engaged start pushing the upper rail into the lower rail assembly.

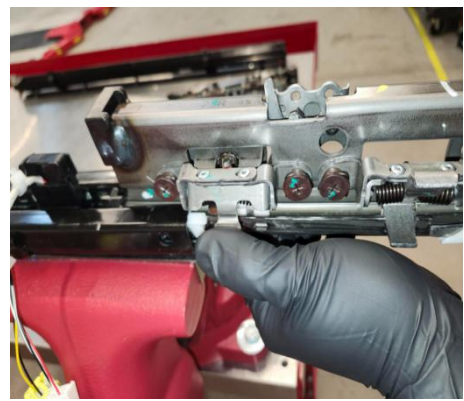
- b. Pay close attention to the white tabs make sure they are lined up before pushing rail in

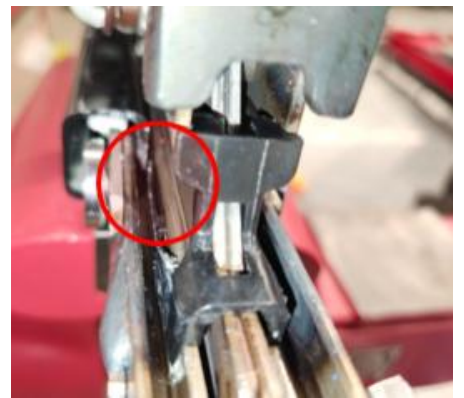
- c. Push down on front lever and slide rail in slowly until it stops.

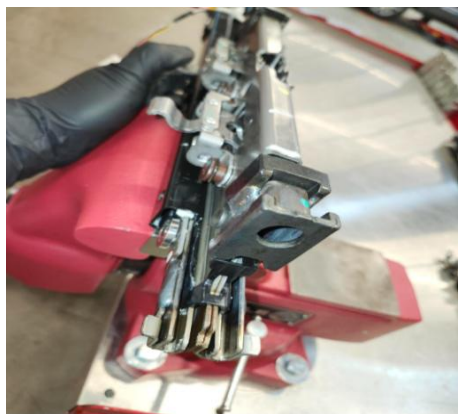
- d. When the rail stops make sure that the black plastic guide is on the inside of the rail on both sides before pushing it forward. **Failure to follow this step will damage the guide.**

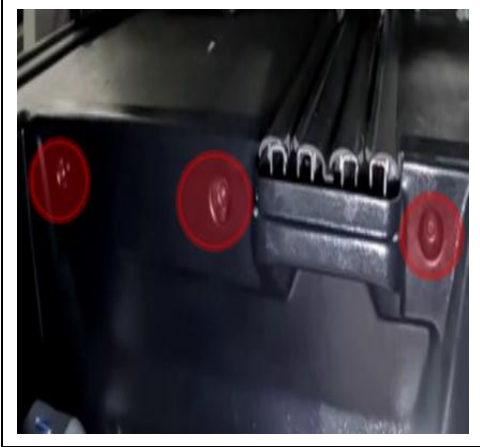
- e. Once confirmed the plastic guide is on the inside of the rail on both sides tap the rail forward into position.

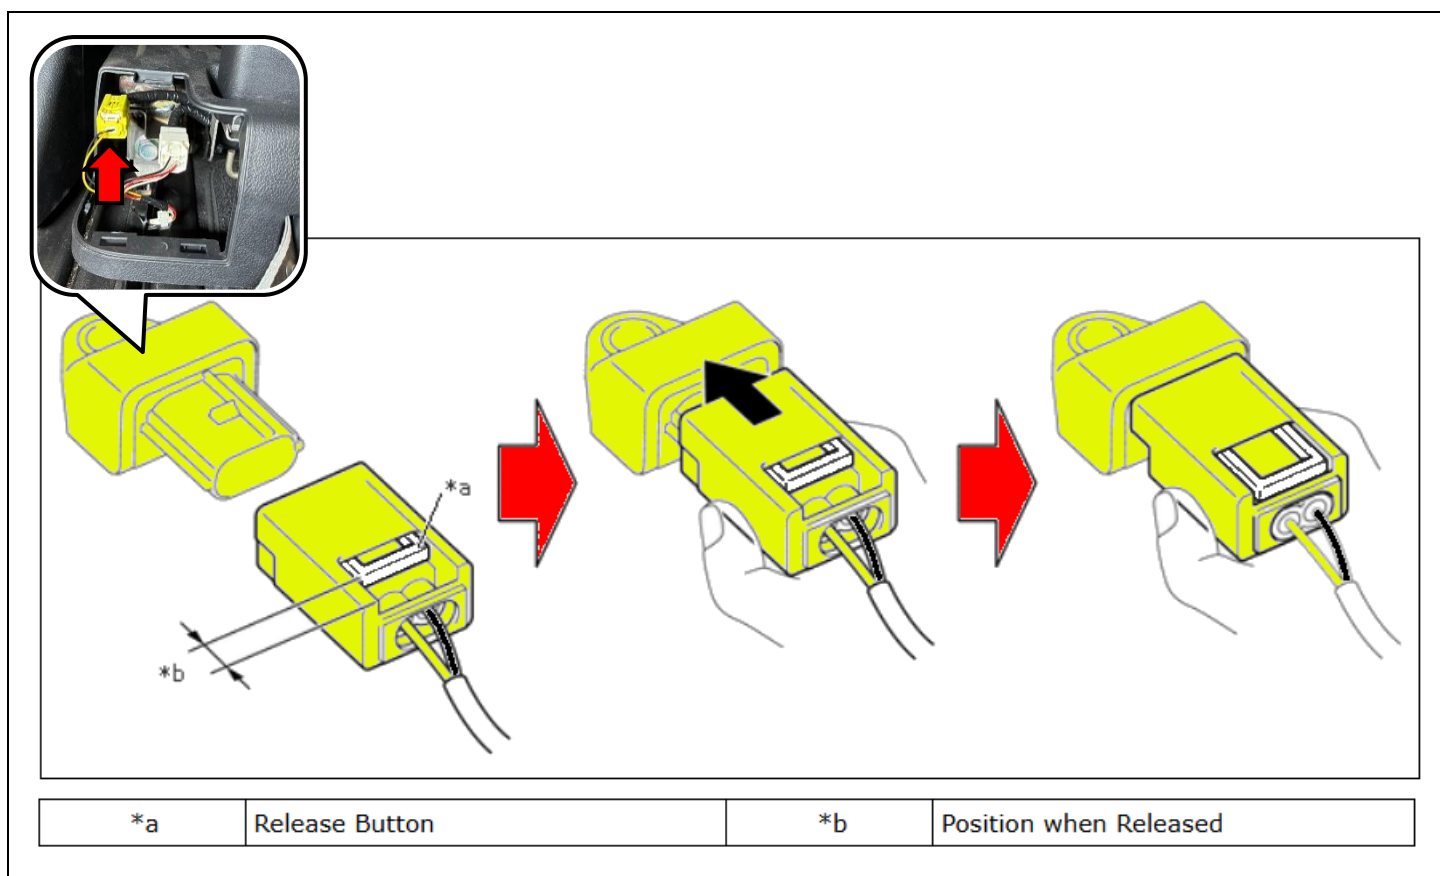
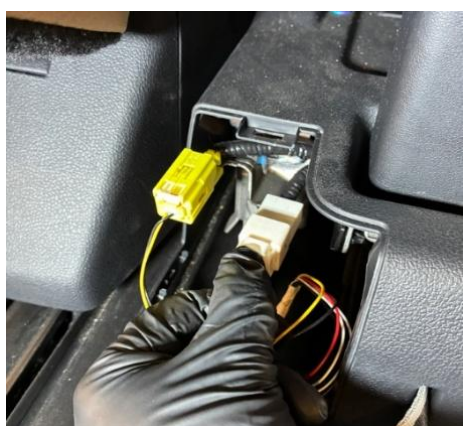
- Before connecting the connector, check that the position of the release button is as shown in the illustration.
- While holding the sides of the connector, slide the connector in the direction shown by the arrow in the illustration until a click sound is heard to connect the airbag connector, and check that the release button is in its original position.

- Slide the connector in straight to connect it. Be careful not to pry the connector.
- To prevent deformation of the connector and possible damage to the partial engagement prevention mechanism, do not press down on the top surface of the connector when connecting it. Be sure to hold the connector by the sides.

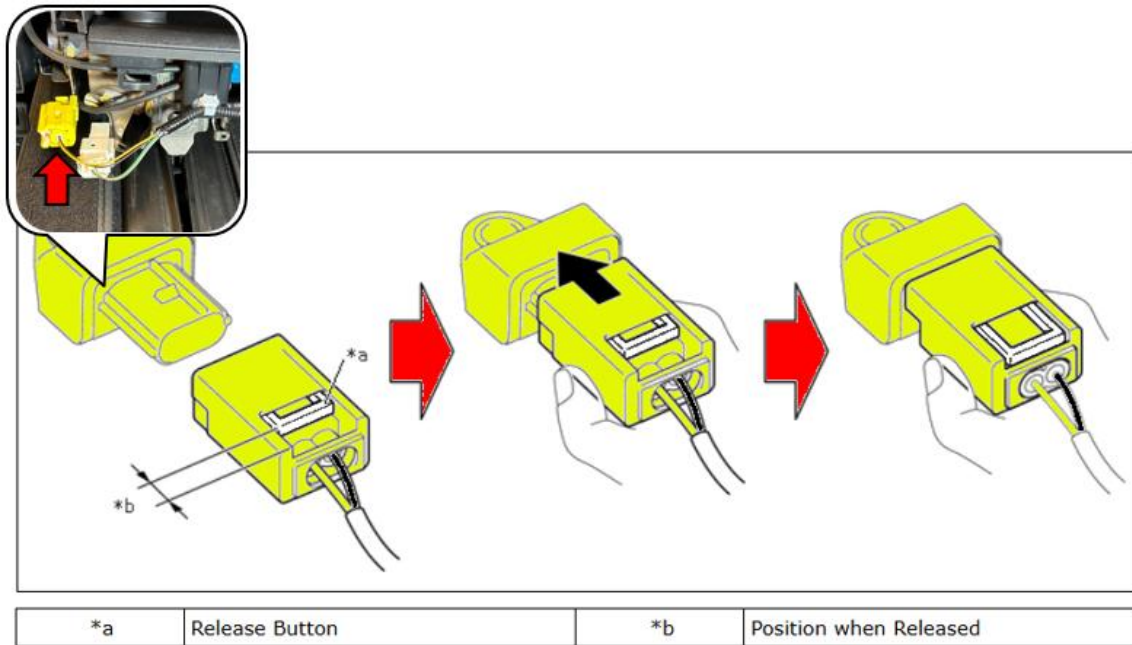
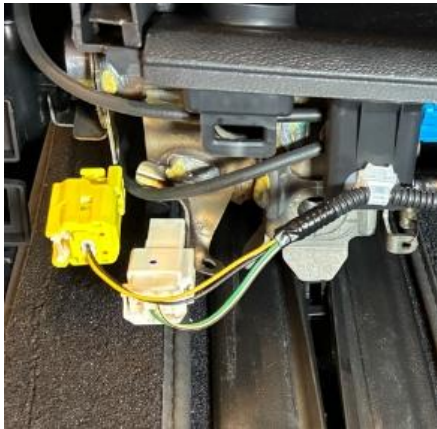
- Before connecting the connector, check that the position of the release button is as shown in the illustration.
- While holding the sides of the connector, slide the connector in the direction shown by the arrow in the illustration until a click sound is heard to connect the airbag connector, and check that the release button is in its original position.

- Slide the connector in straight to connect it. Be careful not to pry the connector.
- To prevent deformation of the connector and possible damage to the partial engagement prevention mechanism, do not press down on the top surface of the connector when connecting it. Be sure to hold the connector by the sides.
