NHTSA:25V-673

Winnebago Towable: CAM0000044

**SUBJECT: Bedroom Shelf May Fail due to Improper Securement**

Bedroom Shelf May fall due to Improper Securement

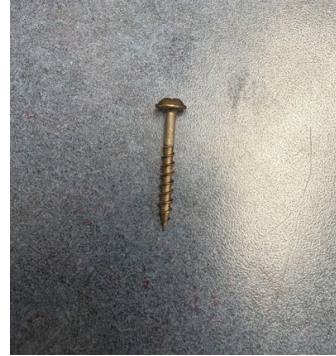
- **Screw gun**
- **#8 Truss Head Coarse Thread Self-Tapping 1.25” Screws**

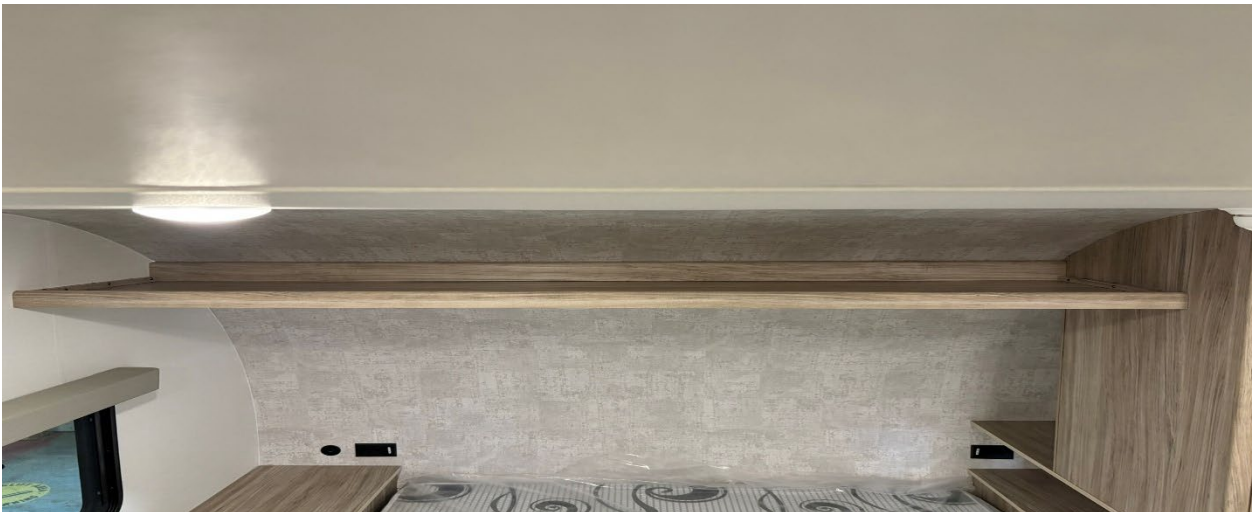
- 1. Inspect the shelf to ensure that it is secured to the top cleat, the sidewall, and RHF wardrobe**

- 2. Install 3 screws into the top stile going into the shelf and into the off-doorside sidewall. Then install 3 screws going into the shelf from the top of the stile.**

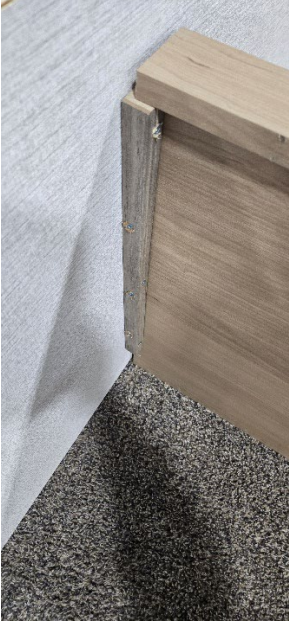
- 3. Install cleat on the bottom of the left side of the shelf, securing with 3 screws into the sidewall backer and 3 screws going up into the shelf.**

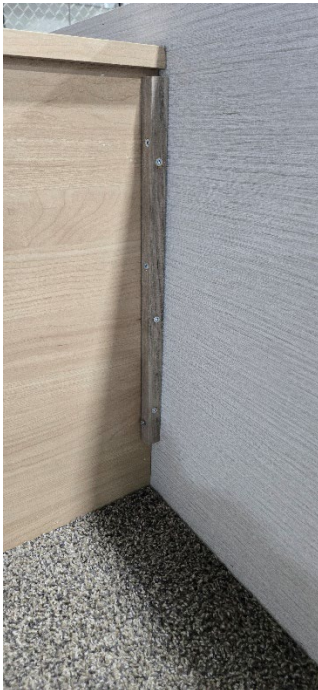
- 4. Repeat on the right side. Secure the cleat to the bottom side of the shelf and into the backer in the wardrobe.**
