RECALL 25V682 / 2025-545 REMEDY INSTRUCTIONS

Concern:
The charge line may not have over-current protection.

USE THIS REPAIR SPECIFICALLY FOR AURORA & CATALINA

CERTAIN 2025 – 2026 – AURORA TRAVEL TRAILERS
CERTAIN 2025 – 2026 – CATALINA TRAILER TRAILERS

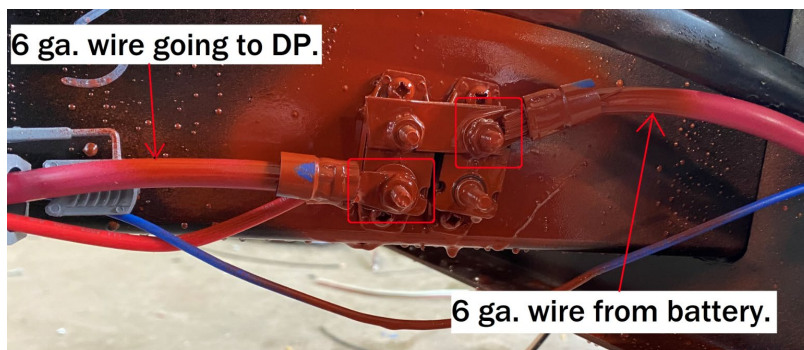
FIGURE 2 - CORRECT

- IF THE 6 AWG. WIRES ARE CONNECTED AS SHOWN IN FIGURE 2, CLAIM THE INSPECTION, WORK COMPLETED.

- REMOVE THE SMALLER WIRE/EYELET FROM THE POST;
- INSTALL THE 6 AWG. WIRE/EYELET ONTO THE POST;
- RE-INSTALL THE SMALLER WIRE/EYELET ONTO THE POST. ROTATE THE SMALLER WIRE WHERE THE EYELET CRIMPS DO NOT OVERLAP. IF THEY OVERLAP, THEY MAY BECOME LOOSE.
- INSTALL THE NUT AND TIGHTEN, CLAMPING THE TWO WIRE/EYELETS TOGETHER, ENSURING PROPER SECUREMENT;
- THE REMEDY SHOULD NOW MATCH FIGURE 2;
