**BULLETIN NUMBER:**  
CB26-E-002

#### FVR FRONT STABILIZER BAR

#### SAFETY RECALL (CUSTOMER VEHICLES ONLY) -- 25V-719

- 2022-2026MY Isuzu FVR Vehicles

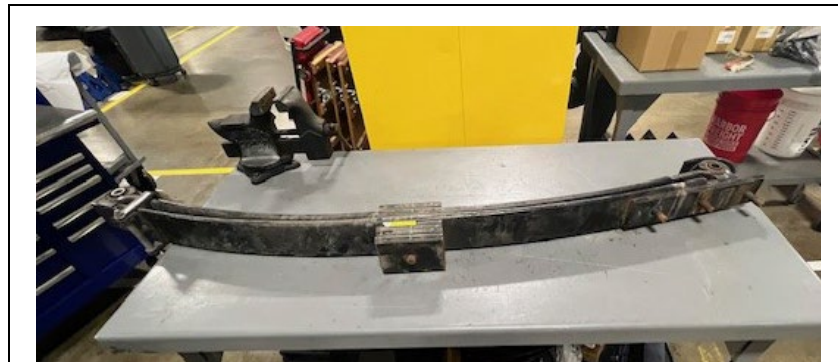
**Figure 8**

15. Place the leaf spring on a suitable work surface. (See Figure 8.)

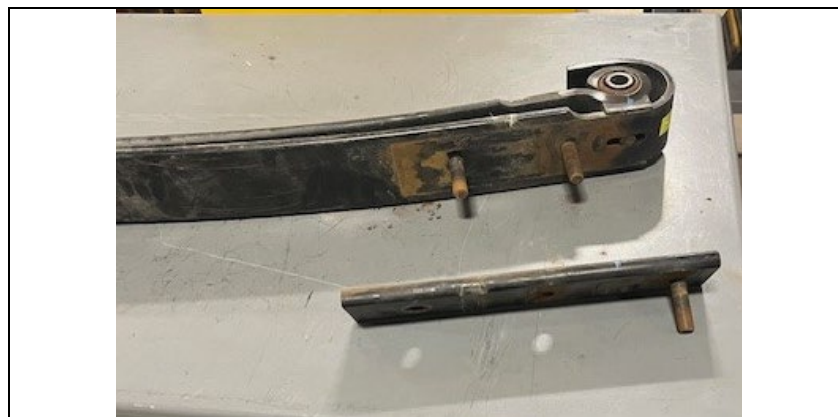
**Figure 9**

16. Remove the stabilizer bar mounting plate on the front of the leaf spring (if not already done). (See Figure 9.)

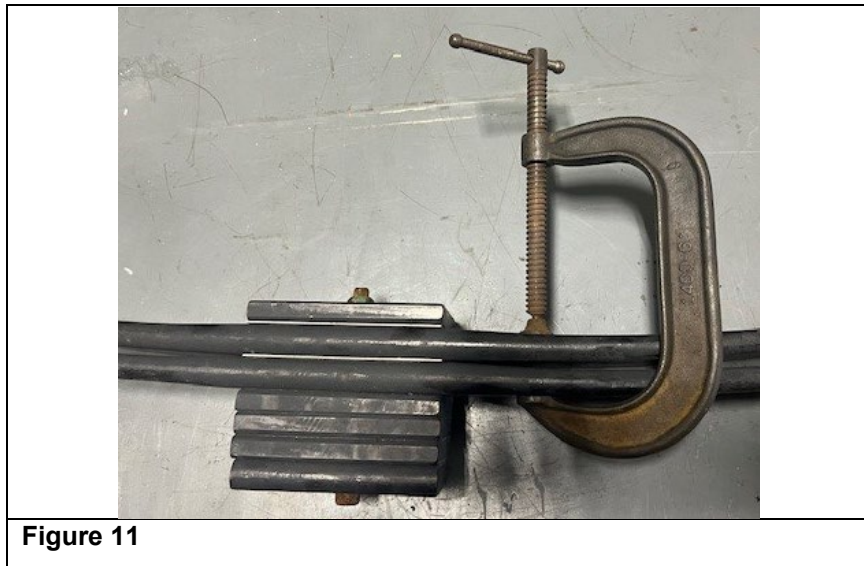
18. Clamp the leaves of the leaf spring together with a large C-clamp. (See Figure 11.)

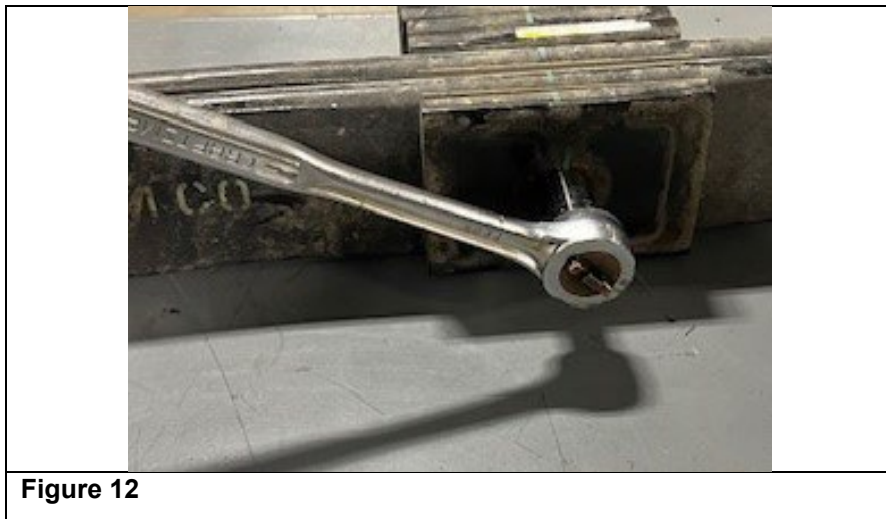
19. Remove the center nut holding the spring leaves together. (See Figure 12.)

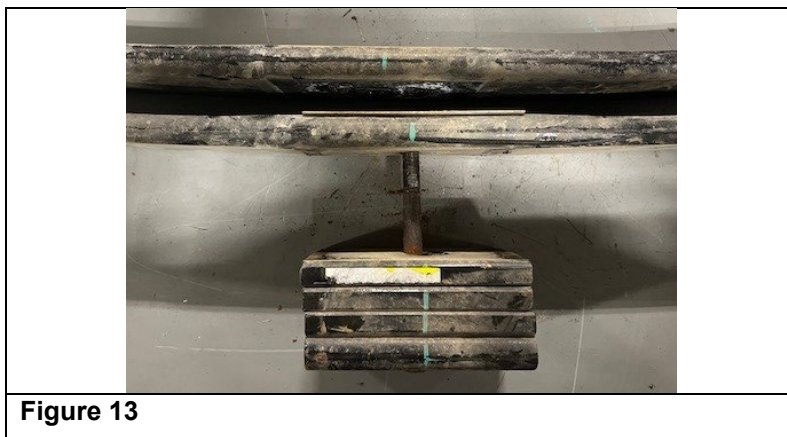
20. Slowly release tension on the C-clamp and remove it. Pull the center pin downward from the spring assembly enough to clear the upper spring leaf. (See Figure 13.)

**NOTE: The center pin can be lightly tapped down with plastic faced hammer to free it up if it does not easily move.**

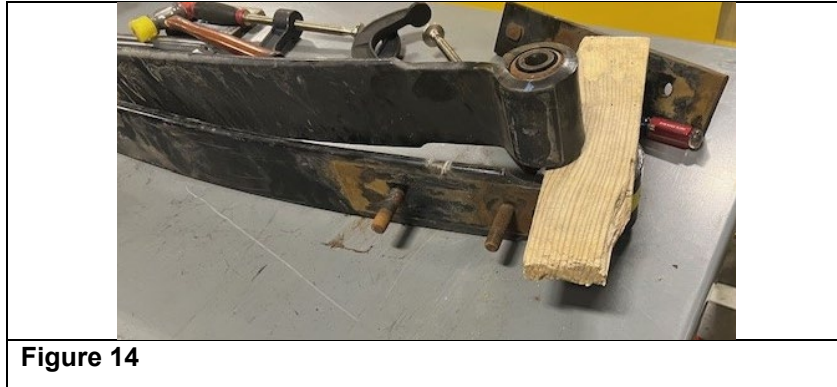
21. Move the upper leaf of the spring assembly upwards enough to clear the two studs and support it with a piece of wood as shown in Figure 14.

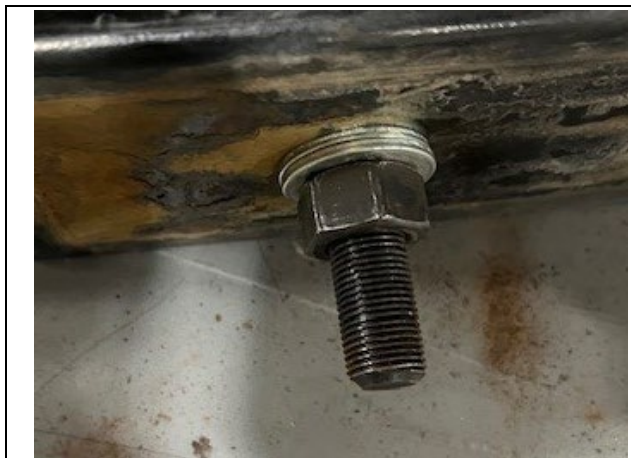
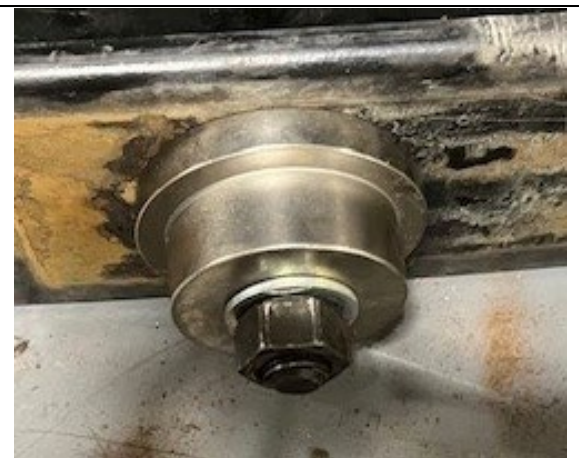
23. Insert a new stud in each empty hole. Stack the old washers or use a spacer and install an old nut on the stud and hand tighten. (See Figures 16 and 17). Tighten the nut to draw the stud into the hole until it is completely inserted, with the head seated flush. Remove the nuts and washers/spacer.

**NOTE: A hammer may be carefully used as necessary to completely seat the studs.**

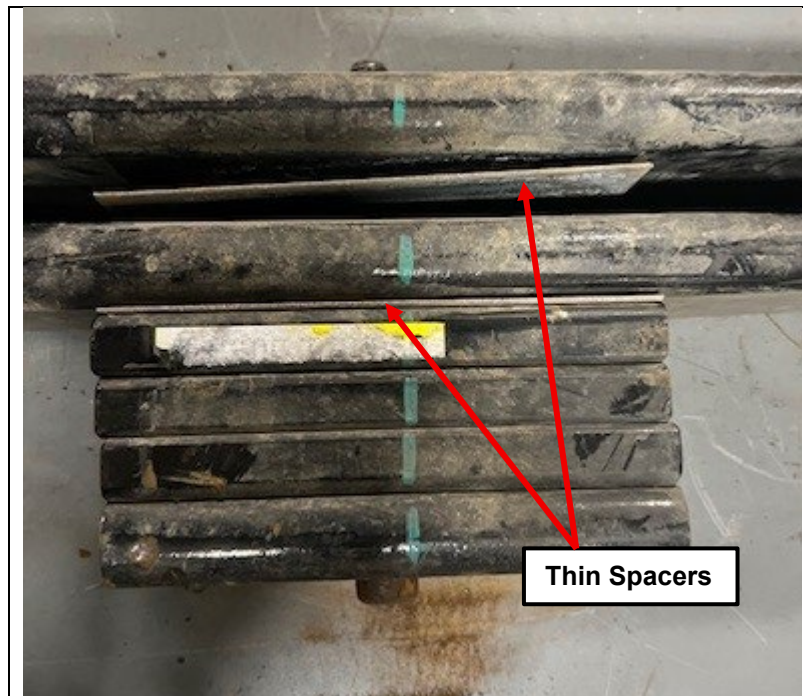
Figure 20

25. Insert the center pin/bolt back through the leaf spring assembly. Ensure that all the thin spacers are properly in place. (See Figure 20.)

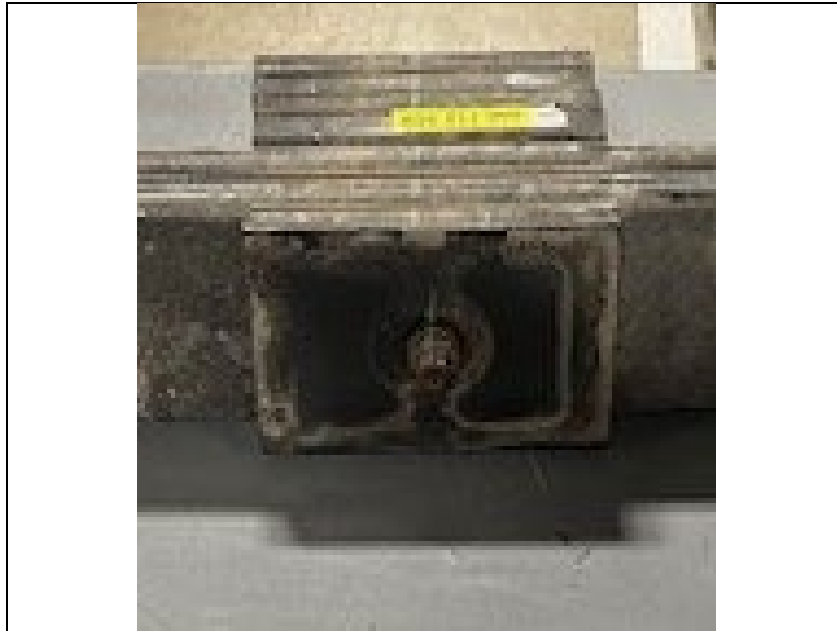
**Figure 21**

26. Install the C-clamp onto the leaf spring leaves and tighten the clamp until the center pin can be pushed completely through. Install the upper leaf spring seat and a new nut (See Figure 21.) **Tighten the nut to 160 N•m (118 lb ft).**

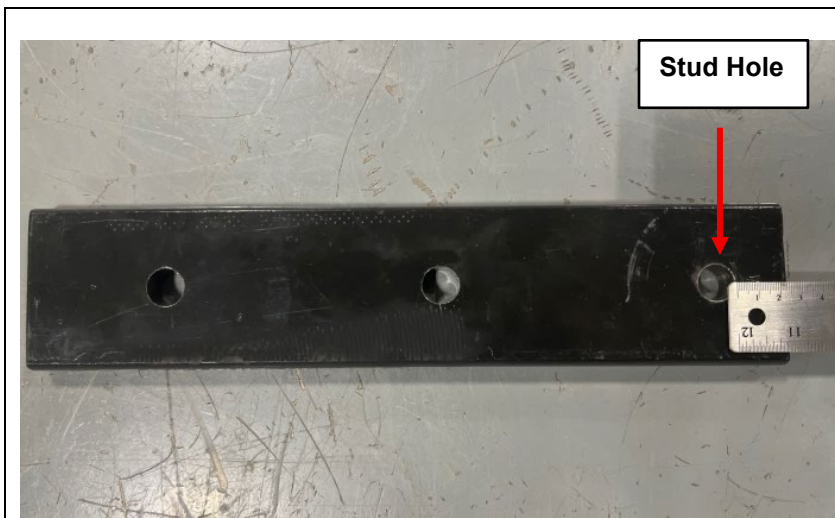
**Figure 22**

27. Install a new stud into a new stabilizer bar mounting plate into the hole on the plate 23mm from the leading edge. (See Figure 22.) Hold the plate in a vice while installing the new stud and use the same process described in Step 23 to install the stud. (See Figure 23.)

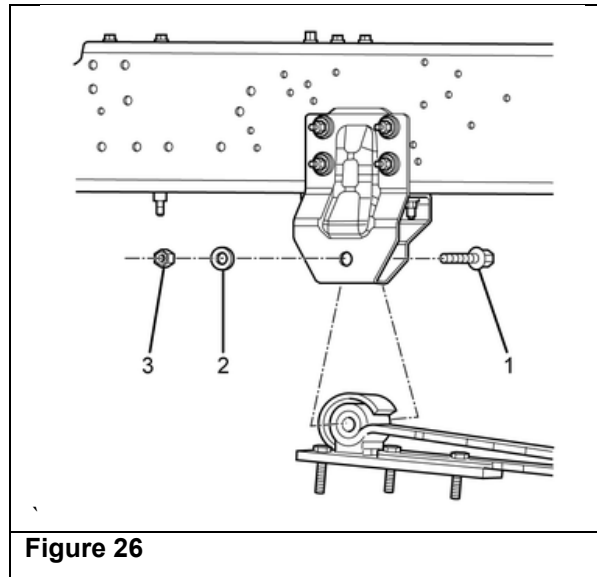
Figure 26

33. Install the front leaf spring eye bolt (1), washer (2) and nut (3), but do not tighten. (See Figure 26.)

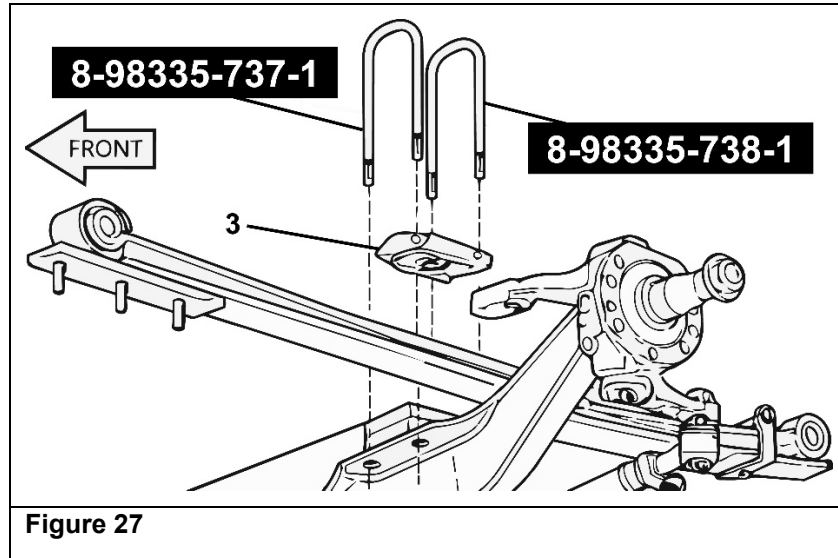
Figure 27

34. Install two *new* U-bolts 8-98335-737-1 (front) and 8-98335-738-1 (rear) with the upper spring spacer (3). (See Figure 27.)

**NOTE: New U-bolts, washers, and nuts must be utilized when installing the leaf spring.**

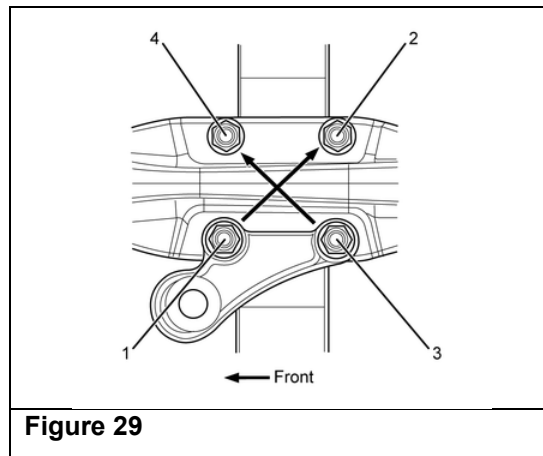
36. Install the *new* U-bolt washers and the *new* U-bolt nuts. (See Figure 29.)

- Tighten the U-bolt nuts (1–4) in a first pass in the sequence shown in Figure 29 to 100 N•m (74 lb ft).
- Tighten the U-bolt nuts (1–4) in a second pass in the sequence shown in Figure 29 to 190 N•m (140 lb ft).
- Tighten the U-bolt nuts (1–4) for a final pass in the sequence shown in Figure 29 to 220 N•m (162 lb ft).

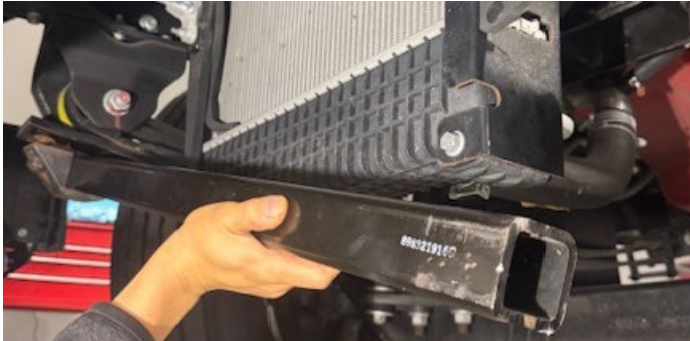
Figure 31

41. Install the old front stabilizer bar by sliding it into the left bracket until it is against the raised ridge on the bracket. (See Figures 31 and 32.)

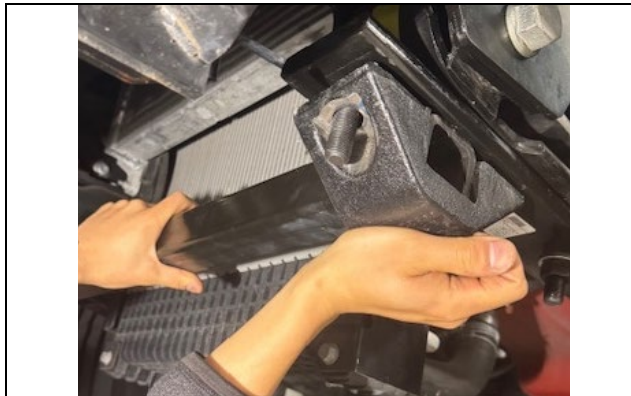
Figure 33

42. Support the stabilizer bar and install the driver side stabilizer bar bracket with new washers and nuts. (See Figure 33.) Ensure that the end of the stabilizer bar is within the raised ridge as shown in Figure 32.

43. Tighten all four (4) nuts of the stabilizer bar brackets and torque to 230 N•m (170 lb ft).
