# SAFETY RECALL

## Engine Compartment Fire - High Duty Cycle

Reference: B3C / NHTSA 25V-720

2018 – 2025 (VF) RAM ProMaster

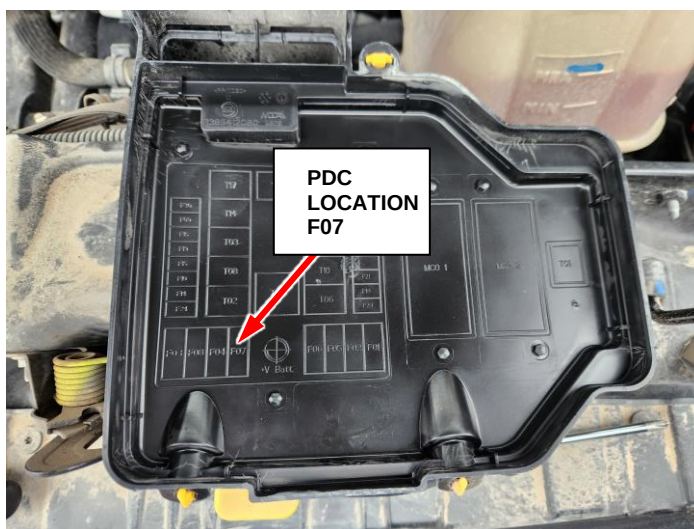
**Figure 6 – PDC Location F07**

1. Loosen the fasteners holding the PDC cover in place and remove it.
2. Remove the old fuse from location F07 and discard it.
3. Install a new 40A fuse to location F07.
