**SAFETY RECALL**  
NORTH AMERICA  
**Engine Compartment Fire**

Reference: 67C / NHTSA 25V-720

2018 – 2026 (VF) RAM ProMaster

Replace the cooling fan module, change the 400W fan fuse, insert an owner's manual addendum and add a label for the Power Distribution Center (PDC).

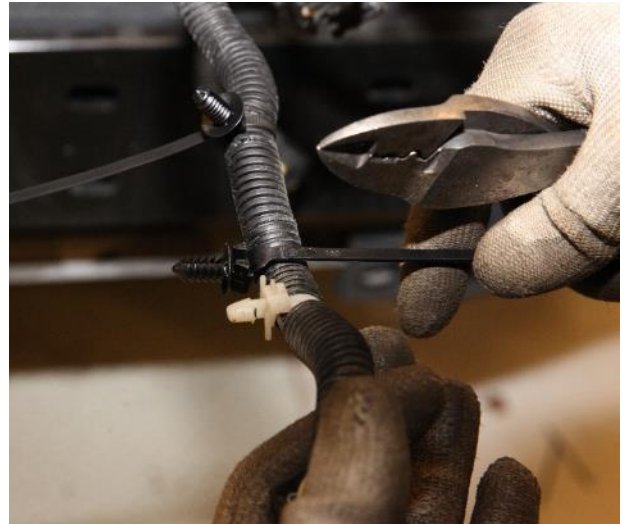
**Figure 19 – Wire Harness Retainers**

19. Replace any damaged retainers on the cooling fan module wire harness. Install the replacement retainers in the same location and direction as the original retainer (Figure 19).
