# SAFETY RECALL

## Engine Compartment Fire - High Duty Cycle

Reference: B3C / NHTSA 25V-720

2018 – 2025 (VF) RAM ProMaster

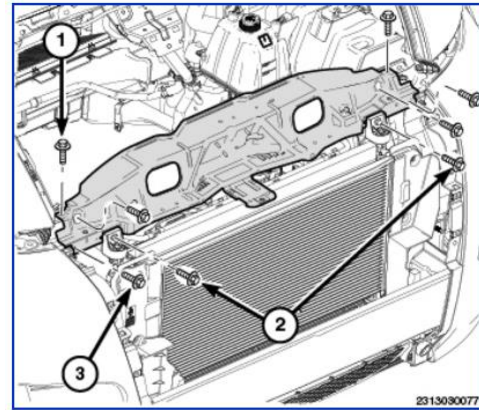
Figure 4 – Radiator Crossmember Fasteners

17. Remove the top fasteners and pull the pull forward the radiator crossmember (Figure 4).

- 1 - Top Fasteners
- 2 - Support Bolts
- 3 - Front Fastener

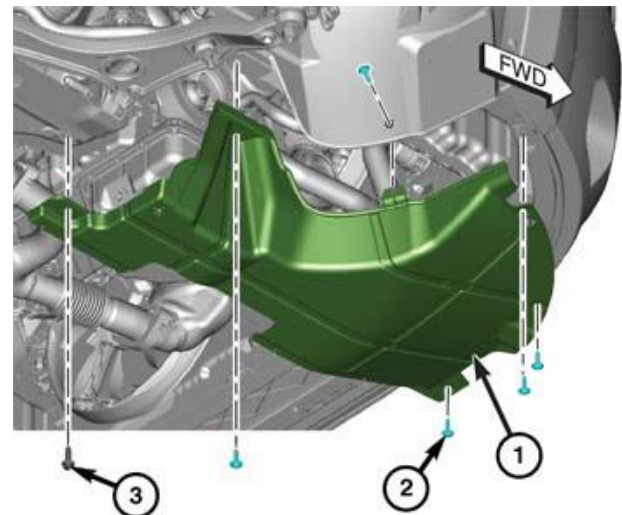
Figure 16 – Right Side Underbody Shield

12. Remove the fastener (3) that secures the right side underbody shield (1) to the cradle (Figure 16).
13. Remove the five fasteners (2) that secure the right side underbody shield (1) to the fascia and wheel liner (Figure 16).
14. Remove the right side underbody shield (1) from the vehicle (Figure 16).

22. Install the right side underbody shield (1) to the vehicle (Figure 16).

23. Install the five fasteners (2) that secure the right side underbody shield (1) to the fascia and wheel liner, tighten securely (Figure 16).

24. Install the fastener (3) that secures the right side underbody shield (1) to the cradle, tighten to 20 N·m (15 ft lbs). (Figure 16).

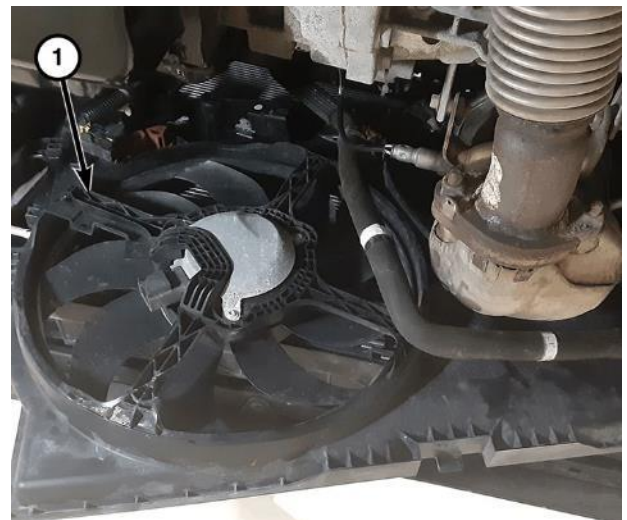
**Figure 18 – Cooling Fan Module**

16. Remove the cooling fan module (1) from the bottom of the vehicle (Figure 18).

20. Install the **NEW** cooling fan module (1) to the vehicle from the bottom (Figure 18).

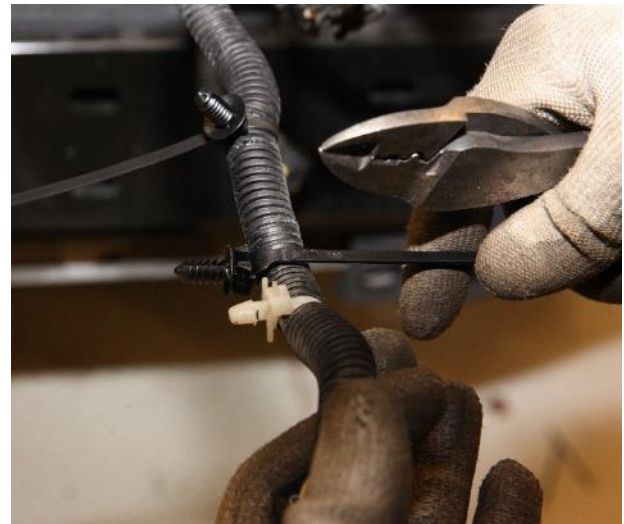
**Figure 19 – Wire Harness Retainers**

19. Replace any damaged retainers on the cooling fan module wire harness. Install the replacement retainers in the same location and direction as the original retainer (Figure 19).
