# SAFETY RECALL

## Engine Compartment Fire - Rental

Reference: C9C / NHTSA 25V-720

2018 – 2026 (VF) RAM ProMaster

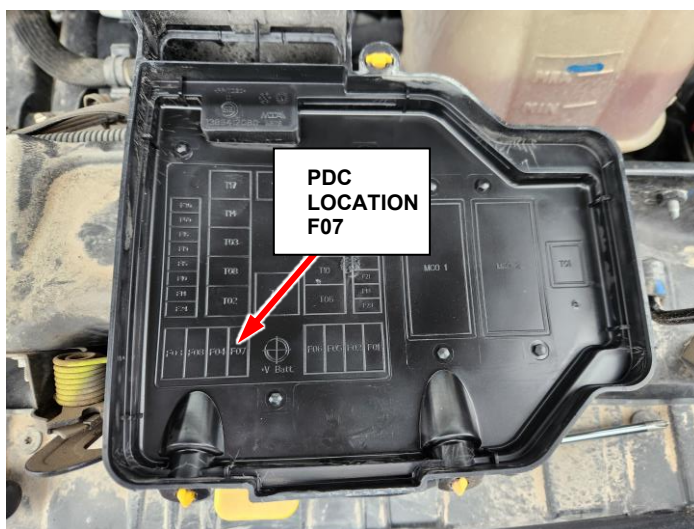
**Figure 6 – PDC Location F07**

1. Loosen the fasteners holding the PDC cover in place and remove it.
2. Remove the old fuse from location F07 and discard it.
3. Install a new 40A fuse to location F07.

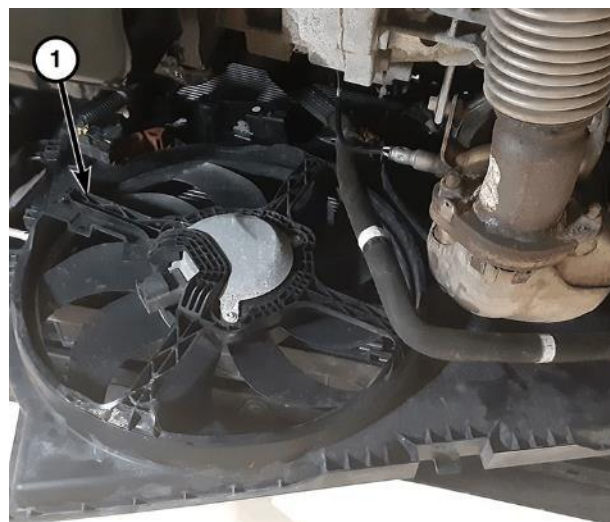
**Figure 18 – Cooling Fan Module**

16. Remove the cooling fan module (1) from the bottom of the vehicle (Figure 18).

20. Install the **NEW** cooling fan module (1) to the vehicle from the bottom (Figure 18).
