# SAFETY RECALL

## Engine Compartment Fire - High Duty Cycle

Reference: B3C / NHTSA 25V-720

2018 – 2025 (VF) RAM ProMaster

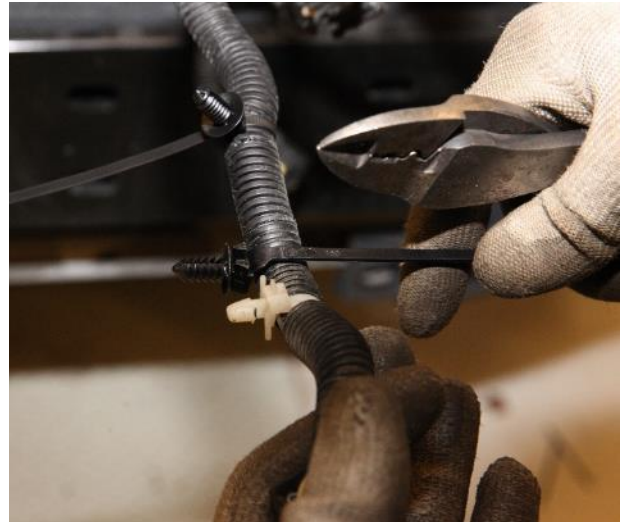
**Figure 19 – Wire Harness Retainers**

19. Replace any damaged retainers on the cooling fan module wire harness. Install the replacement retainers in the same location and direction as the original retainer (Figure 19).
