## Safety Recall Launch Notification

<b>Campaign #</b>	<b>NHTSA ID</b>	<b>Campaign Codeword</b>	<b>Check Spot Welds on Longitudinal Frame Member</b>
2025 110007	25V725	VS3RASCHW

<b>Total Recall Population</b>	366	<b>Model(s)/ Platform(s)</b>	Sprinter (907)
<b>Vehicles in Dealer Inventory</b>	0		
<b>Model Year(s)</b>	2023-2024		
<b>Issue</b>	Mercedes-Benz AG, the manufacturer of Mercedes-Benz Sprinter vehicles, has determined that on certain Sprinter (907 platform) vehicles, the number of spot welds on the longitudinal frame member of the Body in White might not meet specifications. As a result, the seat mounts for the third-row passenger seats might not sufficiently withstand the loads during a crash, which could increase the risk of injury.		
<b>What We're Doing</b>	MBUSA will conduct a voluntary recall. An authorized Mercedes-Benz Sprinter dealer will check the right longitudinal frame member on the affected vehicles and rework it, if necessary.		
<b>Remedy</b>	The remedy is available and parts can be ordered at this time.		
<b>Launch Date</b>	Affected VINs will be flagged in VMI as " <b>OPEN</b> " on Friday, December 2, 2025. The campaign will be visible on the <a href="http:/

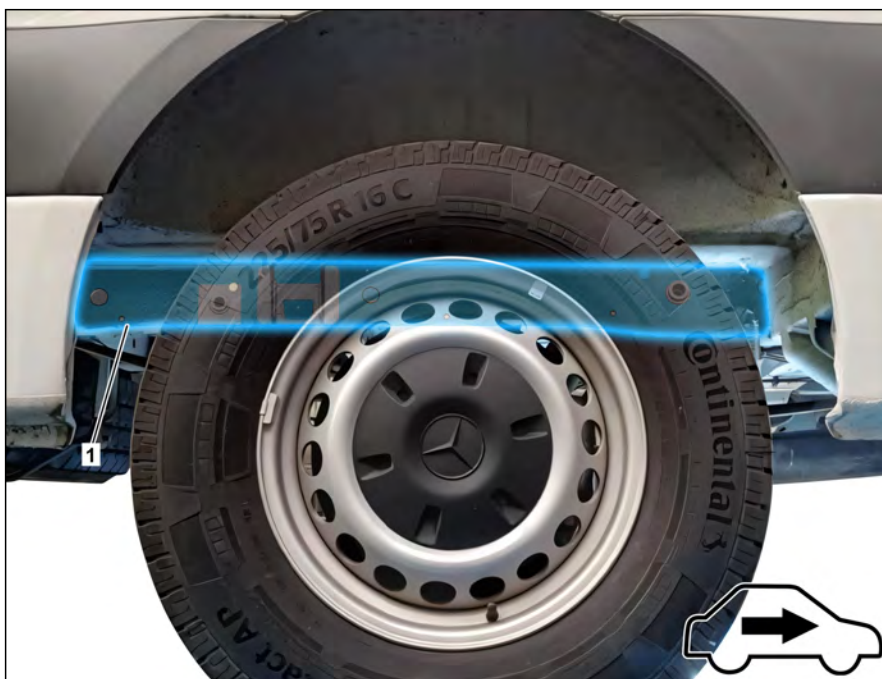
D61.25-A198-76

**Rear right longitudinal member (1) on outside: 9 blind rivet**

1    *Right rear longitudinal member*

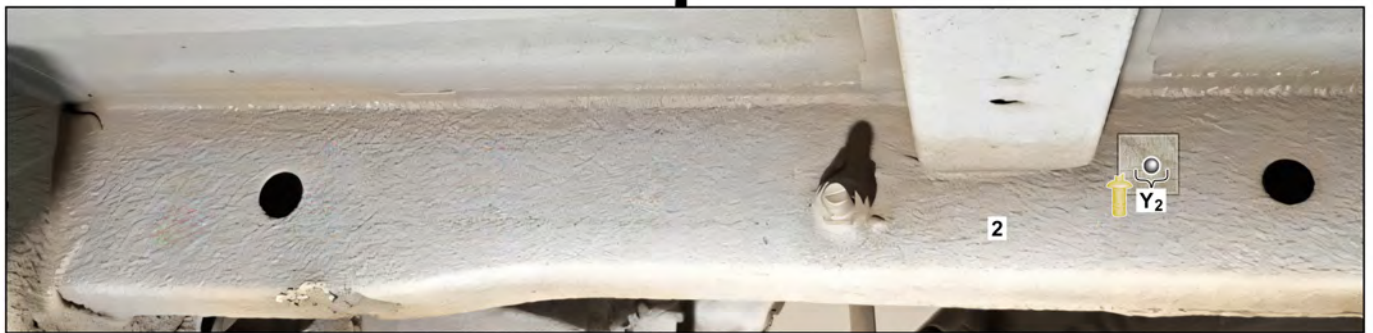
D61.25-A211-79

**Rear left longitudinal member (2) on inside**

20 Rivet rear left longitudinal member (2) with blind rivet 6.5x12.5 (area Y<sub>2</sub>).

Coat respective rivet with seam seal before fitting.
