SAFETY RECALL

SR25-311

DATE :	November 2025	SECTION :	23 ACCESSORIES
SUBJECT:	WALL MOUNTED RETRACTABLE SHOULDER BELT REINSTALLATION

Model	VIN
X3-45 Commuter Model Year: 2025

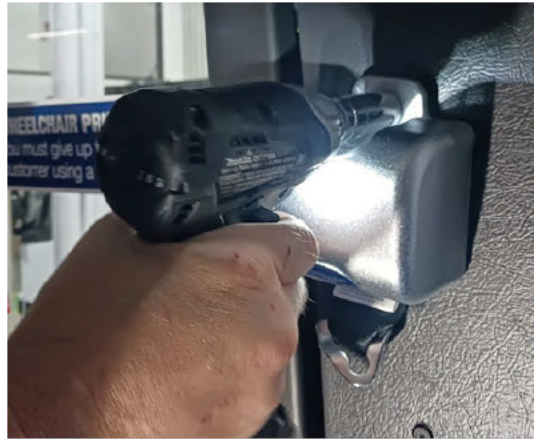
1. Loosen the shoulder belt and remove the bolt.

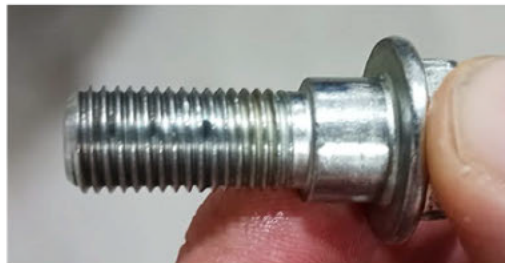
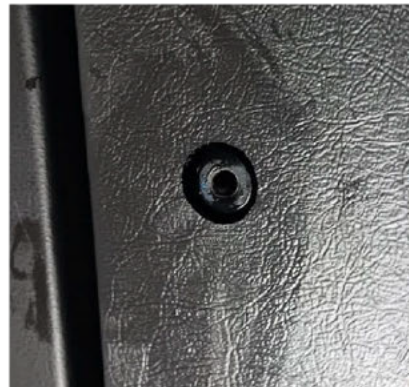
3. Remove scotch grip on the bolt. Use a wire brush to help. Clean the finishing surface.

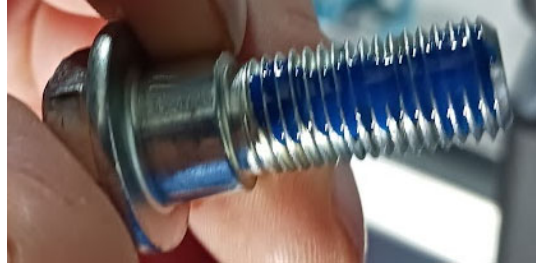
4. When the bolt is clean, put blue loctite 680038 on it.

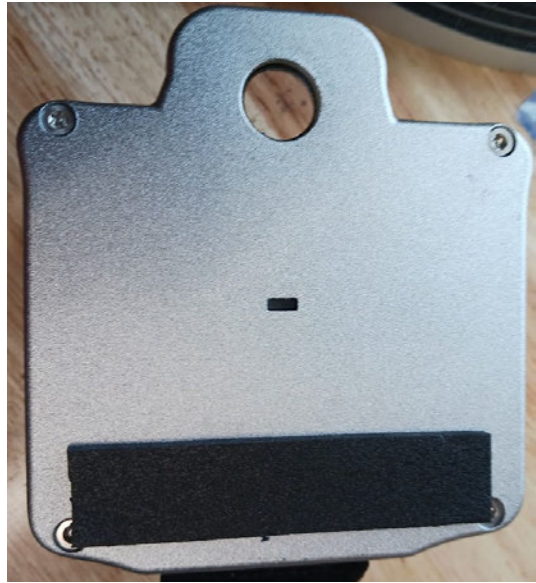
5. Cut a length 3.5inches of tape 506001
6. Put a the protection tape 506001 on the back of the belt.

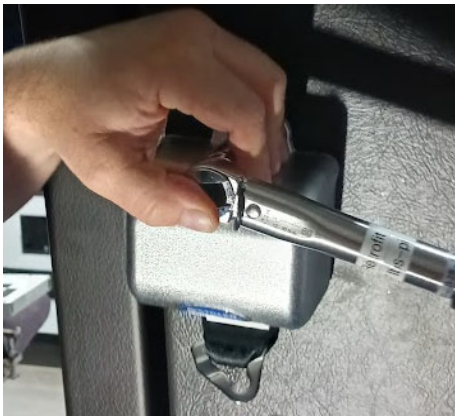
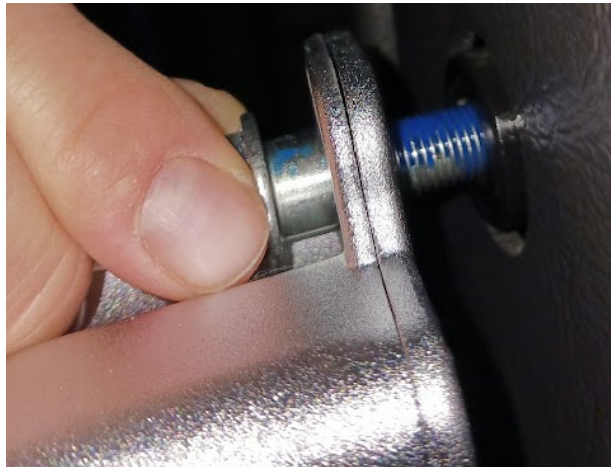
7. Torque the bolt with a **17mm** socket. The torque needs to be with set at **27lbs-ft**.

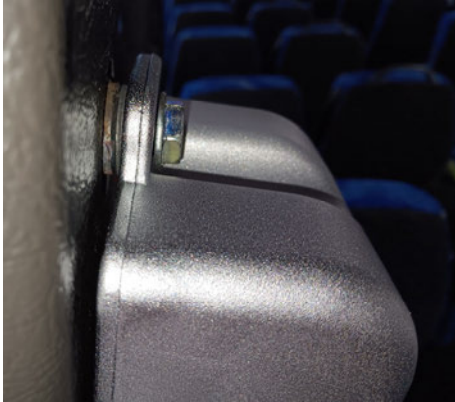
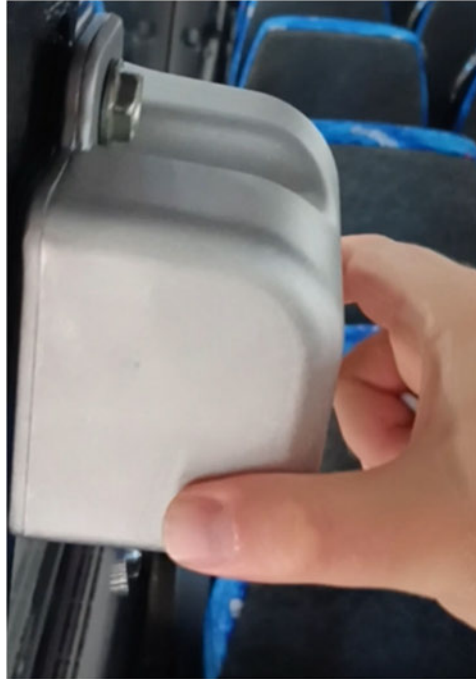
8. **Note :** If the belt touches the finishing surface of the post and is tight. The use of 1 or 2 500897 washers can be necessary. It will shift the shoulder away from the finishing surface.

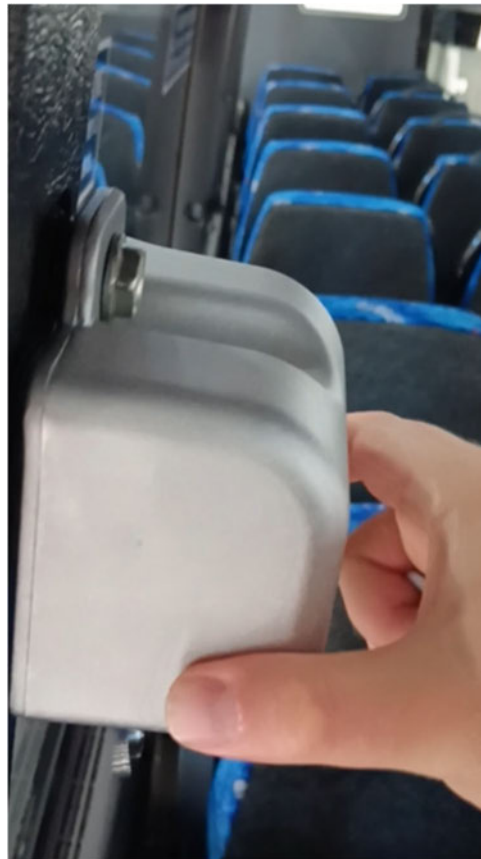
9. Test the belt. It needs to rotate freely.
