Safety Recall

Code: 692K

Subject	Driver & Front Passenger Safety Belt Buckles				
Document History	Date		Summary		
	11/20/2025		Original publication		
Affected Vehicles	Country	Beginning Model Year	Ending Model Year	Vehicle	Vehicle Count
	USA	2025	2025	Q8	30
	USA	2025	2025	RSQ8	26
	USA	2025	2025	SQ8	5
	CAN	2025	2025	Q8	20
	CAN	2025	2025	RSQ8	3
	CAN	2025	2025	SQ8	5
	<p><i>Check Campaigns/Actions screen in Elsa on the day of repair to verify that a VIN qualifies for repair under this action. Elsa is the <u>only</u> valid campaign inquiry & verification source.</i></p> <ul style="list-style-type: none"> ✓ Campaign status must show "open." ✓ If Elsa shows other open action(s), inform your customer so that the work can also be completed at the same time the vehicle is in the workshop for this campaign. 				
Problem Description	A rivet that secures the safety belt buckle to the driver's or front passenger's safety belt stalk may be missing. In a crash, a missing safety belt rivet can cause the safety belt to malfunction, increasing the risk of injury to the occupant.

Subject: Safety Recall 692K - Driver & Front Passenger Safety Belt Buckles

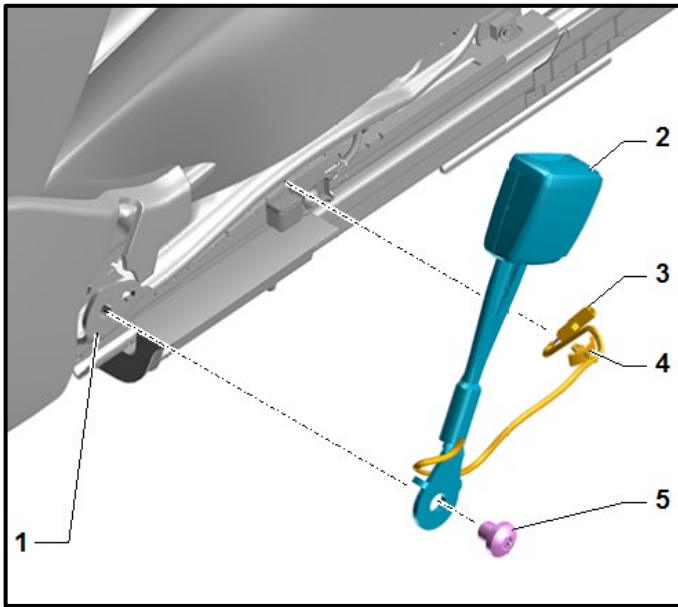
Repair Overview

- Perform seat belt buckle tug test.
- Replace both front seat belt buckles, regardless of test results.

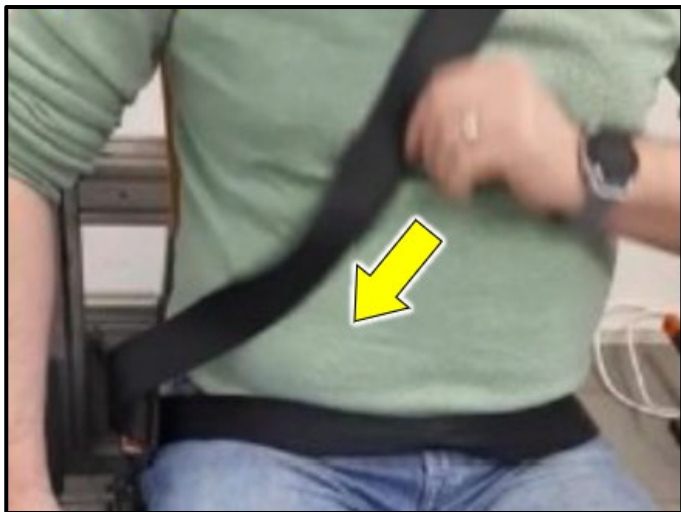
- While sitting in the front seat, put the seat belt on and ensure that it is fully buckled.
- Quickly pull on the seat belt in the direction indicated <arrow> to engage the seat belt reel locking mechanism.
- Keep steady pressure applied to the belt so that the locking mechanism stays engaged.

The test in this section must be performed for the driver and passenger front seats prior to replacing the seat belt buckles.

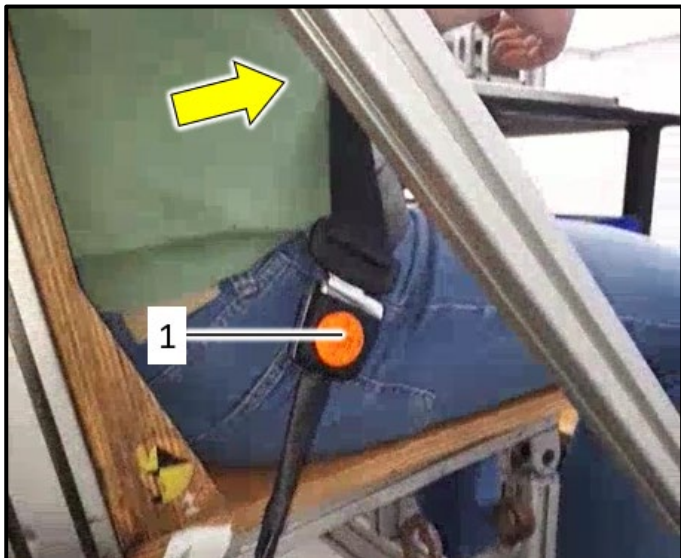
- Lean forward several times in the direction indicated <arrow> to apply pressure to the buckle <1>.
- Slightly lift your hips upwards and away from the buckle <1> to apply pressure to the assembly.

The test steps below are to be performed with the seat belt locking mechanism engaged.

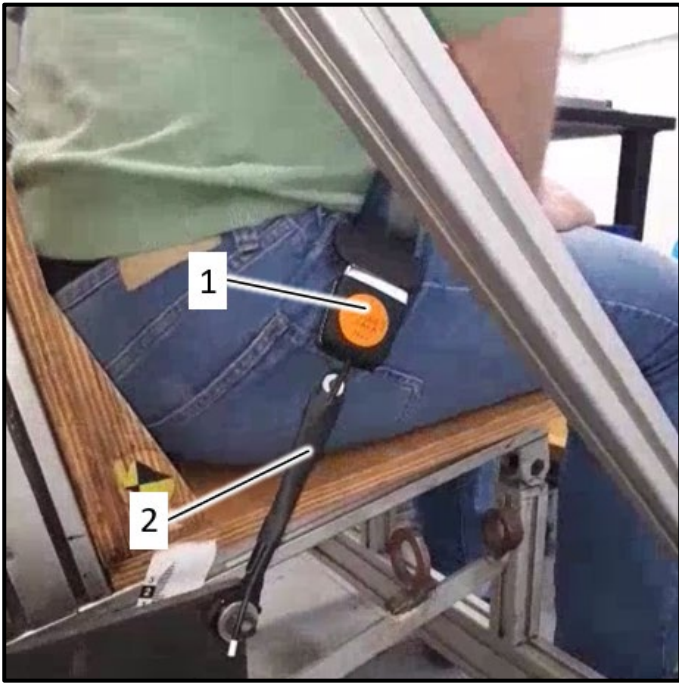
- Take note if the buckle <1> has separated from the tether <2>.
- Repeat the test on the other seat.

Document the test results for each front seat belt buckle on the repair order.

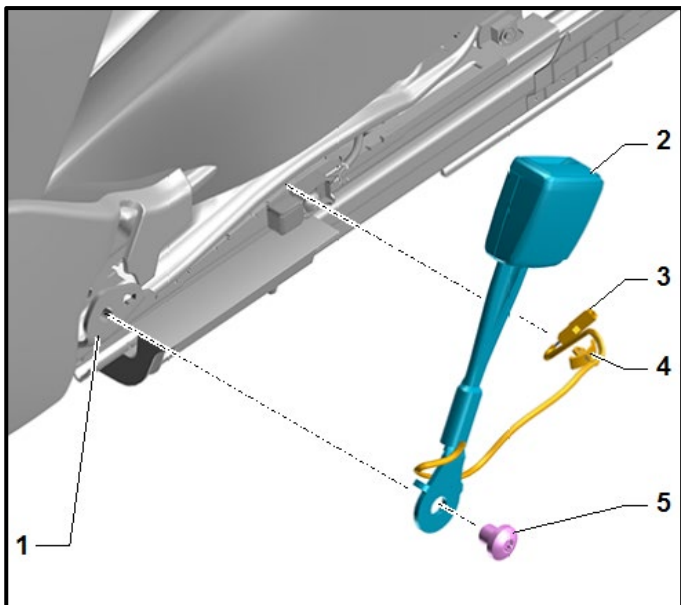
- Replace both front seat belt buckles per the ELSA repair manual:
 - *Repair manual > Body > Body Interior > 69 Passenger Protection, Airbags, Seat Belts > Seat Belts > Front Seat Belt Latch, Removing and Installing.*

Part Number	Part Description
4K8-857-755-R MNB	Seat belt buckle (right)
4K8-857-755-M MNB	Seat belt buckle (left)
