## NHTSA Safety Recall 25v-784

### *Claim Preparation & Repair Instructions*

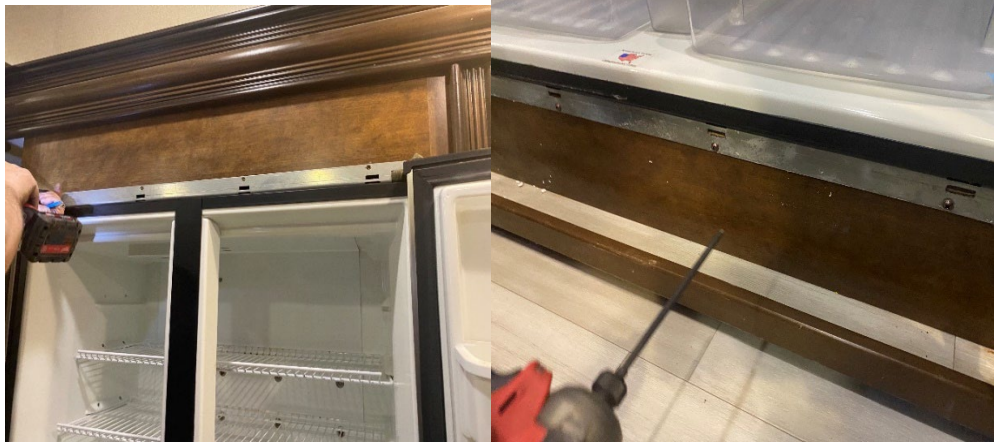
**Step 4:**

Remove the upper and lower covers to access the screws securing the refrigerator in place.

Once all the cooling unit is secured, reinstall the refrigerator into position and secure with screws as discussed in Step 4.

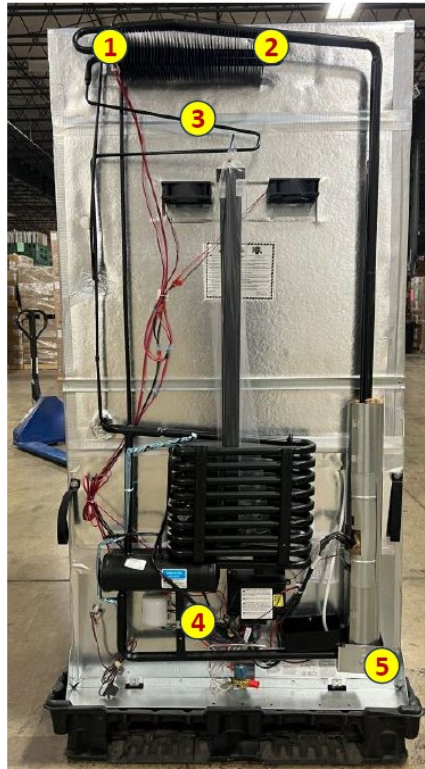
**Step 6:**

Replace fasteners of the cooling unit that are loose/broken. Only loose/broken fasteners need to be replaced. Fasteners are in the following positions:
