HYUNDAI

Technical Service Bulletin

26-01-023H

SUBJECT: FUEL TANK EXPANSION - CHECK VALVE REPLACEMENT, FUEL TANK INSPECTION, & ECM UPDATE (RECALL 286)

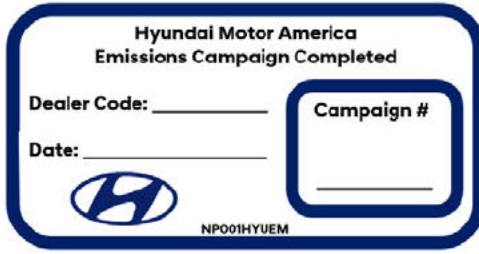
<ol style="list-style-type: none"> 1. Clip-Hose (14720-15006S) 2. Clip-Hose (14720-13806S) 3. Valve-Check 4. Hose Assembly-Vapor, A 5. Hose Assembly-Vapor, B
Hyundai Emissions Label	NP001-HYUEM

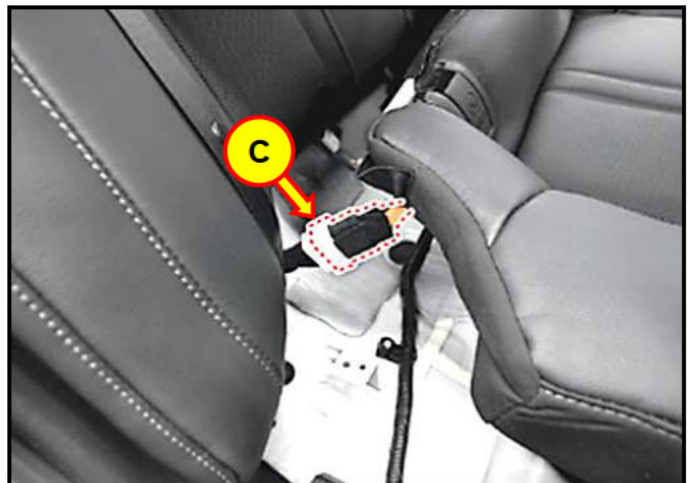
Remove the rear seat cushion assembly (A) by pulling it upward.

2. Disconnect the rear seat heater connector if equipped (B).

3. Disconnect the rear seat heater unit connector if equipped (C).

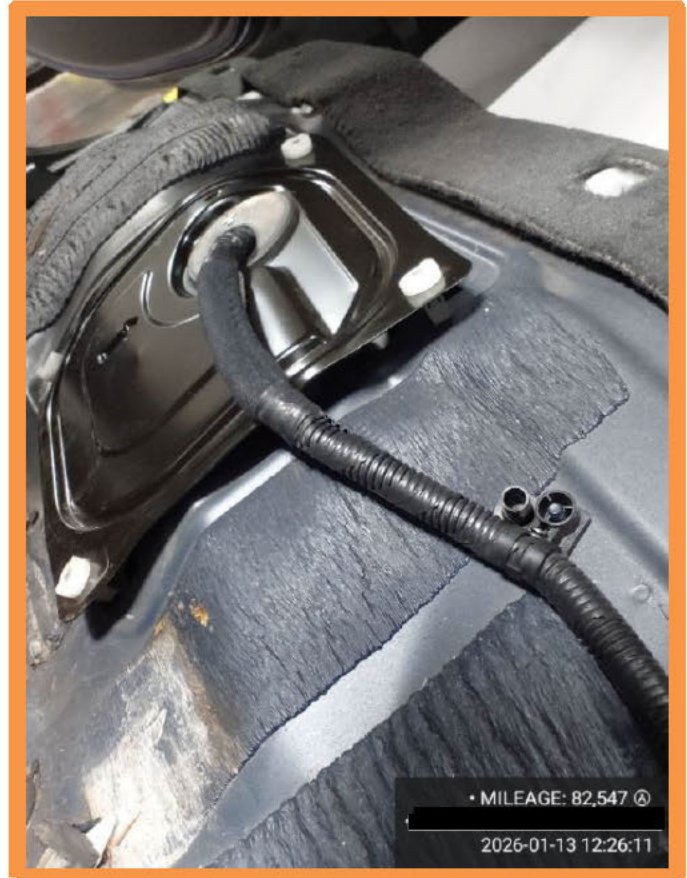
5. Inspect the fuel pump service cover and surrounding areas for the following items:
- Damage or deformation of the sheet metal.
 - Evidence of a previous sheet metal repair or repair attempt.
 - Gap between the fuel pump service cover (D) and surrounding sheet metal.

6. Submit a Prior Approval (PA) Request with the following information:
- Repair Group: **Other**
 - Claim Type: **Recall/Campaign**
 - Required Attachment: **Fuel Pump Cover Area**

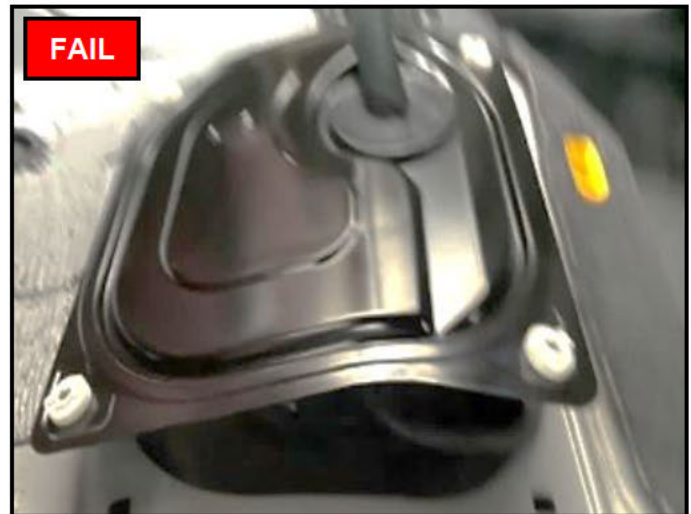
PASS: If all of the items above are **NOT** present:

FAIL: If any of the items are present:

Do NOT continue with the remaining service procedure in this TSB. Hold the vehicle until otherwise directed by PA.

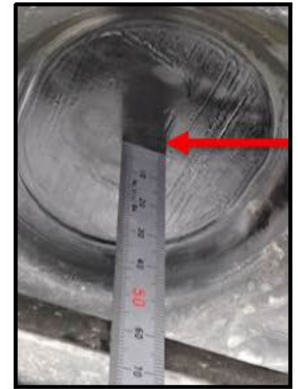
Be sure to measure from the center of the circular feature (C) in the fuel tank as shown.

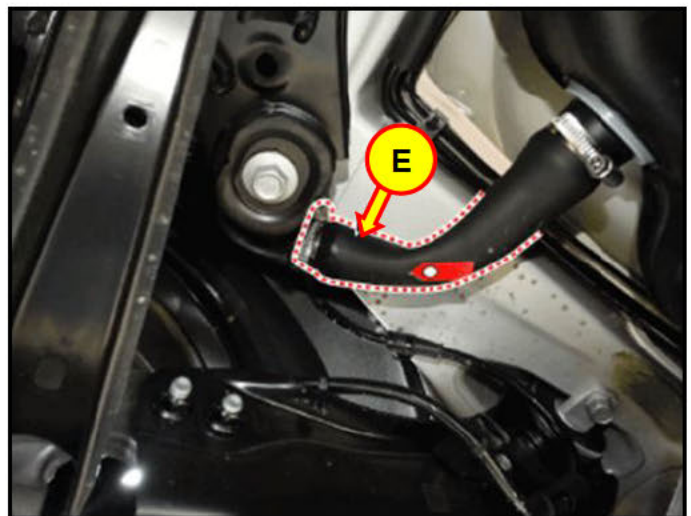
7. Disconnect the fuel filler hose (E).

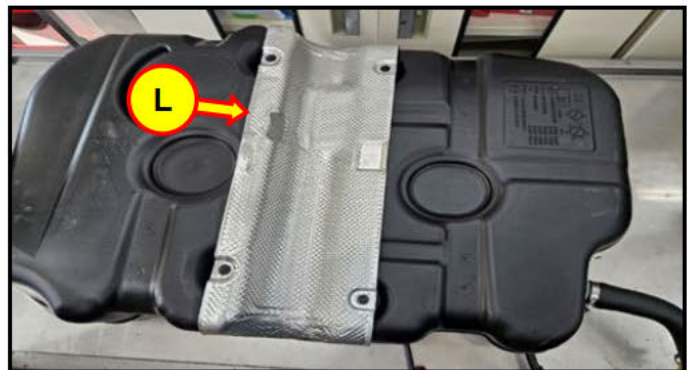
13. Attach the fuel tank heat protector (L) to the new fuel tank.

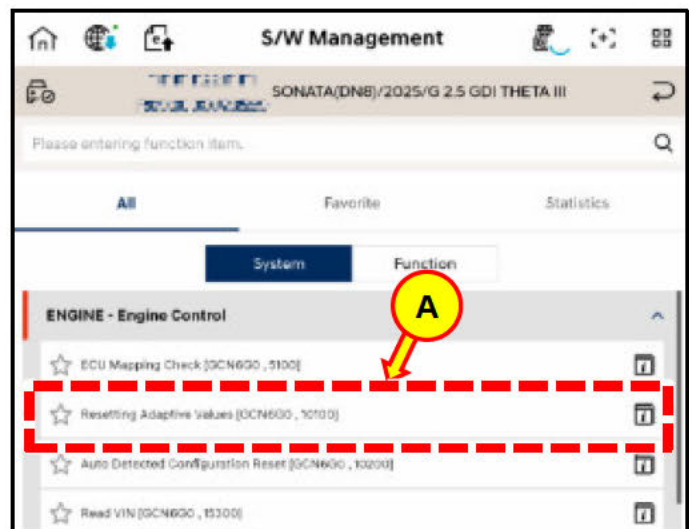
5. Perform an **All Systems Fault Code** search and erase DTC history that had incidentally occurred from the ECU update.
6. Reset adaptive values (A) using GDS.

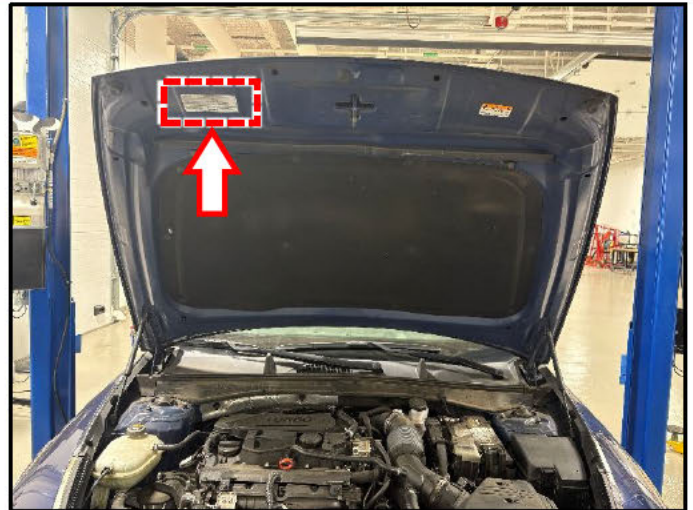
- Fill in the Dealer Code and Date on the emissions label, and apply adjacent to the existing label, on the underside of the hood, as shown.

Be sure to clean the mounting surface to ensure proper label adhesion.

If there is a Campaign **9B1** label already present, do **NOT** place the Recall **286** emissions label directly over it.
