**HYUNDAI**  
**Technical Service Bulletin**

GROUP <b>RECALL</b>	NUMBER <b>25-01-088H</b>
DATE <b>DECEMBER 2025</b>	MODEL(S) <b>IONIQ 5 (NEA EV)</b>

**SUBJECT:** FRONT SEAT BELT RETRACTOR MOUNTING BOLTS  
 INSPECTION & REPLACEMENT (RECALL 287)

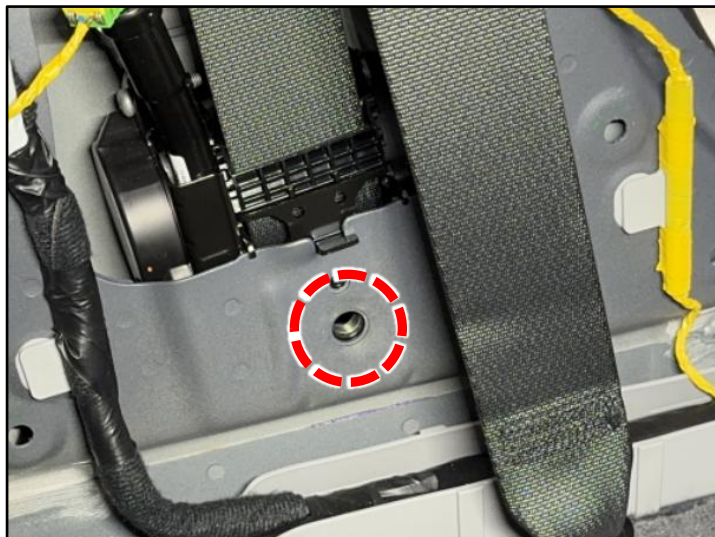
**Description:** Certain IONIQ 5 (NEA EV) vehicles may have an incorrectly installed seat belt retractor on the B-Pillar(s). A loose or unsecured seat belt retractor may not function as designed, increasing the risk of injury during a crash.

This bulletin provides instructions to inspect the driver and front passenger seat belt retractor bolts, install new bolts if required, and tighten to specification.

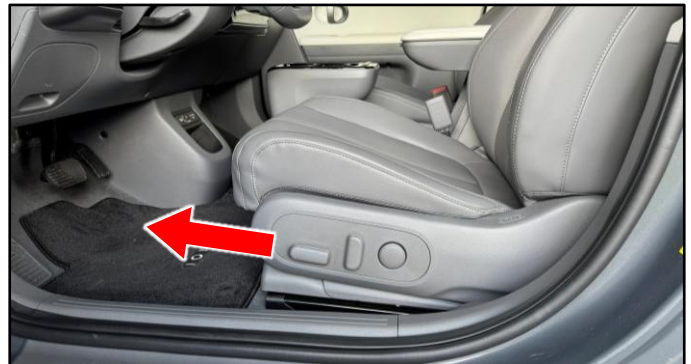
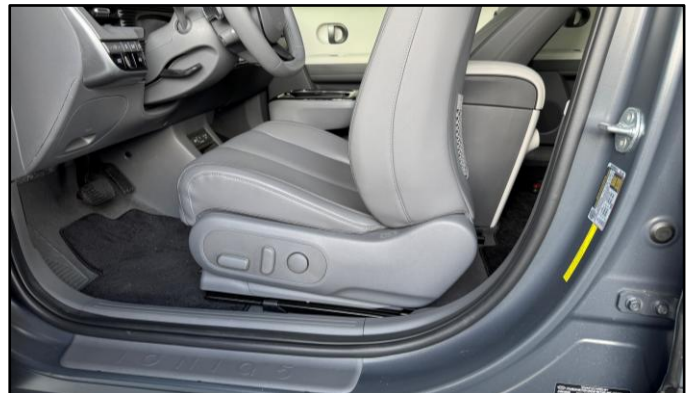
1. Adjust the driver and front passenger seats to the front-most position.

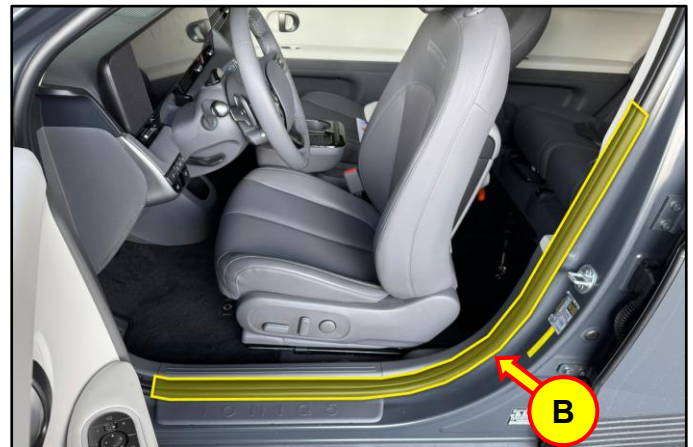
3. Lift the indicated section of the body side weather strip (B) from the driver side front door opening.

Do **NOT** remove the entire weather strip from the door opening.

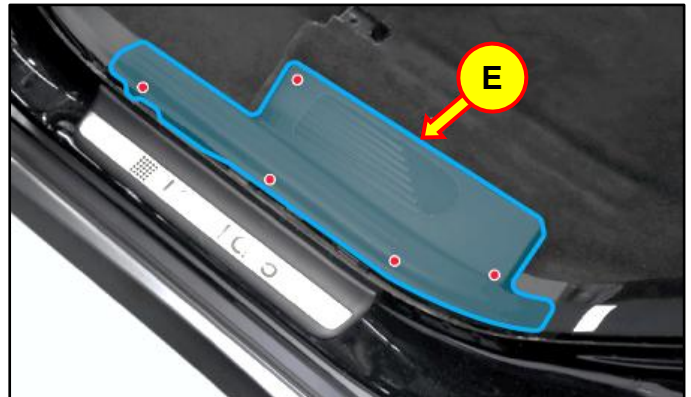
6. Remove the driver side rear door scuff trim (E).

Replace any damaged or broken clips (P/N: **85839-3X000**).

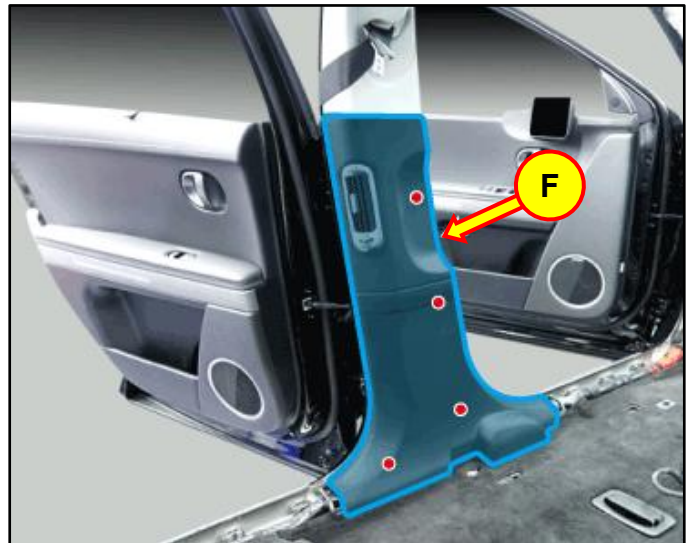
7. Remove the center pillar trim lower assembly (F).

To aid in removal, start by popping out the top clip and continue working down the trim piece.

Replace any damaged or broken clips (P/N: **82315-2W000**).

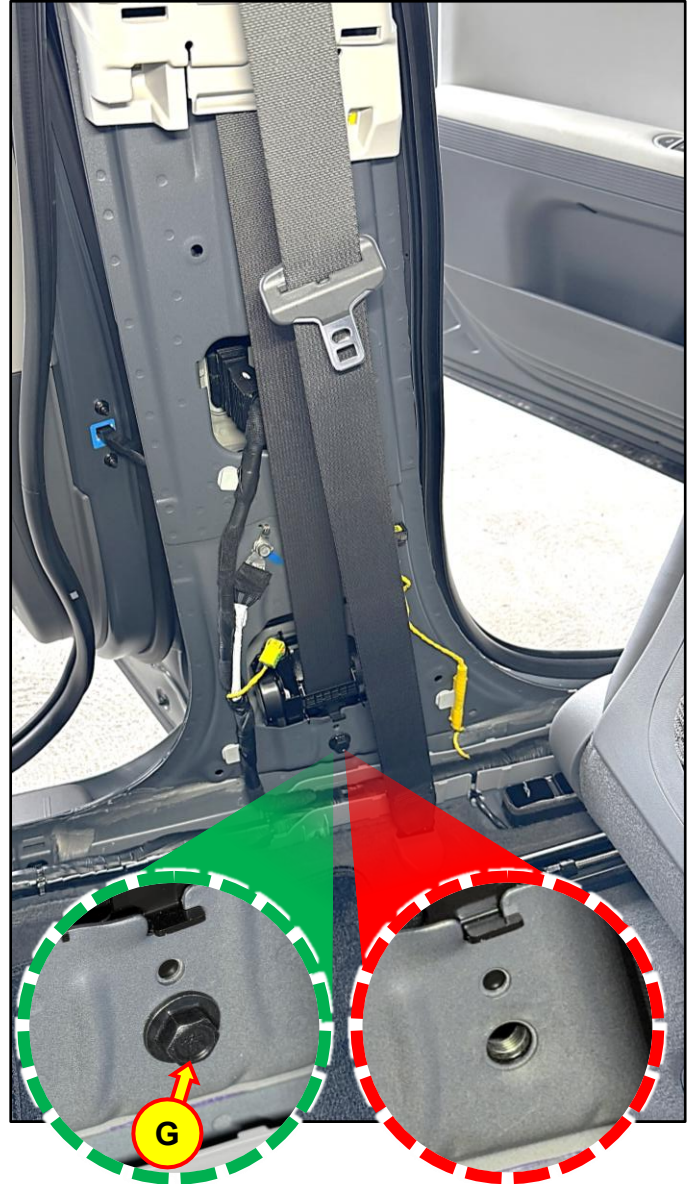
8. Confirm whether the driver's seat belt retractor mounting bolt (G) is present:

- **PRESENT:** Proceed to **Step 10** to confirm the retractor bolt is properly torqued.
- **NOT PRESENT:** Proceed to the next step to install the retractor bolt.

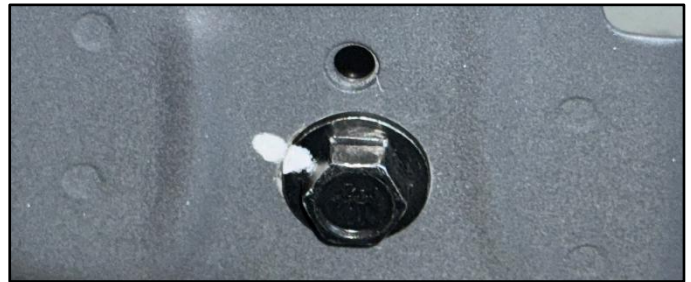
10. Torque the driver's seat belt retractor mounting bolt and mark with a paint pen.

lb-ft	36
N.m	49

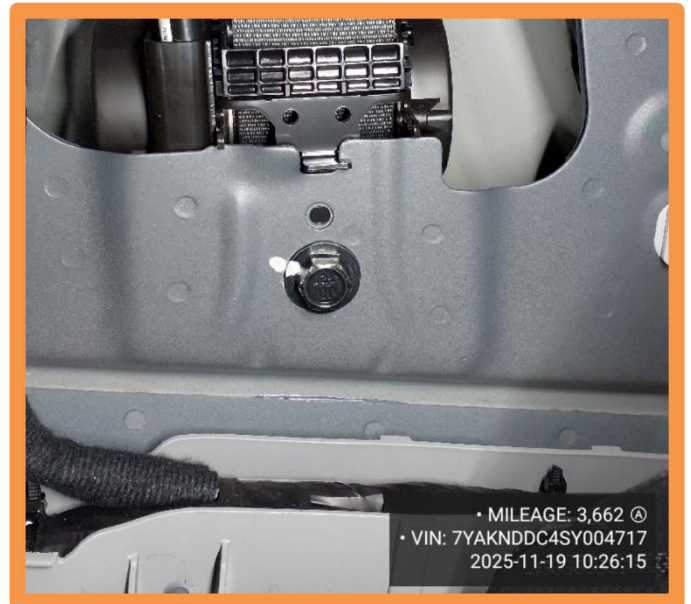
Using the STUI camera function, take a photo of the driver's seat belt retractor mounting bolt installed.

**NOTE:** If the STUI camera function is **NOT** used, write the last 6 digits of the VIN and date of repair on a piece of paper to include in the photo.
