HYUNDAI Technical Service Bulletin

25-01-091H

DECEMBER 2025

SUBJECT: SIDE CURTAIN AIRBAG (SCAB) INSPECTION & CORRECTION
(RECALL 289)

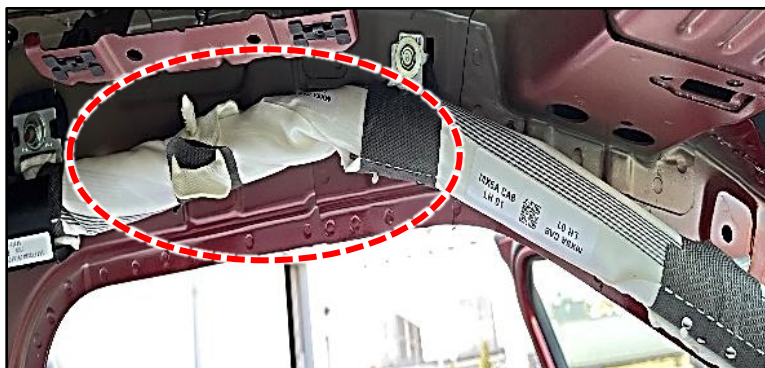
Description: Certain Santa Cruz (NXT), Santa Fe (MX5A), Santa Fe Hybrid (MX5A HEV), and Tucson (NX4A) vehicles equipped with Side Curtain Airbags (SCAB) may have been improperly installed, which can potentially result in abnormal airbag deployment during a crash, increasing the risk of injury to occupants. An abnormal airbag deployment could increase the risk of injury to occupants during a crash. Follow the information in this TSB to reinstall the SCAB in the correct orientation.

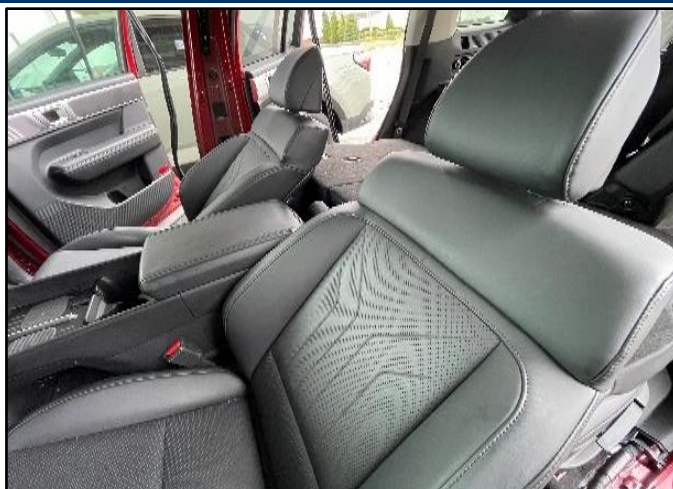
1. Remove the front row seats by referring to the shop manual:
 - **Body (Interior / Exterior / Electrical) > Front Seat > Front Seat Assembly > Removal**

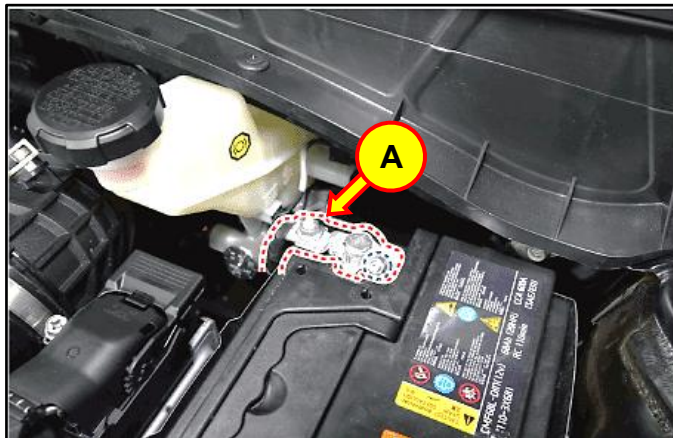
2. Disconnect the negative (-) battery terminal (A).

Tightening Torque:

lb-ft	6.5
lb-in	78
N.m	8.8

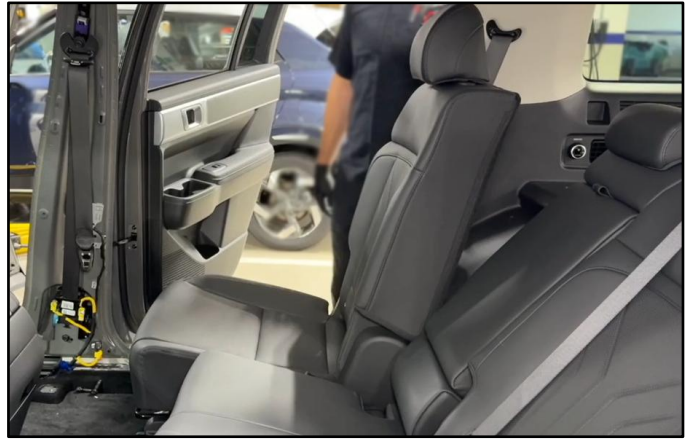
5. Remove the 2nd row seats by referring to the shop manual:
- **Body (Interior / Exterior / Electrical) > Rear Seat > Rear Seat Assembly > Removal**

Santa Fe & Santa Fe Hybrid: Proceed to **step 6**.

Tucson: Proceed to **step 7**.

Santa Cruz: Proceed to **step 8B**.

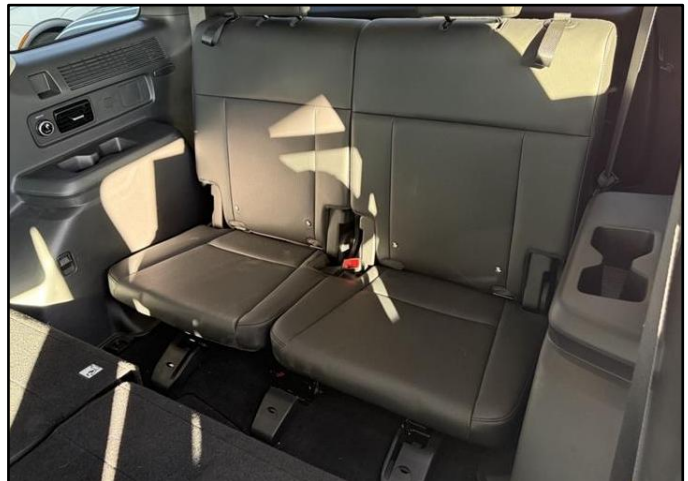
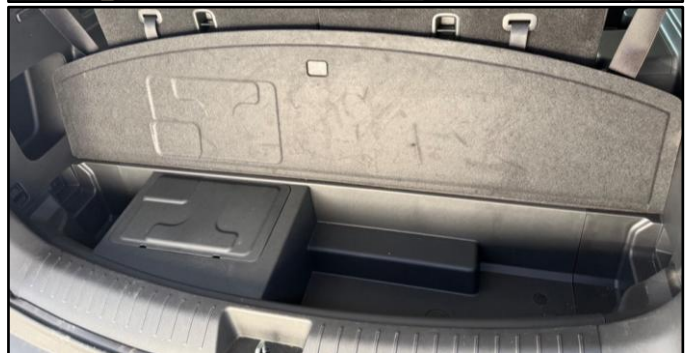
6. **i Information**

This step is **ONLY** for Santa Fe & Santa Fe Hybrid.

Remove the 3rd row seats and luggage trim by referring to the shop manual:

- **Body (Interior / Exterior / Electrical) > Rear Seat > Rear Seat Assembly > Removal and Installation**

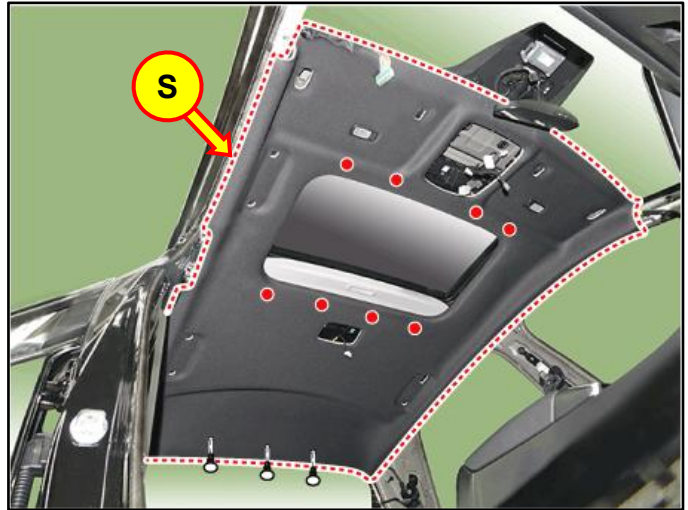
16. Carefully lower the headliner (S) to get access to both Side Curtain Airbags (SCAB).

Exercise caution when lowering the headliner as to not crease or damage it. Assistance from another tech or support tool to hold headliner may be required.

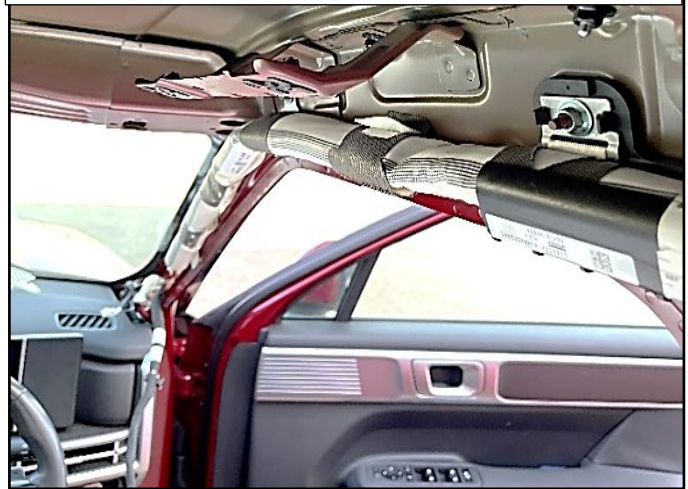
NOT TWISTED

17. Visually inspect curtain airbag for twisting on both sides:

- **NOT TWISTED:** Proceed to **step 20**.
- **TWISTED:** Proceed to **step 18**.

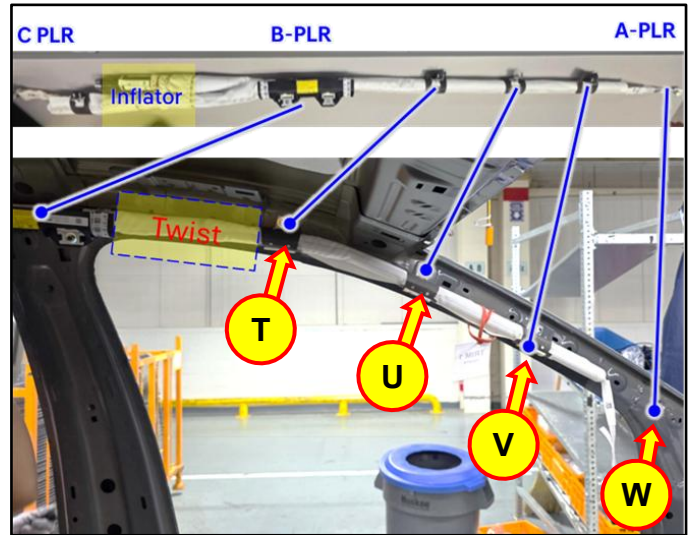
18. Remove the nuts and bolts (T, U, V, W) in alphabetical order to untwist the airbag.

Number of nuts and bolts will vary by model:

- Santa Fe and Santa Fe Hybrid: **4** nut washers and **7** bolts.
- Santa Cruz and Tucson: **2** nut washers and **8** bolts.

19. Untwist the curtain airbag(s) then reinstall the nuts and bolts in the reverse order of the removal process, ensuring no twists are present.

Tightening Torque:

Bolt:

lb-ft	7.25
lb-in	87
N.m	9.8

Nut:

lb-ft	3.65
lb-in	44
N.m	4.9

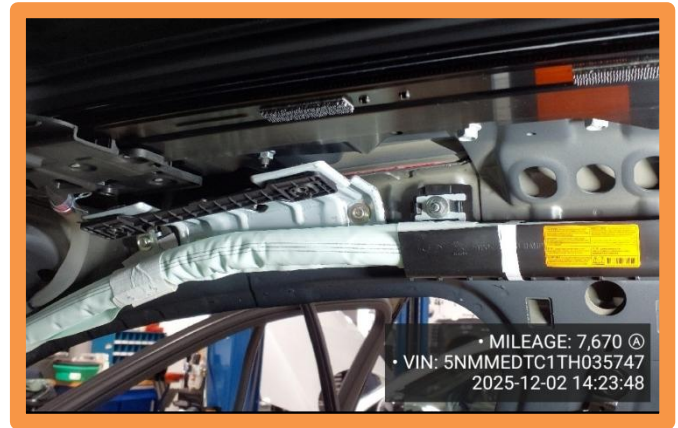
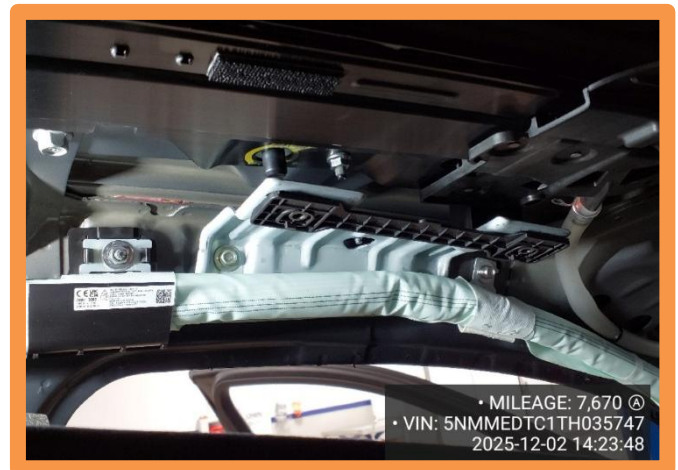
Using the STUI camera function, take a photo of both RH and LH Side Curtain Airbags (SCAB) correctly installed.
