## Technical Service Bulletin

<b>GROUP</b>	<b>NUMBER</b>
<b>RECALL</b>	<b>26-01-002G</b>
<b>DATE</b>	<b>MODEL(S)</b>
<b>JANUARY 2026</b>	<b>GV70 (JK1A)</b>

**SUBJECT:** SIDE CURTAIN AIRBAG (SCAB) INSPECTION & CORRECTION  
(RECALL 029G)

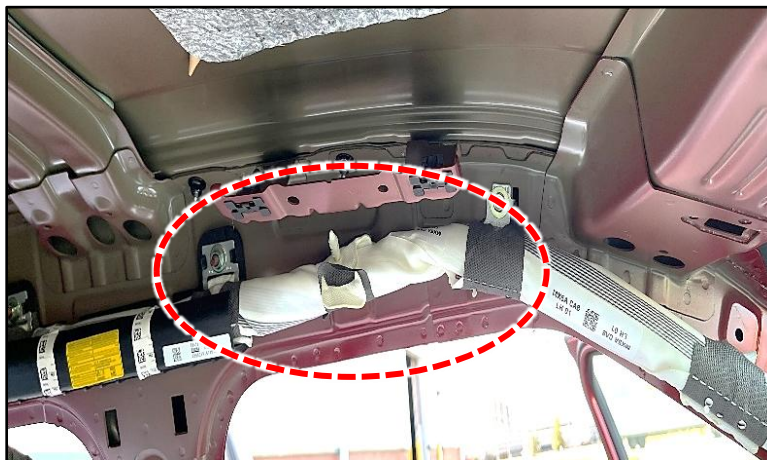
**Description:** Certain GV70 (JK1A) vehicles equipped with Side Curtain Airbags ("SCAB") may have been improperly installed, which can potentially result in abnormal airbag deployment during a crash, increasing the risk of injury to occupants. An abnormal airbag deployment could increase the risk of injury to occupants during a crash. Follow the information in this TSB to reinstall the SCAB in the correct orientation.

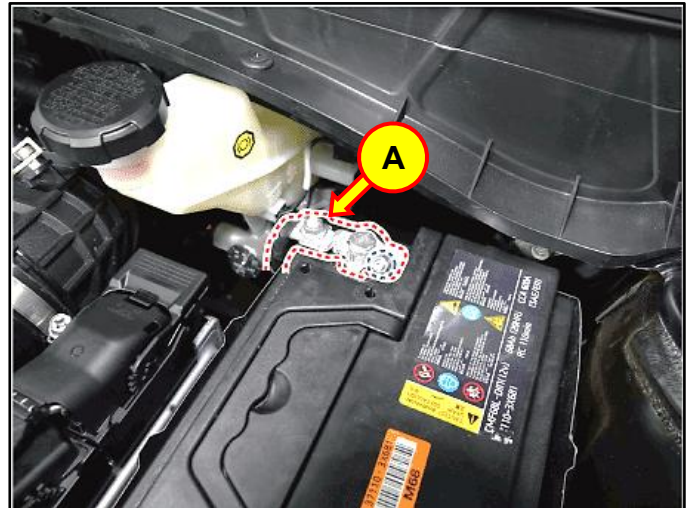
1. Disconnect the negative (-) battery terminal (A).

**Tightening Torque:**

lb-ft	6.5
lb-in	78
N.m	8.8

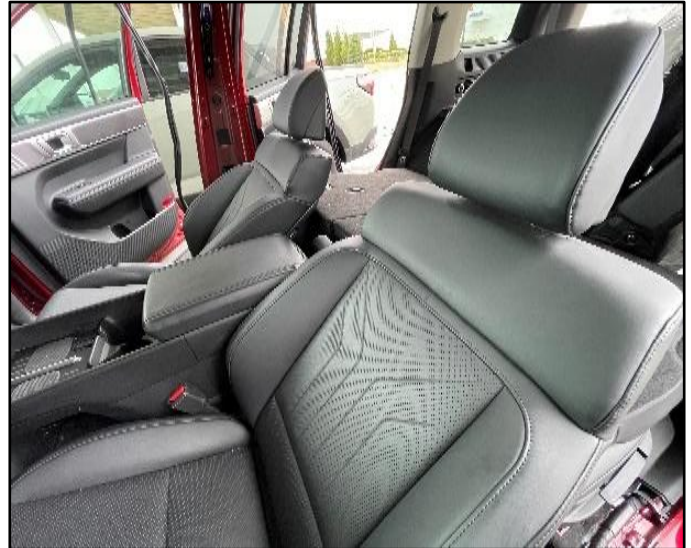
2. Remove the front row seats by referring to the shop manual:
  - **Body (Interior / Exterior / Electrical) > Front Seat > Front Seat Assembly > Removal**

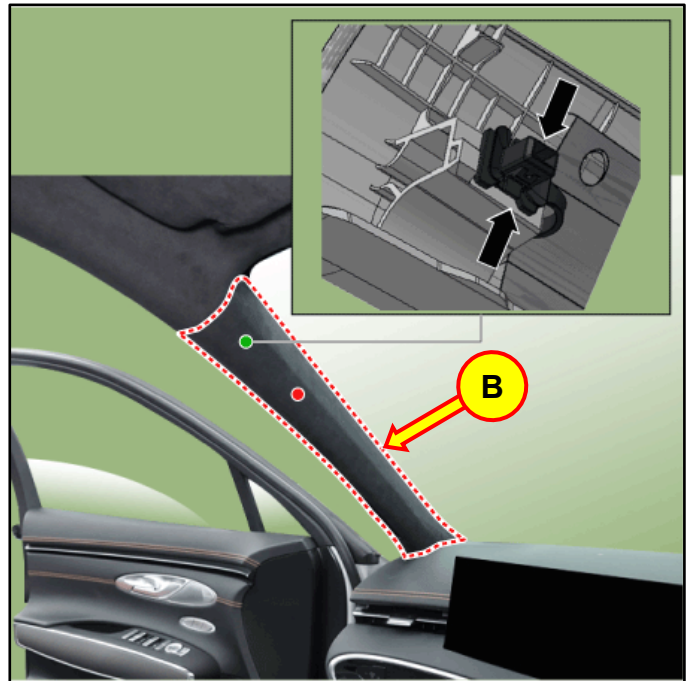
3. Remove the front pillars (B) on both sides by referring to the shop manual:
  - **Body (Interior / Exterior / Electrical) > Interior Trim > Front Pillar Trim > Removal and Installation**

Replace clips (P/N: **85815-C1100**) for the A-pillar trim. These are one time-use clips.

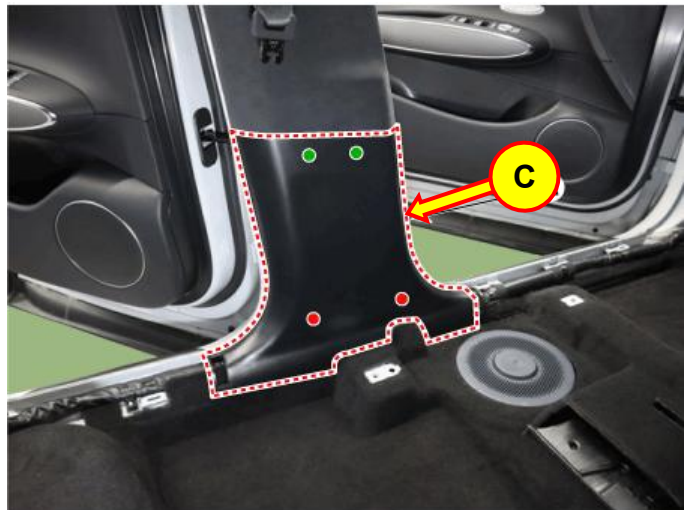
4. Remove the front door and rear door scuff trim on both sides by referring to the shop manual:
  - **Body (Interior / Exterior / Electrical) > Interior Trim > Door Scuff Trim > Removal and Installation**

Remove the lower center pillar lower trim (C).

Replace fasteners (P/N: **82315-2P000**) for the lower B-pillar trim if damaged.

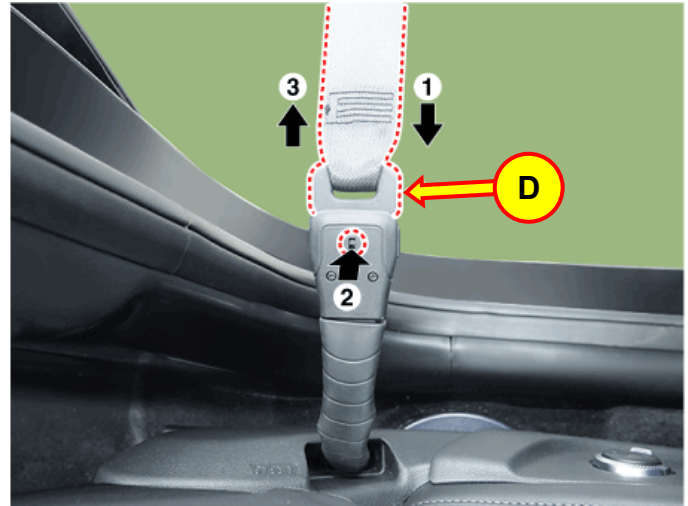
5. Remove the front anchor seat belt (D) on both sides:
  1. Push the front anchor seat belt (D) upward in the direction of ①.
  2. Insert a flat-tip screwdriver into the slot in the direction of ②.
  3. Pull the front anchor seat belt (D) upward in the direction of ③ to remove it.

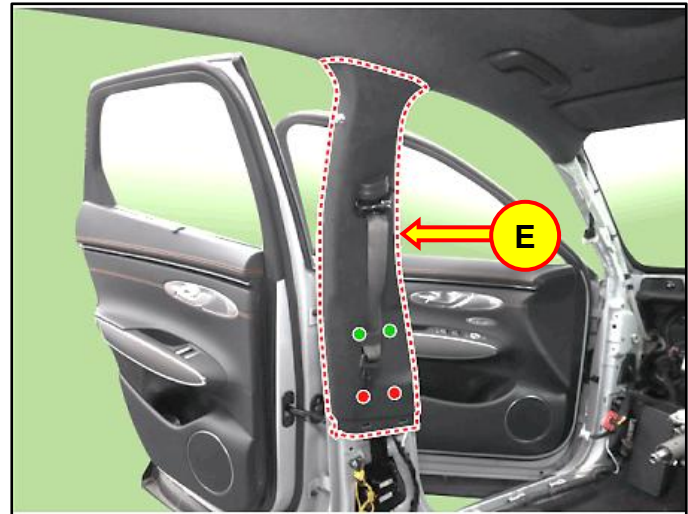
6. Remove the upper center pillar trim (E) on both sides by referring to the shop manual:
  - **Body (Interior / Exterior / Electrical) > Interior Trim > Center Pillar Trim > Removal and Installation**

Replace clips (P/N: **85858-3S100**) for the upper B-pillar trim if damaged.

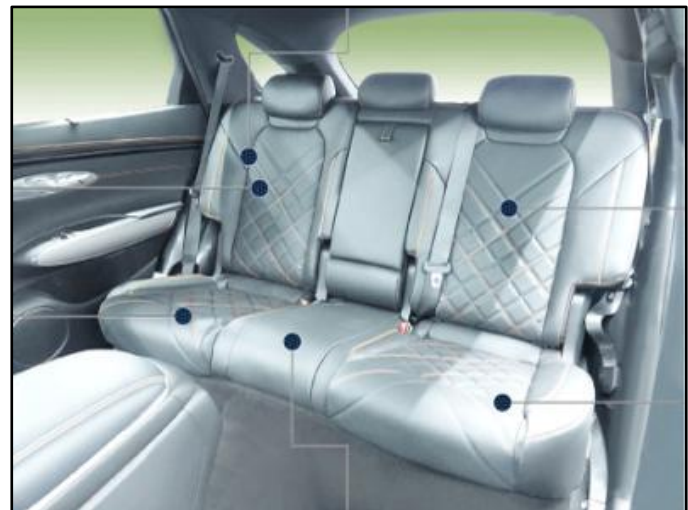
7. Remove the 2nd row seats by referring to the shop manual:
  - **Body (Interior / Exterior / Electrical) > Rear Seat > Rear Seat Assembly > Removal and Installation**

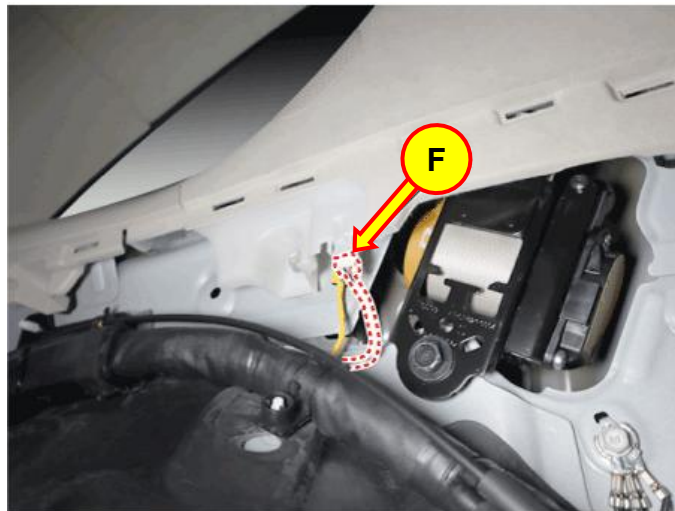
8. Remove the luggage side trim on both sides by referring to the shop manual:
  - **Body (Interior / Exterior / Electrical) > Luggage Trim > Luggage Side Trim > Removal and Installation**

9. Disconnect the speaker connector (F).

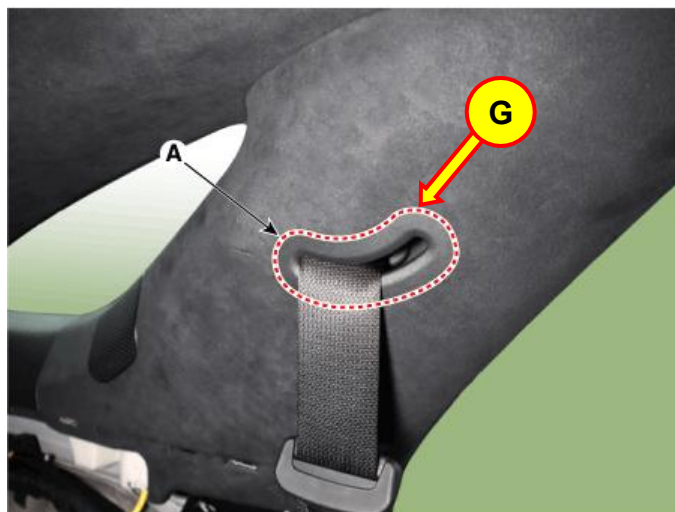
10. Disconnect the seat belt cover (G).

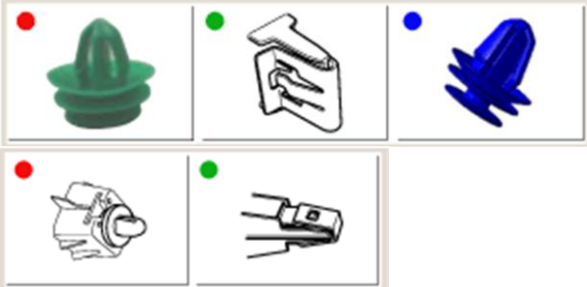
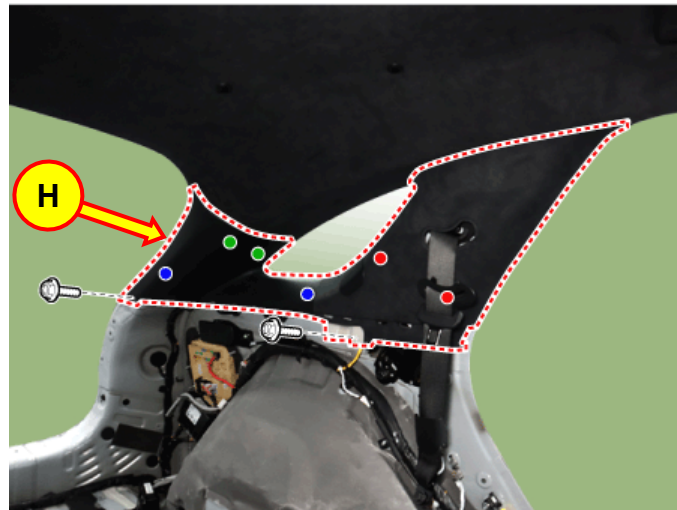
11. Remove the rear pillar trim (H), after removing the bolts.

Replace any damaged clips or retainers.

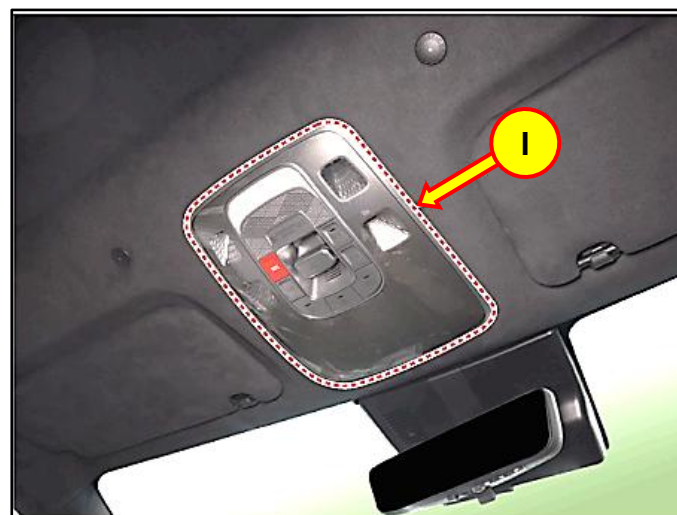
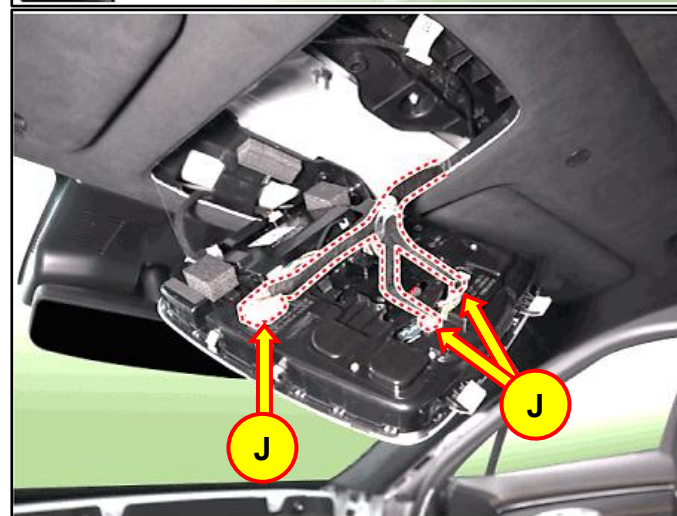
12. Remove the overhead console assembly (I) by referring to the shop manual:
- **Body (Interior / Exterior) Interior > Roof Trim > Overhead Console Assembly > Removal and Installation**

Use a plastic trim removal tool to prevent damage to parts.

Remove the overhead console connectors (J).

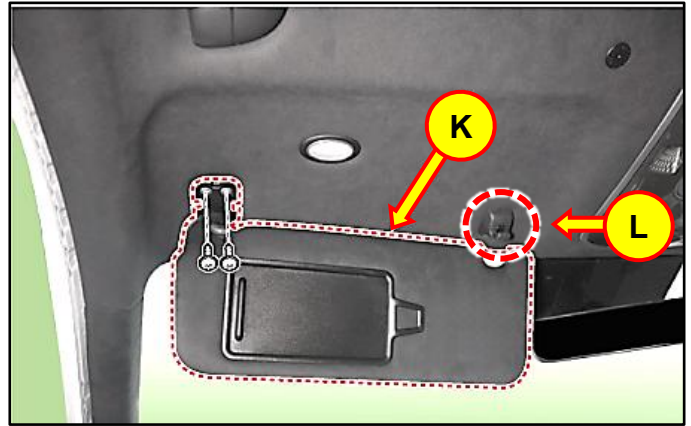
13. Remove the sun visors (K) and retainers (L) on both sides by referring to the shop manual:
- **Body (Interior / Exterior / Electrical) > Roof Trim > Sunvisor > Removal and Installation**

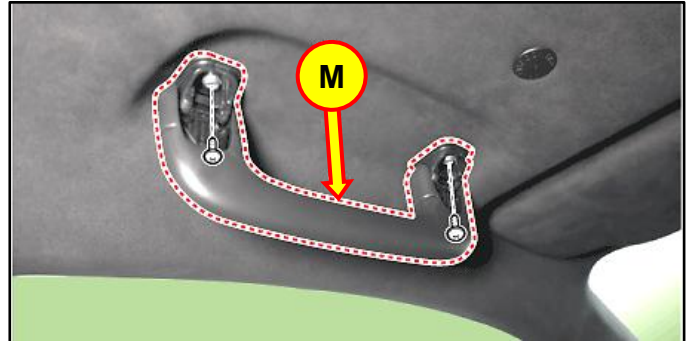
14. Remove the assist handles (M) on both sides by referring to the shop manual:
- **Body (Interior / Exterior / Electrical) > Roof Trim > Assist Handle > Removal and Installation**

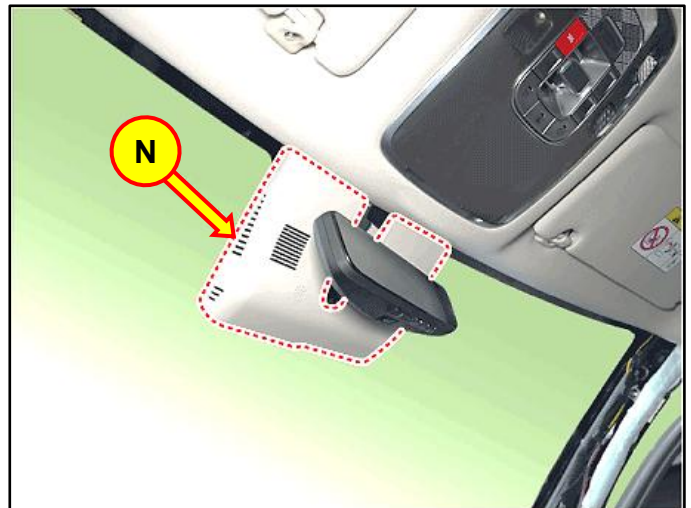
15. Remove the rear-view mirror cover (N) and rain sensor cover.
- **Body (Interior / Exterior / Electrical) > Mirror > Inside Mirror Assembly > Removal**

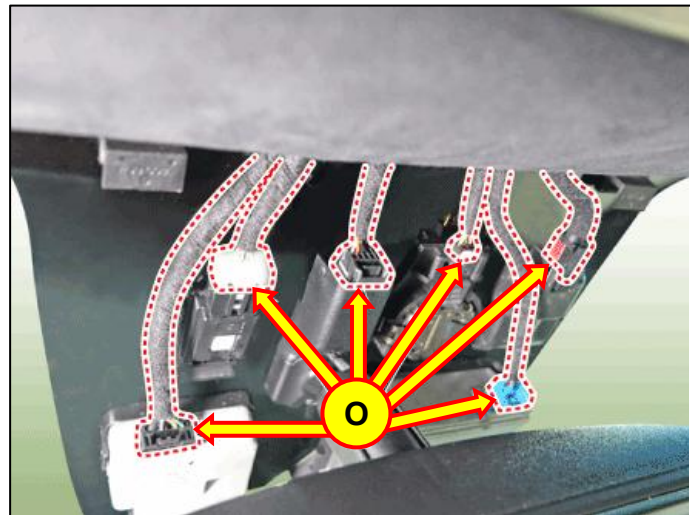
16. Disconnect the connectors (O) from the windshield.

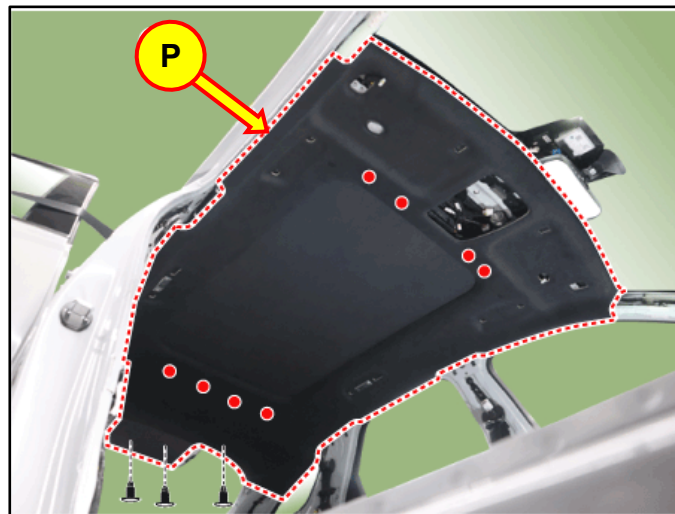
17. Lower the headliner (P) to get access to both Side Curtain Airbags (SCAB).

Lower the headliner gently to prevent creasing or damage. Additional support from another technician or a holding tool may be required.

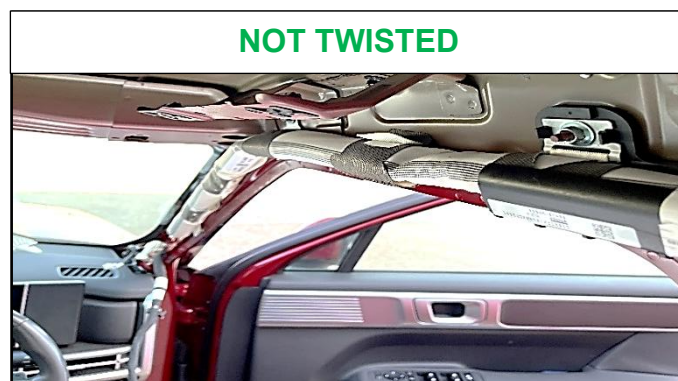
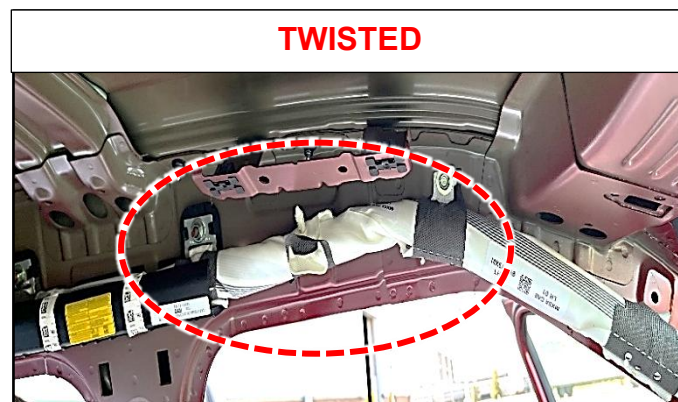
18. Visually inspect curtain airbag for twisting on both sides:

- **NOT TWISTED:** Proceed to **step 21**.
- **TWISTED:** Proceed to **step 19**.

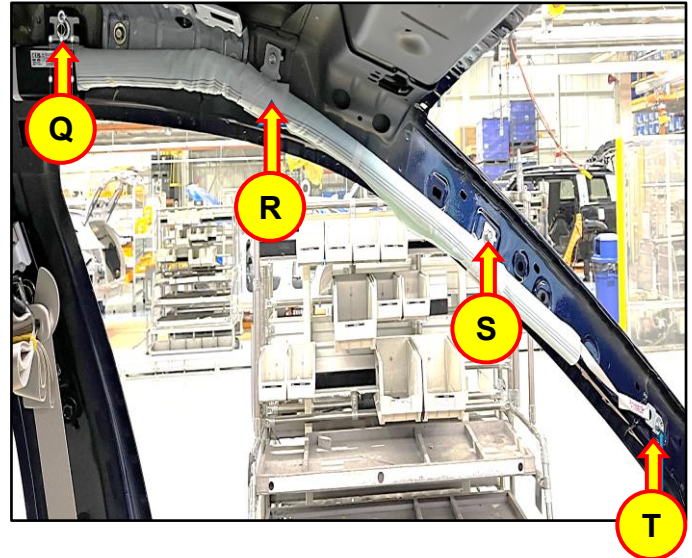
19. Remove the nuts and bolts (Q, R, S, T) in alphabetical order.

**Tightening Torque:**

**Bolt:**

lb-ft	7.25
lb-in	87
N.m	9.8

**Nut:**

lb-ft	3.65
lb-in	44
N.m	4.9

20. Untwist the side curtain airbag then reinstall the nuts and bolts in the reverse order of the removal process.

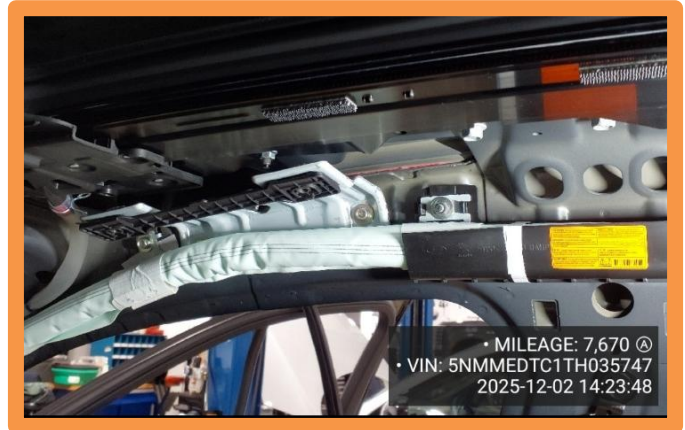
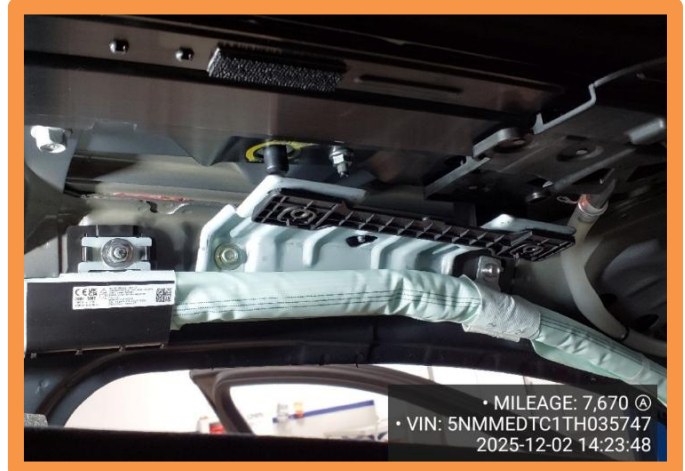
Using the STUI camera function, take a photo of both RH and LH Side Curtain Airbags (SCAB) correctly installed.

**NOTE:** If the STUI camera function is **NOT** used, write the last 6 digits of the VIN and date of repair on a piece of paper to include in the photo.

21. Untwist the side curtain airbag then reinstall the nuts and bolts in the reverse order of the removal process.
