SAFETY RECALL
 NORTH AMERICA
Curtain Airbag Inflator

Reference: C7C / NHTSA 25V-824

FCA US LLC

RAM Remedy available for
 2019 (DS) Ram 1500 Pickup
 2019 (DJ) Ram 2500 Pickup
 2019 (D2) Ram 3500 Pickup

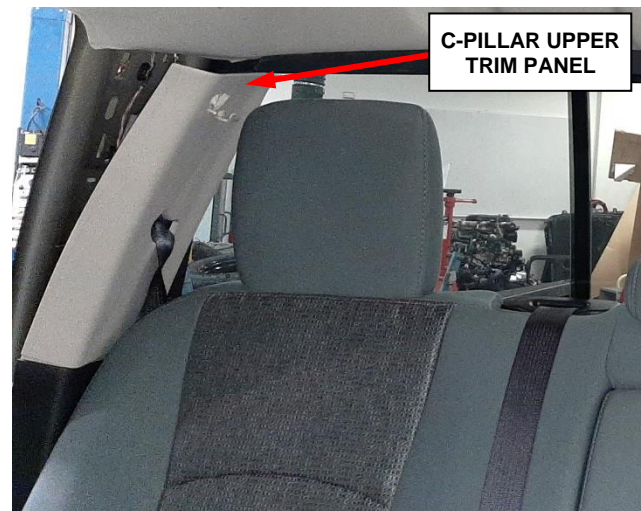
Figure 11 – C-Pillar Trim Panels

18. Release the retaining clips and tilt the top of the C-pillar upper trim panel inward (Figure 11).

42. Position the upper trim panel to the C-pillar then engage the retaining clips (Figure 11).
43. Install and tighten the screw that secures the C-pillar upper trim panel. Then install the airbag applique (Figure 10).
