SAFETY RECALL
 NORTH AMERICA
Curtain Airbag Inflator

Reference: C8C / NHTSA 25V-824

FCA US LLC

RAM Remedy available for
 2019 (DS) Ram 1500 Pickup
 2019 (DJ) Ram 2500 Pickup
 2019 (D2) Ram 3500 Pickup

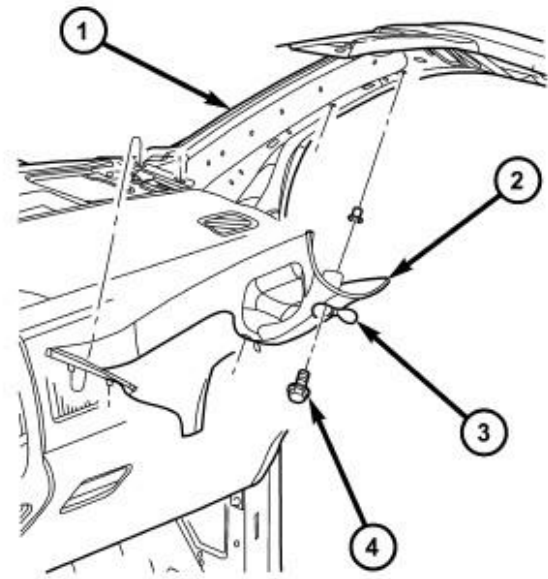
Figure 1 – A-Pillar

1. Using a small flat-bladed tool, carefully open the two fastener covers (3) located in the A-pillar trim panel (2) (Figure 1).

65. Position the locating tab of the A-pillar trim panel (2) into the slot located in the top of the instrument panel (Figure 1).
66. Install the A-pillar trim panel onto the A-pillar (1) and install the two bolts (4). Tighten the bolts to 5 N·m (44 in. lbs.) (Figure 1).

-
67. Close the two fastener covers (3) located in the A-pillar trim panel (Figure 1).
 68. Install the door seals around the door openings.
 69. Return the vehicle to the customer or inventory.
