**SAFETY RECALL**  
 NORTH AMERICA  
**Curtain Airbag Inflator**

Reference: C7C / NHTSA 25V-824

**RAM** Remedy available for  
 2019 (DS) Ram 1500 Pickup  
 2019 (DJ) Ram 2500 Pickup  
 2019 (D2) Ram 3500 Pickup

**SYMPTOM DESCRIPTION**

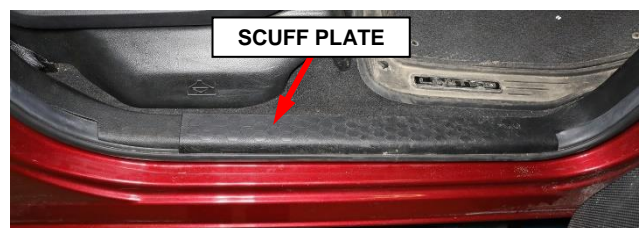
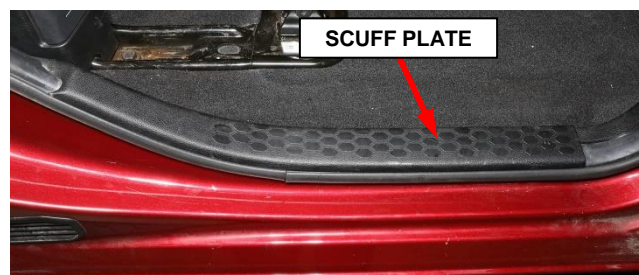
**Figure 5 – Door Sill Scuff Plates**

10. Release the front and rear door sill scuff plates on either side of the B pillar lower trim panel to allow for removal of the B-pillar lower trim panel (Figure 5).

49. Install the seat belt turning loop cover (Figure 7).
50. Position the B-pillar lower trim panel and engage the retaining clips fully (Figure 6).
51. Position the front and rear door sill scuff plates and engage the retainers (Figure 5).

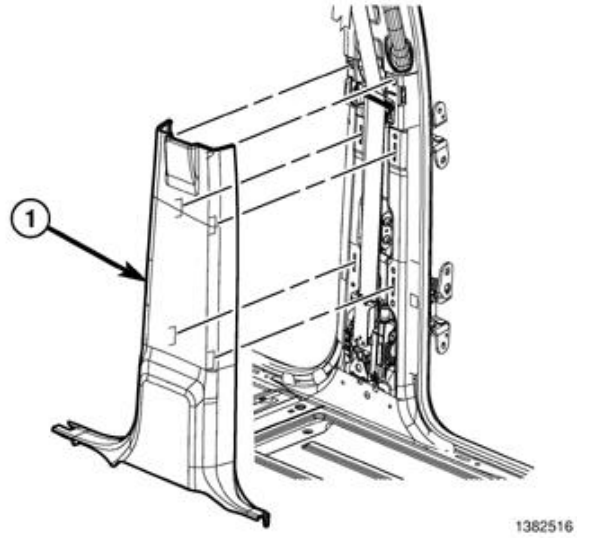
**Figure 6 – B-Pillar Lower Trim Panel**

11. Release the retaining clips and remove the B-pillar lower trim panel to allow for removal of the B-pillar upper trim panel (Figure 6).

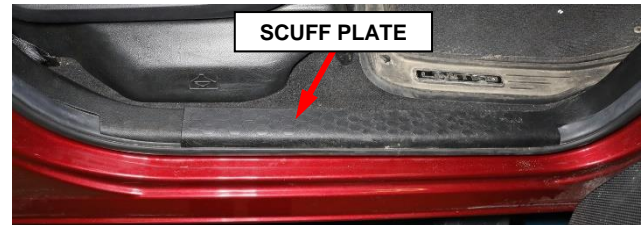
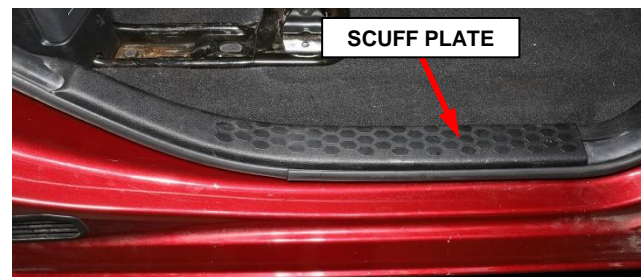
**Figure 24 – Door Sill Scuff Plates**

9. Release the front and rear door sill scuff plates on either side of the B pillar lower trim panel to allow for removal of the B-pillar lower trim panel (Figure 24).

- 60. Install the B-pillar upper trim panel (1) and engage the retaining clips fully (Figure 27).
- 61. Install the grab handle bolts and tighten to 5 N·m (44 in. lbs.). Close the fastener covers (2) (Figure 27).
- 62. Remove and **DISCARD** the bolt retainer and the bolt from the seat belt turning loop, save the spacer washer for reuse (Figure 40).
- 63. Using a **NEW** bolt and reusing the spacer washer, install the turning loop then tighten the bolt to 40 N·m (30 ft. lbs.) (Figure 26).
- 64. Install the seat belt turning loop cover (Figure 26).
- 65. Position the B-pillar lower trim panel and engage the retaining clips fully (Figure 25).
- 66. Position the front and rear door sill scuff plates and engage the retainers (Figure 24).

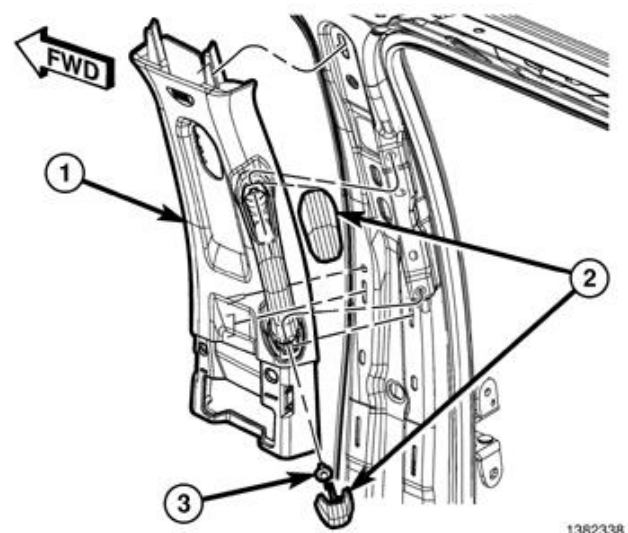
**Figure 27 – B-Pillar Upper Trim Panel**

12. On the B-pillar, use a small flat-bladed tool to carefully open the two fastener covers (2) located on the grab handle (Figure 27).

13. Remove the two bolts (3) that secure the grab handle to the B pillar (Figure 27).

14. Using a trim stick C-4755 or equivalent, release the retaining clips that secure the B pillar upper trim panel (1) then position the trim panel out of the way. It is not necessary to remove the seat belt from the trim panel (Figure 27).

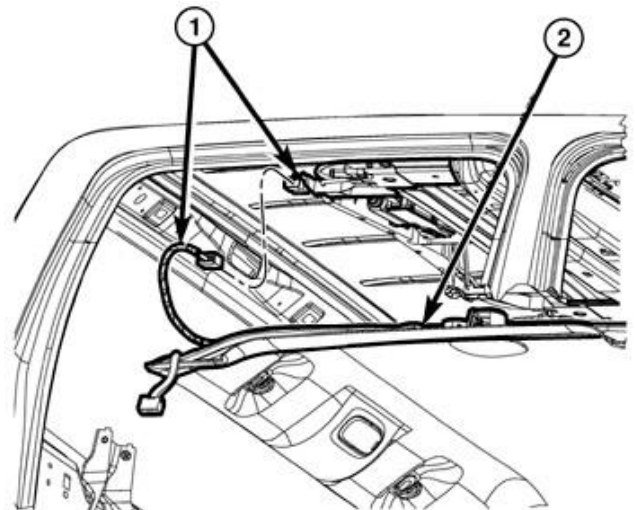
**Figure 36 – Headliner Harness**

- 27. Carefully lower the headliner (2) allowing it to rest on the seat backs and instrument panel (Figure 36).

**CAUTION:** Disconnect any wiring harness electrical connectors (1) as necessary to allow enough wiring harness slack while lowering headliner. It will not be necessary to remove the headliner from the vehicle (Figure 36).
