## **TECHNICAL INSTRUCTIONS**

### **SAFETY RECALL 25TA16**

**Upper 3<sup>rd</sup> Row Center Seatbelt Anchor Bolt May be Cross Threaded**

**Certain 2024- 2025 Model Year Highlander and Highlander HV**

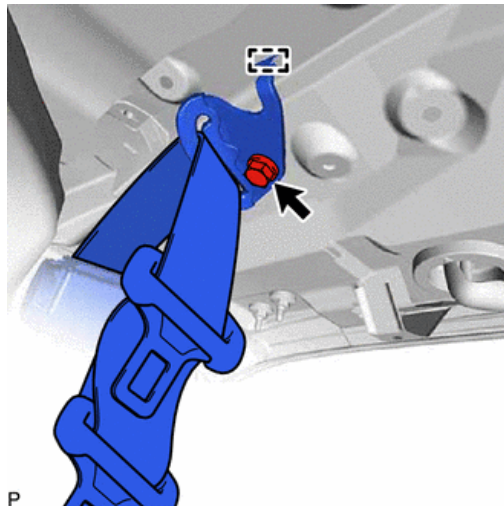
The third-row center upper seat belt anchor bolt may have been cross-threaded during the manufacturing process and can cause the vehicle not to comply with federal safety standards. A cross threaded seat belt anchor bolt can affect seat belt performance and increase the risk of injury during certain collisions.

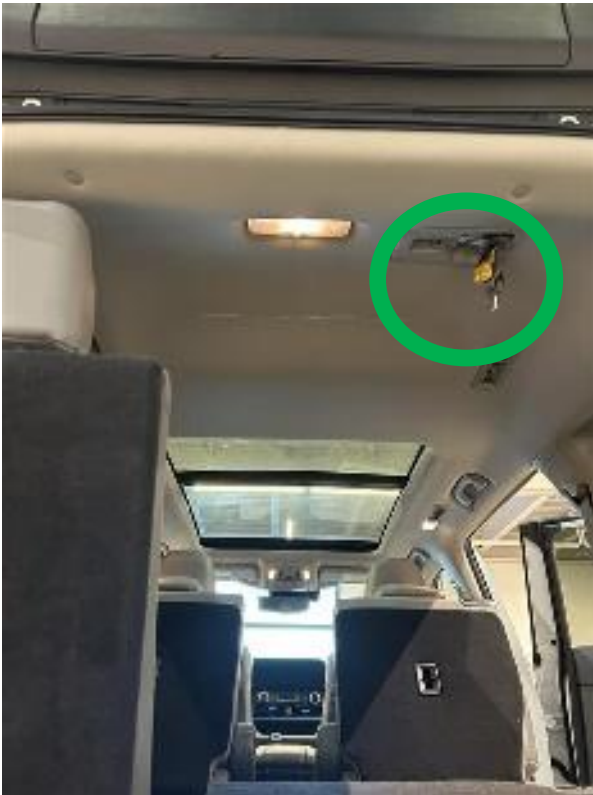
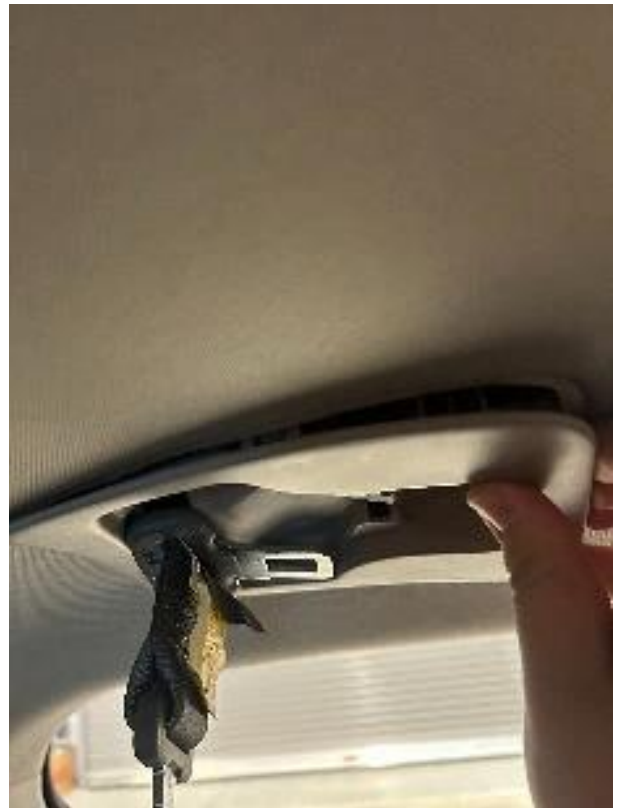
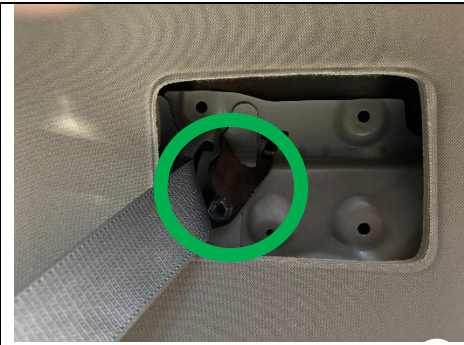
### 2. Remove the Third-Row, Center, Upper Seat belt Anchor cover

- a) Locate the third-row, center, upper seat belt anchor cover.
- b) Carefully remove the seat belt anchor cover, using a trim removal tool, if necessary, by gently prying down on the cover.

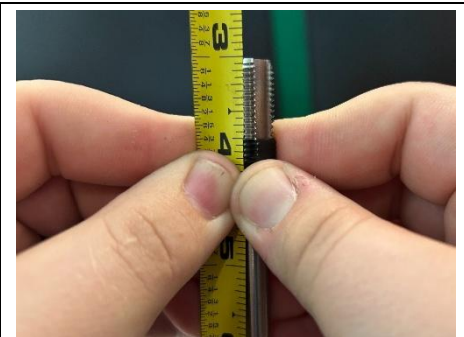
### 4. Ensure Proper Tap is Being Used

- a) Ensure tap being used to complete the repair is a 7/16"x20 NF **BOTTOMING** tap
- b) Use of an improper tap, such as a taper tap, could result in incomplete repair of the welded nut threads, or damage to the vehicle roof, as an improper type of tap may not have enough complete cutting threads to reach all the way through the welded nut without contacting the vehicle roof

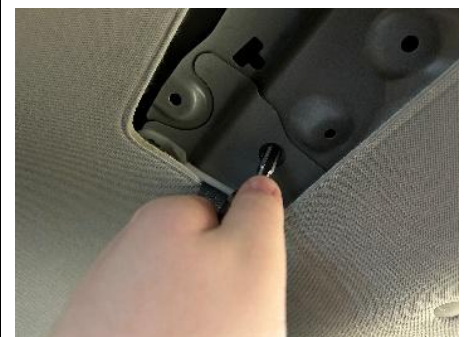
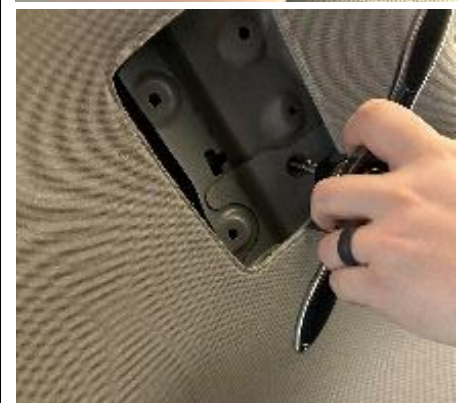
### 5. Use Tap to Repair Threads

- a) Using a measuring tape, mark  $\frac{3}{4}$ " back from the lead end of the tap. Once marked, wrap tape around the tap with the edge on the tap aligned with you mark and  $\frac{3}{4}$ " of threads exposed. This ensures the tap is not driven too deep, as damage to the vehicle's roof could be the result
- b) Insert a 7/16"x20NM tap into the welded nut for the seat bolt anchor bolt and thread in as far as you can **BY HAND**.
- c) Using a **manual** tap driver, **carefully** begin driving tap into the welded nut to clean the threads, making sure to only repair existing threads – **DO NOT CUT NEW THREADS**.

- **DO NOT** use power tools during this repair
- **Only drive tap the minimum depth necessary to clean all the threads, excessive depth can result in damage to the vehicle's roof**
- **EXTREME** care must be taken to ensure threads are not further damaged and new threads are not cut
- **If the welded nut is further damaged, new threads are cut, or threads are too damaged to repair IMMEDIATELY contact Quality Compliance at [quality\\_compliance@toyota.com](mailto:quality_compliance@toyota.com). DO NOT ATTEMPT FURTHER REPAIR.**

**HINT:** Due to the damage being repaired, some resistance should be expected when driving the tap. If excessive resistance is present, **DO NOT** continue. Remove tap, ensure tap is being driven straight and new threads are not being cut, and try again. A small amount of cutting oil can be applied to the tap to aid the repair.

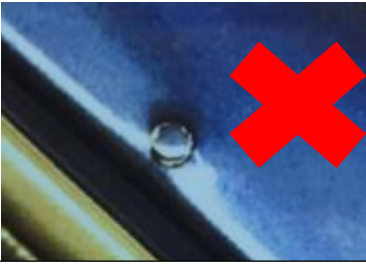
Example: Body panel damage due to a tap being run too deep

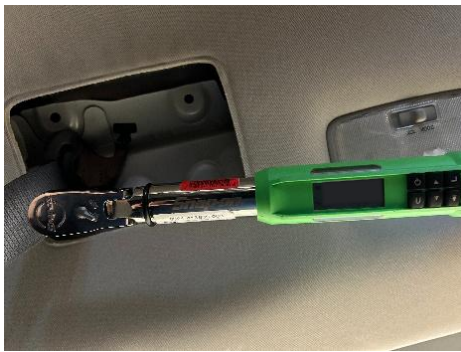
## 6. Reinstall Seat belt Anchor

- Place seat belt anchor in proper position and install new seat belt anchor bolt **BY HAND**.
- Once the seat belt anchor bolt is hand tight, torque bolt to 42 nm.
