# HYUNDAI Technical Service Bulletin

GROUP <b>RECALL</b>	NUMBER <b>26-01-037H</b>
DATE <b>APRIL 2026</b>	MODEL(S) <b>SEE BELOW</b>

**SUBJECT:** TOW HITCH HARNESS – INSPECTION, REMOVAL, AND DUST CAP INSTALLATION (RECALL 290)

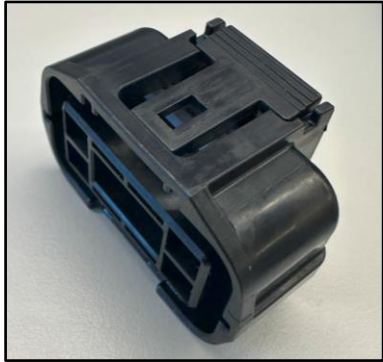
Model	Part Name	Part Number	Figure	Quantity
Tucson (NX4/NX4A)	Dust Cap	GZ095-12021

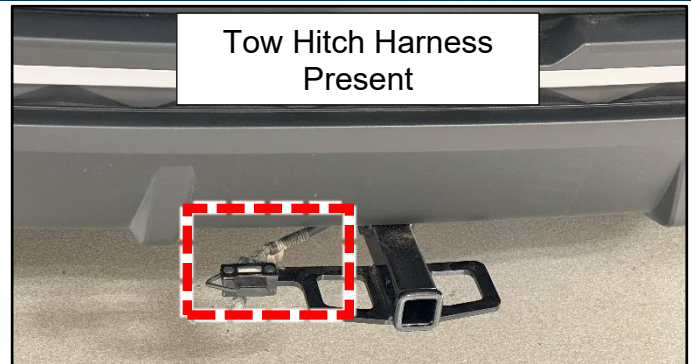
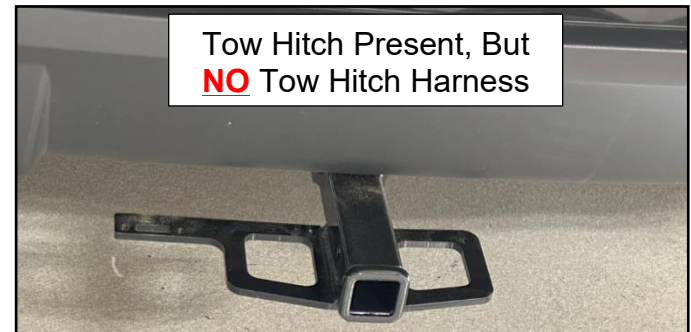
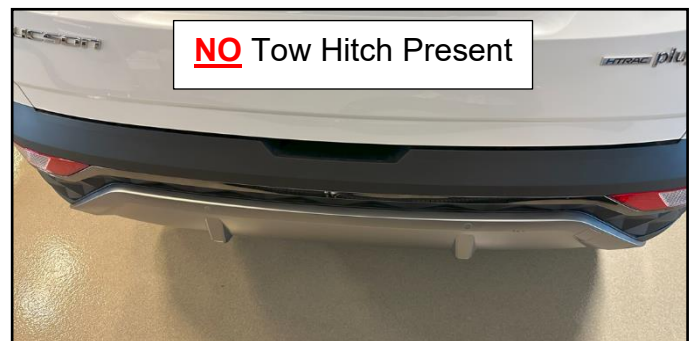
1. Visually inspect the rear center lower bumper for a tow hitch harness:

- Tow hitch harness present
  - Proceed to [Tow Hitch Harness Removal and Dust Cap Installation](#) section.
- Tow hitch present, but **NO** tow hitch harness
  - Proceed to **step 2**.
- **NO** tow hitch present
  - Proceed to **step 2**.

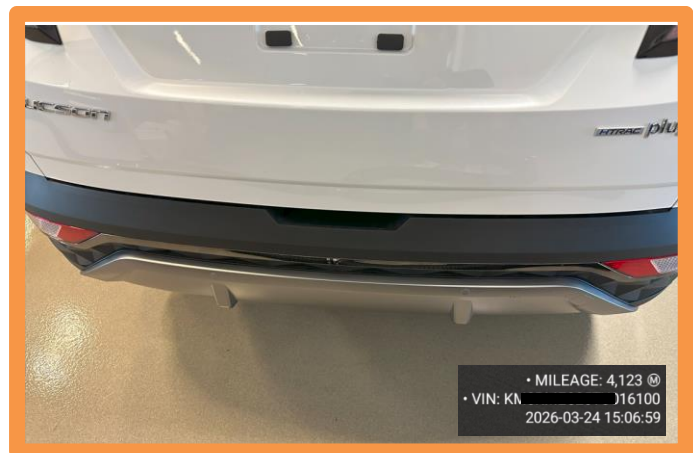
Using the STUI camera function, take a photo of the tow hitch area.

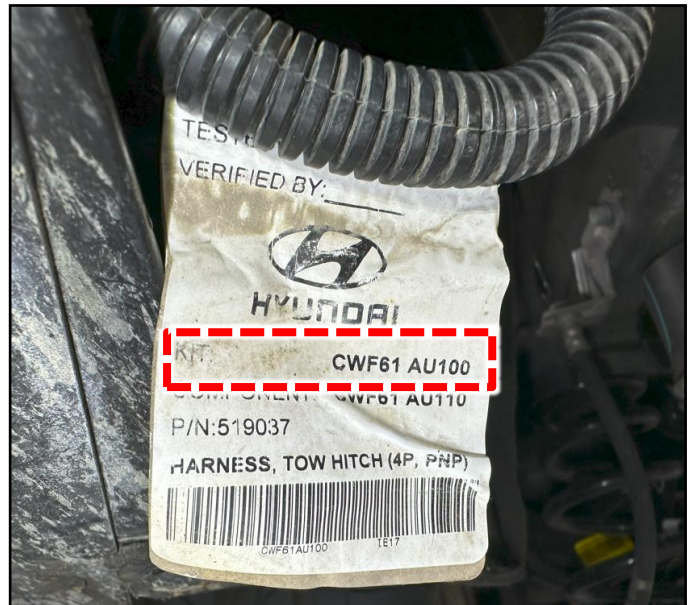
3. Locate the tow hitch harness tag to ensure it is a genuine factory Hyundai part (**CWF61-AU100**):

- If it is a genuine factory Hyundai part, then proceed to **step 5**.
- If it is **NOT** a genuine factory Hyundai part, proceed to **step 4**, put vehicle back together, and complete the service procedure.

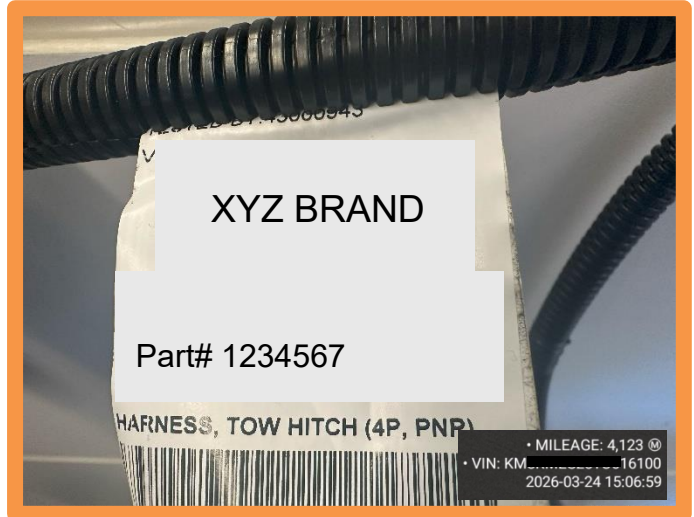
Using the STUI camera function, take a photo of the non genuine factory Hyundai tow hitch harness.

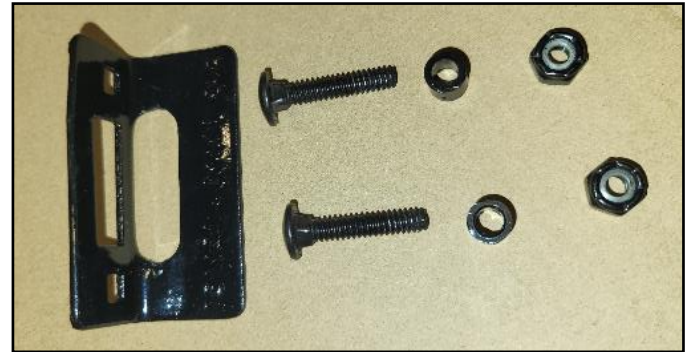
6. Put the nuts and harness bracket into a bag and place the bag in the customer's glove box.

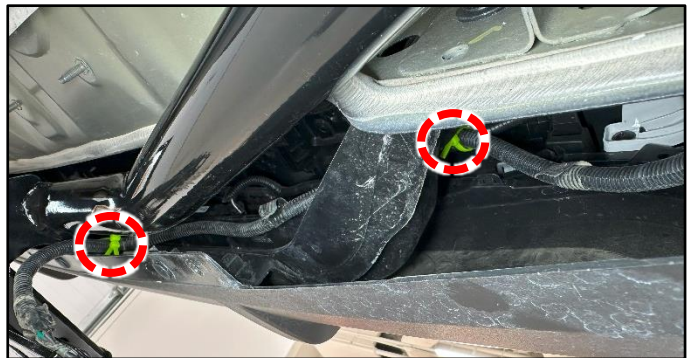
7. Remove all the zip ties that are holding the tow hitch harness in place.

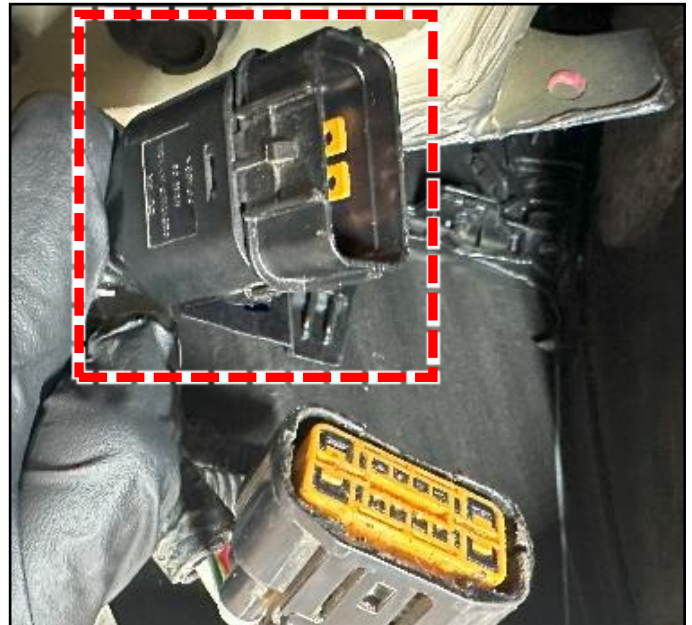
8. Disconnect the tow hitch harness from the prewire of the vehicle.

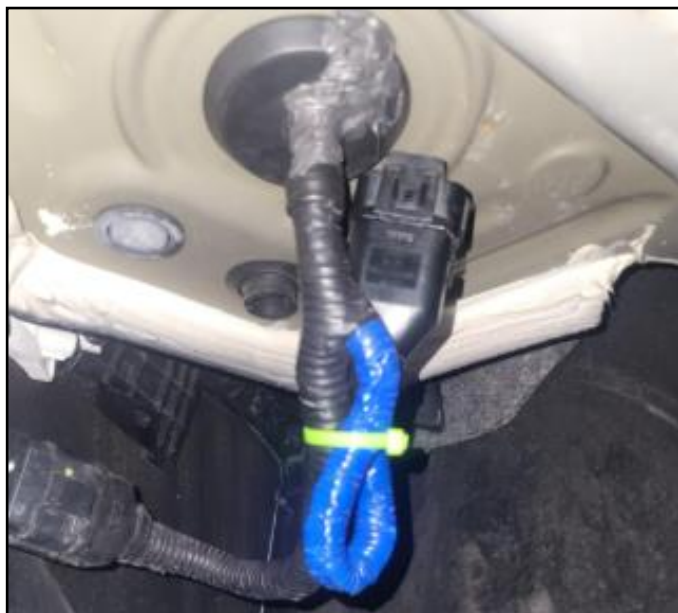
10. Use a new zip tie to secure the prewire on the vehicle frame rail clip as shown.

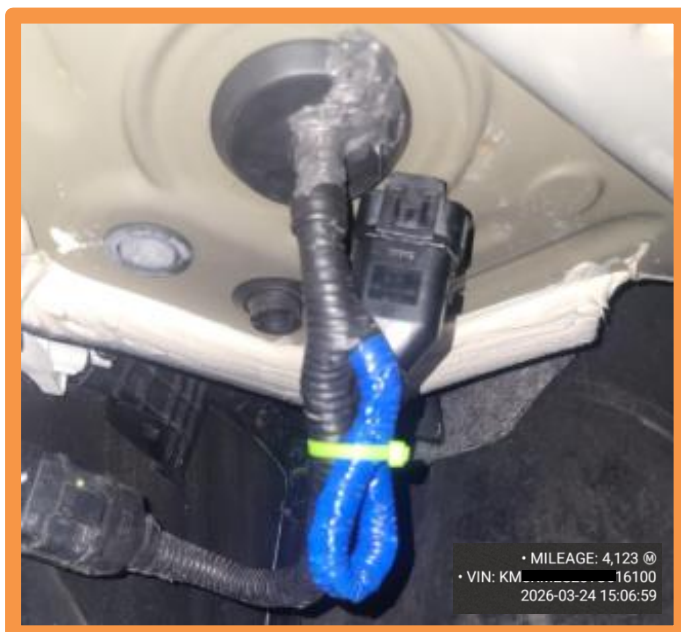
Using the STUI camera function, take a photo of the secured prewire with the installed dust cap.

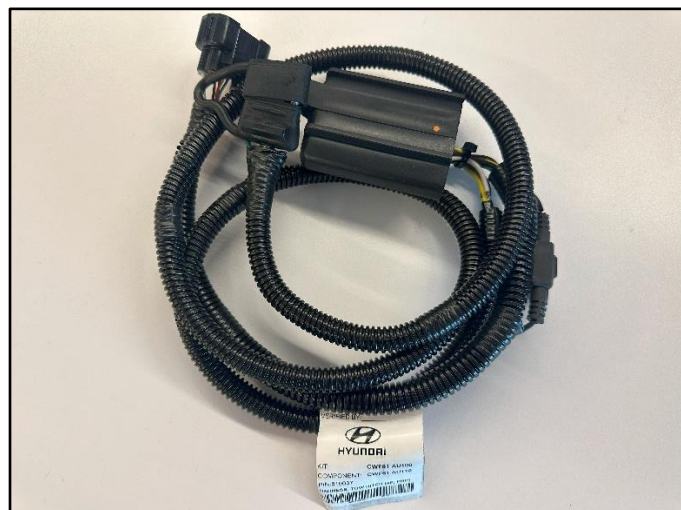
12. Discard the removed tow hitch harness.
