# Compliance Recall

## Code: 69D8

**Subject** Rear Outboard Seat Belts

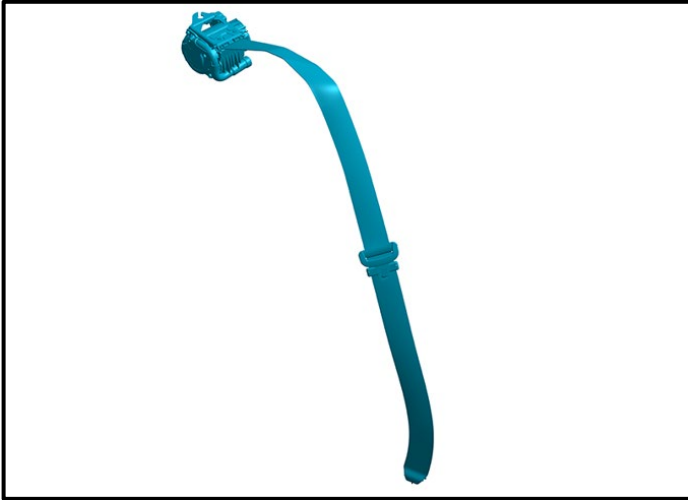
## Repair Overview

- **Criteria 01:** Inspect driver rear seat belt and replace if necessary.
- **Criteria 02:** Inspect passenger rear seat belt and replace if necessary.
- **Criteria 03:** Inspect both rear outer seat belts and replace if necessary.

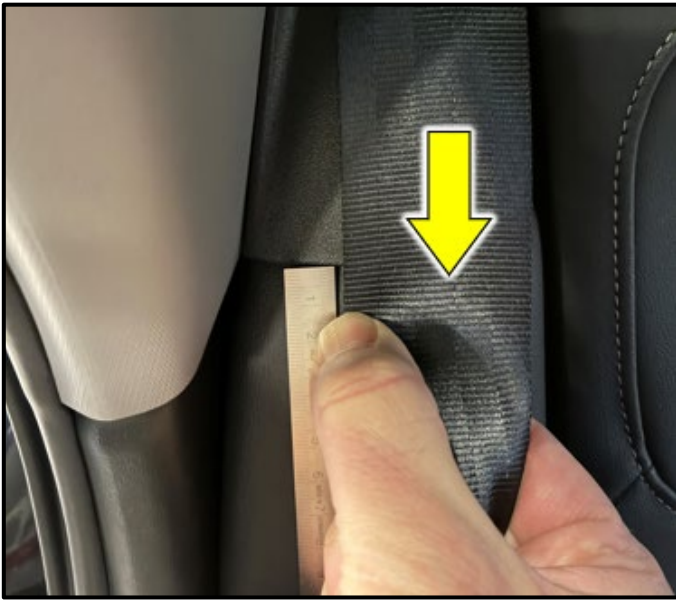
- Gently pull the seat belt in the direction indicated <arrow> until the belt retractor locks in place (seat belt cannot be pulled out further).
- Take note of how far the belt traveled before the locking mechanism engaged.
