## Recall Repair Instructions

**NHTSA Recall # 25V-905**

**Tiffin Motorhomes Recall # WAY-106**

**Models Involved:** 2025 & 2026 Open Trail Motorhomes equipped with a diesel generator

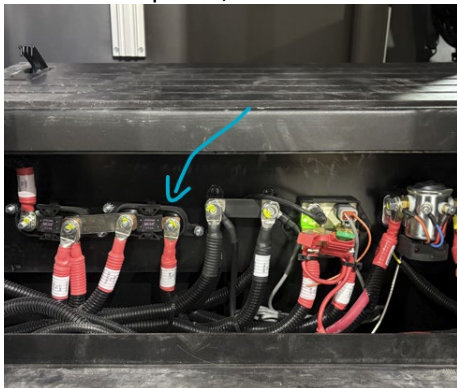
Figure 1

1. Locate the step well and remove the access panel from the step area to reveal the harness connection point to the fuse. Locate the inverter to battery harness located beneath the step well, see figure 1. This harness runs from the step well, across the coach and into the battery box beneath the furniture.

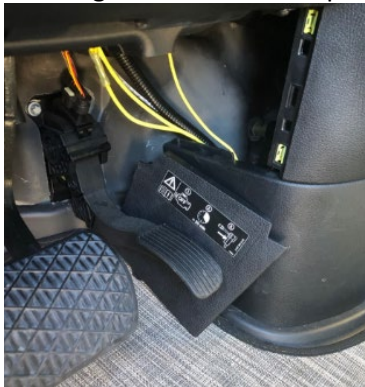
Figure 2A

1. Disconnect all electrical power from chassis by unplugging shore power cord if connected.
2. Disconnect the chassis battery at the battery disconnect. Remove the access panel next to the accelerator pedal (see Figure 2A). Push in the red tab shown in Figure 2B and then pull to disconnect (some models may have a black tab). **NOTE:** This step is critical to prevent any unintentional short circuits or electrical damage while working on electronic components.

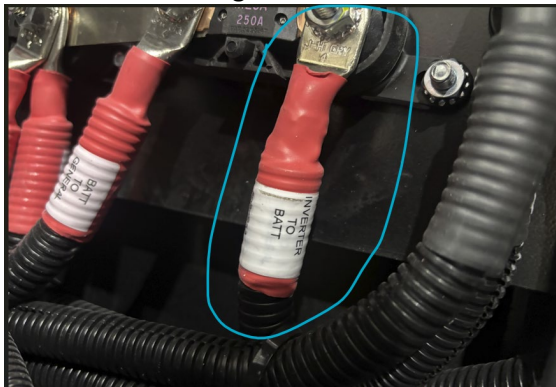
Figure 3

2. The incorrect wire harness will be labeled with part # 5060954, see figure 3. The correct wire harness will be labeled with part # 5185602.
3. If the correct harness part # 5185602 is installed, please file a warranty claim to clear the recall from the motorhome. If the incorrect harness part # 5060954 is installed, proceed with repair instructions below.

4. With power off to the coach, remove the terminal connection for harness, labeled INVERTER TO BATT 5060954. Remove the existing harness from the underbelly and properly dispose of.

7. Install the new inverter to battery harness, part # 5185602, and route through existing wire pathway. Reconnect the harness to the inverter and torque to 106 in-lbs.
8. Reconnect the other end of the harness in the step area to the terminal lug. Torque to 110 in-lbs.
9. Reassemble all removed components. Reinstall any removed trim and access panels, being careful not to overtighten or strip the fasteners. Reconnect chassis battery cable and the access panel.

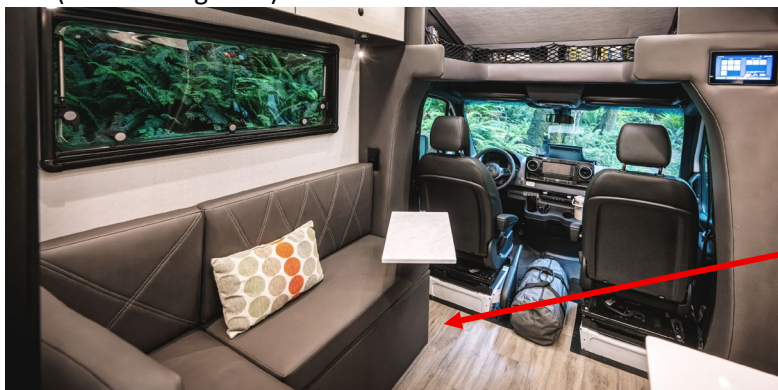
Figure 4

5. Remove the furniture access panel and any cushions to gain access to the electrical components beneath the sofa (shown in figure 4) or booth base.

Remove cushions or furniture seat base

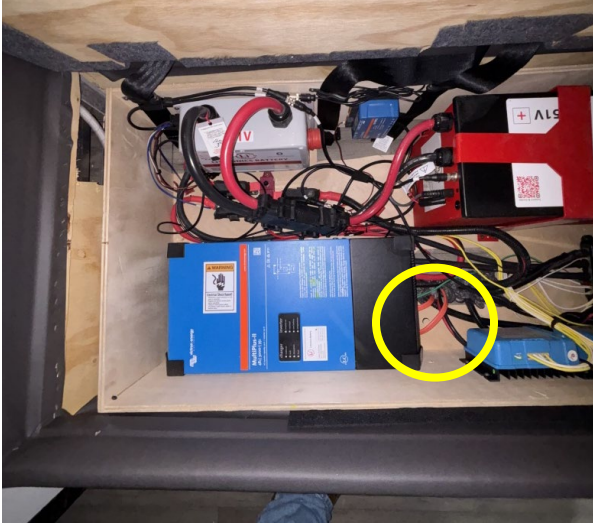
Figure 5

6. Remove the harness from the inverter connection shown in figure 5.
