## CR285 – Repositioning of Heat Reflective Sheath on Rear Brake Hose

Panigale V4 S/STD MY 2025 (all country versions)

**Safety Recall Campaign SRV-RCL-25-001**

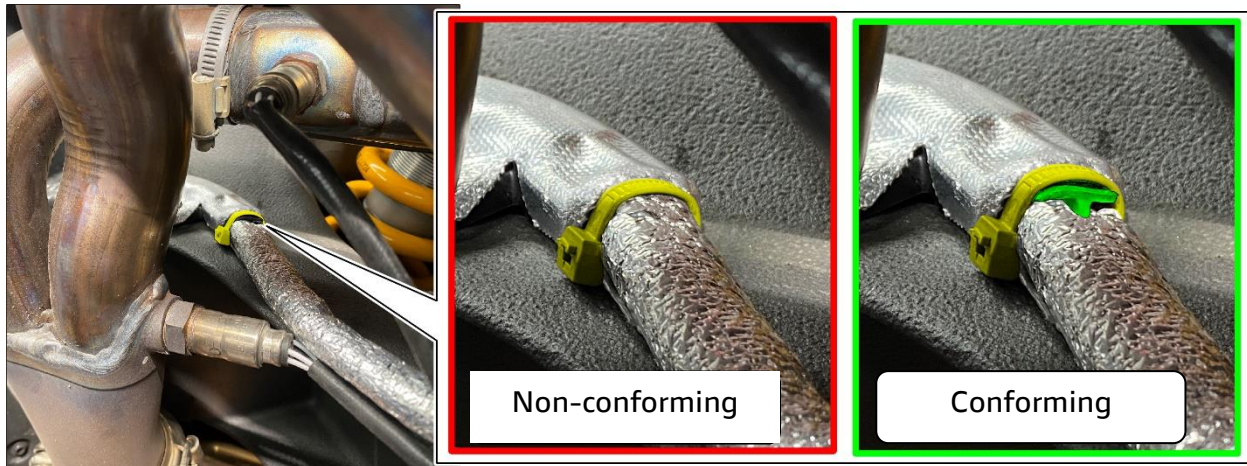
**Background:** If the heat reflective sheath is not correctly positioned or moves from the proper retainer on the rigid brake hose duct, the brake hose from the ABS control unit to the rear brake caliper could be damaged due to heat coming from the rear bank exhaust manifold.

To solve the problem, it has been decided to reposition the heat reflective sheath by moving it under the rigid brake hose duct, so that it is kept in place by the rigid duct retaining tooth.

**Solution:** Changing the position of the heat reflective sheath on the rear brake hose for the ABS control unit/brake caliper and secure it with a new grey self-locking tie Part no.74142941A, which is resistant to high temperatures.

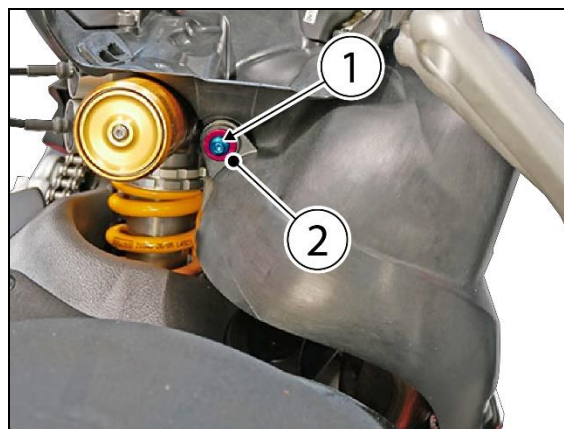
1. Position the motorcycle on the rear paddock stand.
2. Loosen and remove **screw (1)** together with **washer (2)**.

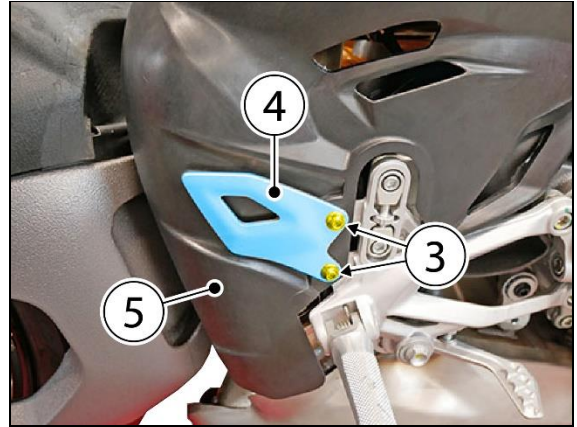
3. Loosen 2 screws (3) securing heel guard (4) and rear bank heat guard (5).

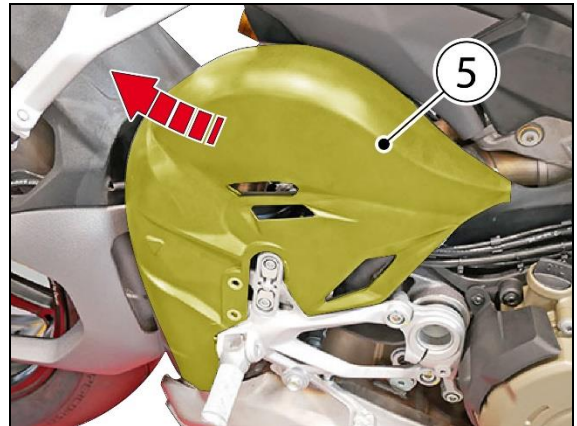
4. Remove rear bank heat guard (5) by sliding it out towards the rear side of the motorcycle.

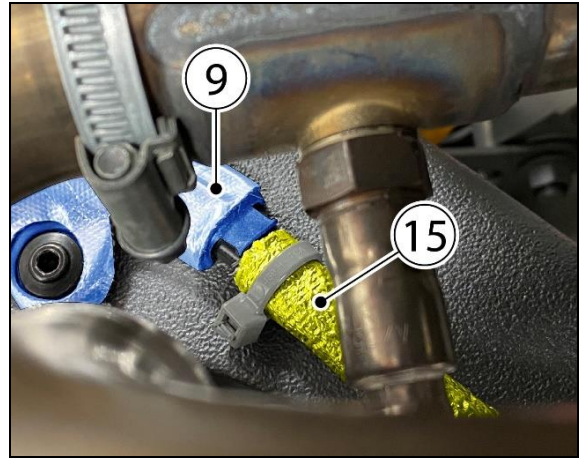
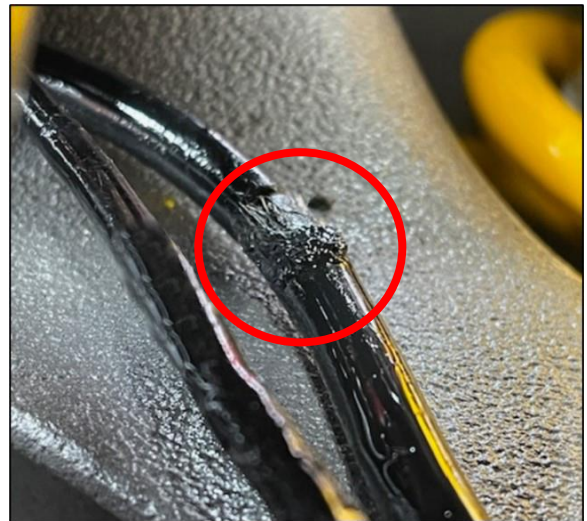
5. Visually check the position of **heat reflective sheath (15)** with respect to **rigid duct (9)**.

If positioned as shown in the figure, i.e. leaving the rear brake hose unprotected, it is necessary to visually check the integrity of the rear brake hose.

**NOTE:** A thermally damaged brake hose could appear as shown in the figure.

**NOTE:** A superficial mark due to the inner retainers of the rigid duct, on the other hand, is to be considered normal.

**NOTE:** If the heat reflective sheath is missing or damaged, fit a new one, Part no.4601P401A; the cost of the spare part used is offset in the labor reimbursement.

If the rear brake hose is thermally damaged, it is necessary to open a Youtech support request and replace it, otherwise go to the next point.

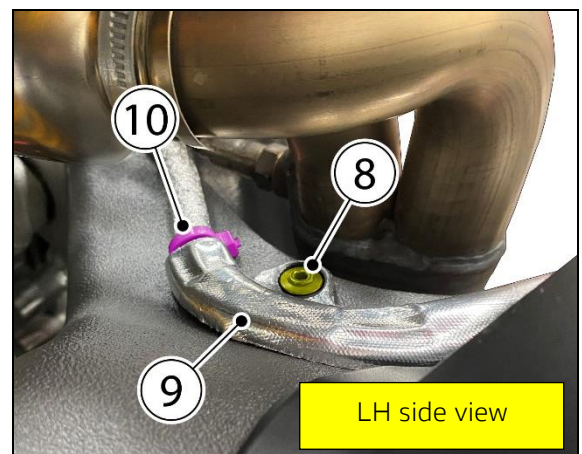
6. Loosen **screw (8)** securing the **rigid duct (9)**.
7. Remove the self-locking **tie (10)**.

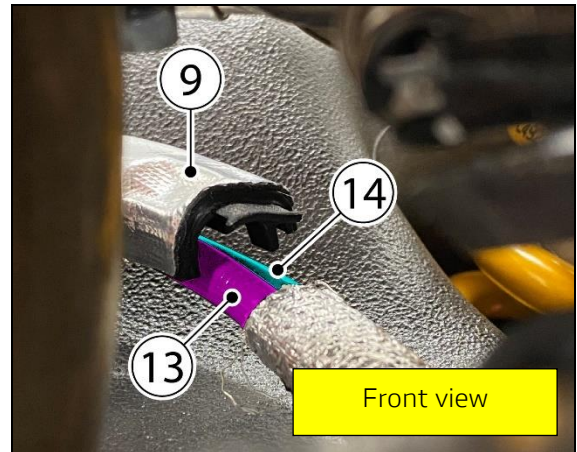
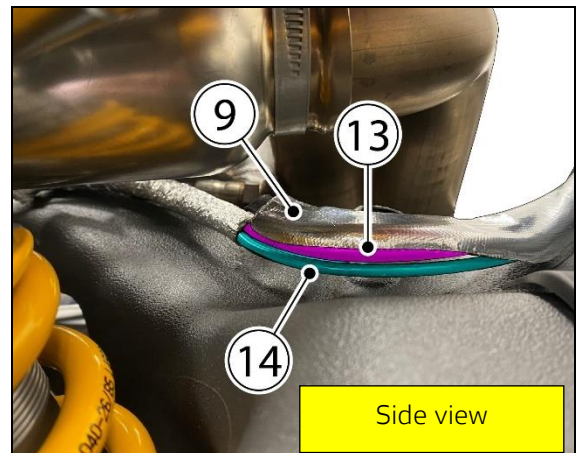
8. Release rear brake hose (13) and speed sensor cable (14) from the inner retainers of rigid duct (9).

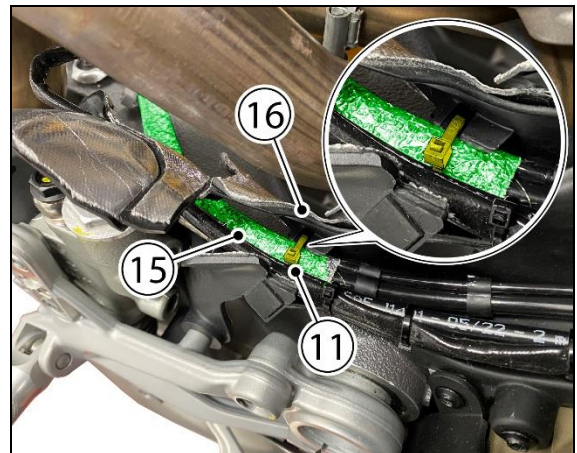
9. Remove small self-locking tie (11) that ties the rear brake hose and rear speed sensor cable assembly, located inside the heat reflective sheath (15), to heat guard (16).

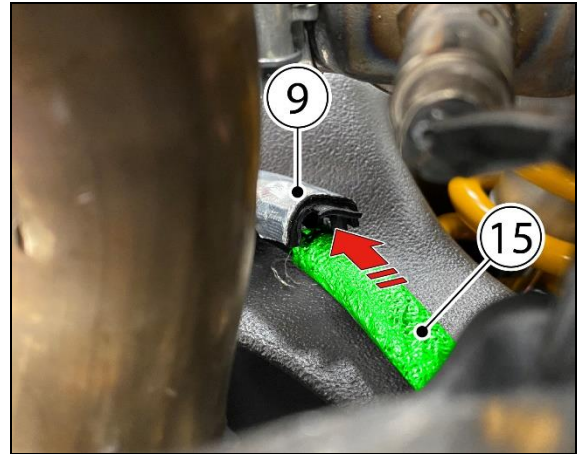
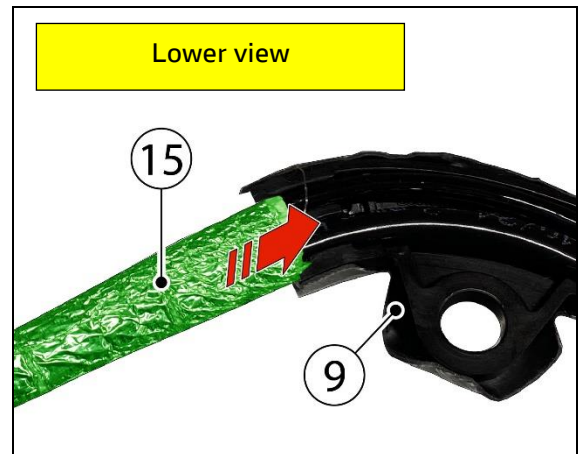
10. Position heat reflective sheath (15) under rigid duct (9), inserting it by at least 3mm.

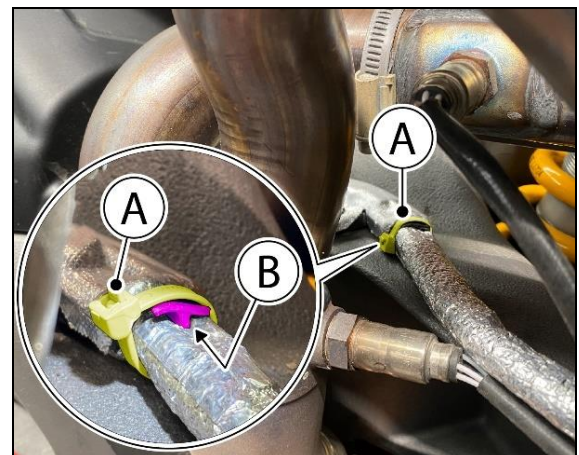
11. Tie heat reflective sheath to rigid duct using a grey self-locking tie (A) Part no. 74142941A.

**WARNING:** For this application, only use the grey self-locking tie Part no. 74142941A, which is resistant to high temperatures.

**WARNING:** Make sure that tooth (B) of rigid duct is positioned as shown in the figure.

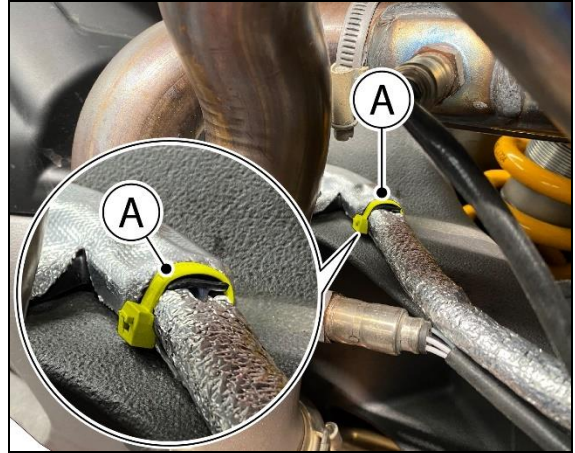
12. Aim the tie (A) as shown in the figure.

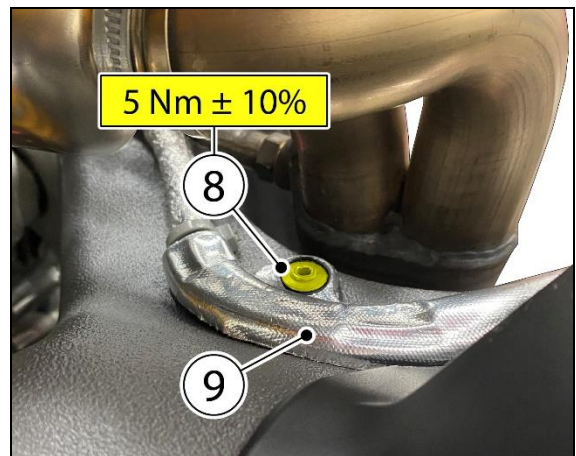
13. Reinstall rigid duct (9) with screw (8).

14. Tighten the screw (8) to a torque of 5 Nm ± 10%.

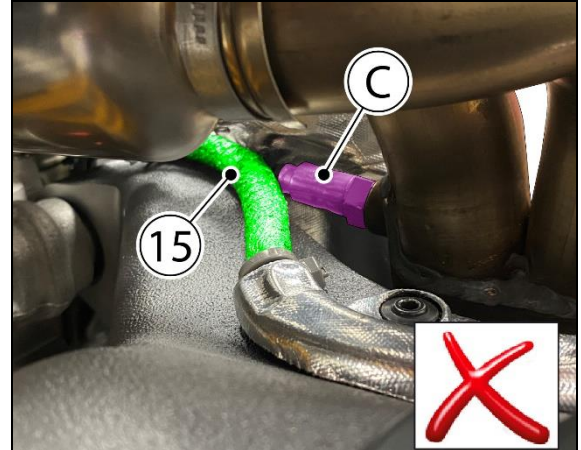
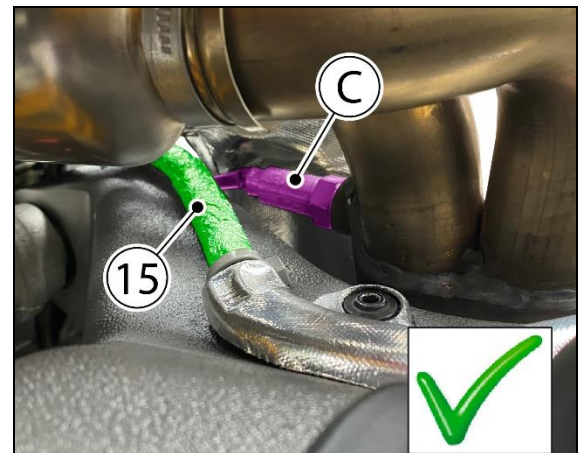
15. Make sure that the rear brake hose and rear speed sensor cable assembly, positioned inside the **heat reflective sheath (15)**, are **not in contact with lambda sensor (C)**.

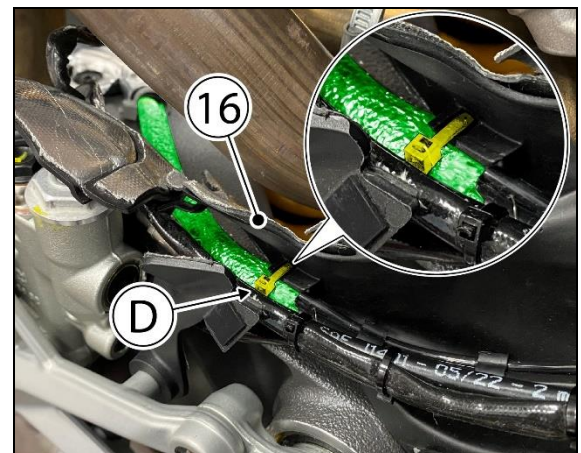
16. Secure the rear brake hose and rear speed sensor cable assembly, located inside the **heat reflective sheath (15)**, to heat guard (16) using a **self-locking tie (D)**.

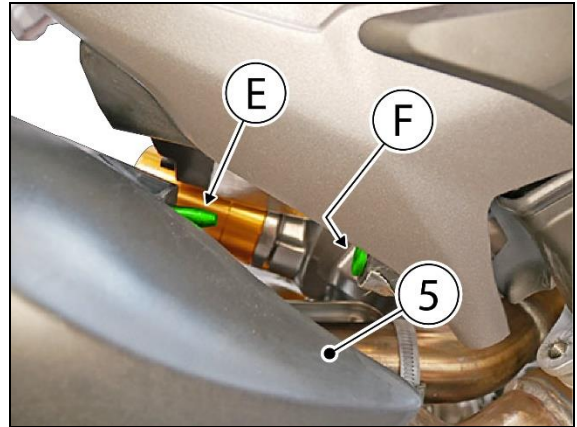
17. Position rear bank heat guard (5) by inserting pin (E) inside vibration damper (F).

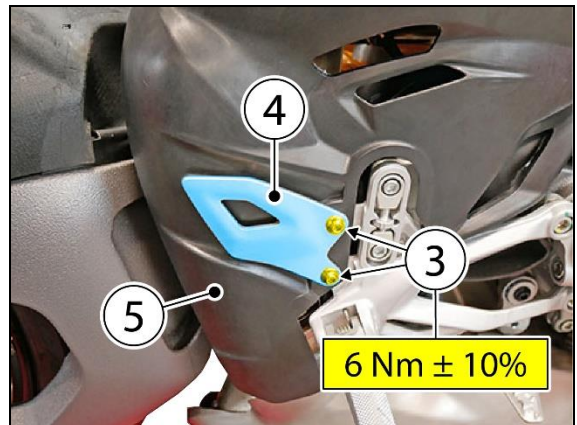
18. Position heel guard (4) on rear bank heat guard (5).

19. Tighten the 2 screws (3) to a torque of 6 Nm  $\pm$  10%.

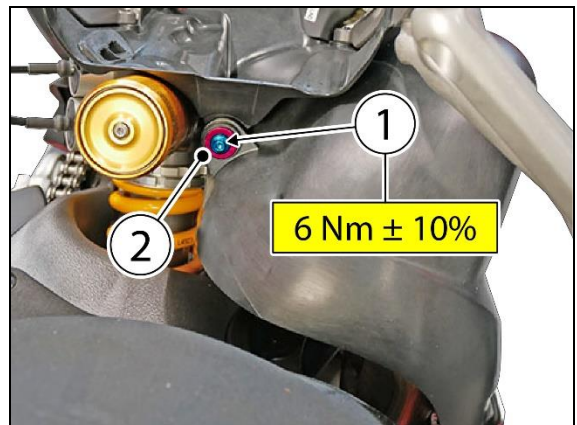
20. Start the screw (1) along with the relevant washer (2) in-between and tighten it to a torque of 6 Nm  $\pm$  10%.
