Safety Recall: 2014–20 MDX and 2017–20 MDX Sport Hybrid Moisture in the Inner Taillights

Supersedes 25-001 dated July 9, 2025 to revise the information highlighted in **yellow**.

An uneven sealing surface allows moisture to enter the inner taillight(s), causing one or both of the inner taillights to malfunction.

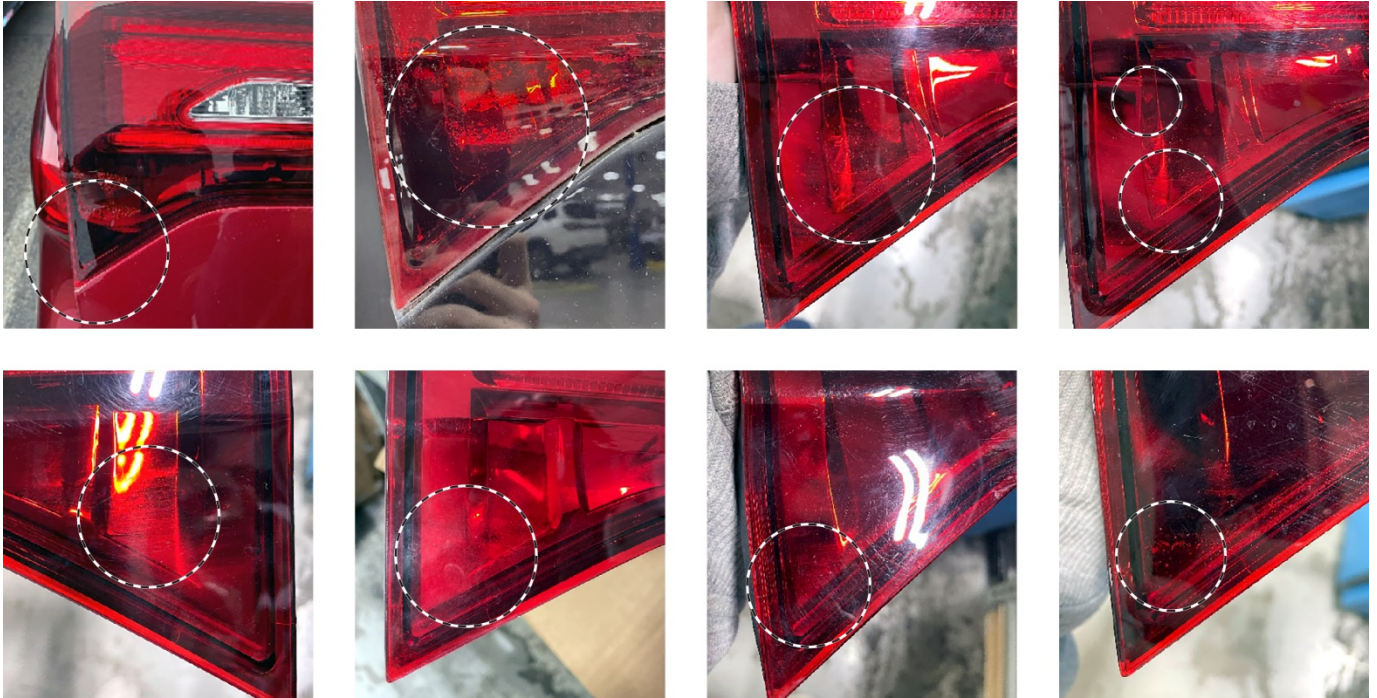
Method 1

Check to see if any of the following examples of moisture apply to the client's vehicle:

Inspection Results	Repair Direction
The inner taillights are working, and no moisture was detected.	Do REPAIR A to install the new sub harness.
The inner taillight(s) is not working.	Do REPAIR B to install the new sub harness and replace the failed inner taillight(s).
The inner taillight(s) has moisture inside.	
Both inner taillights are not working and small light fuse is blown.	Do REPAIR B to install the new sub harness, replace both inner taillights, and replace the fuse.

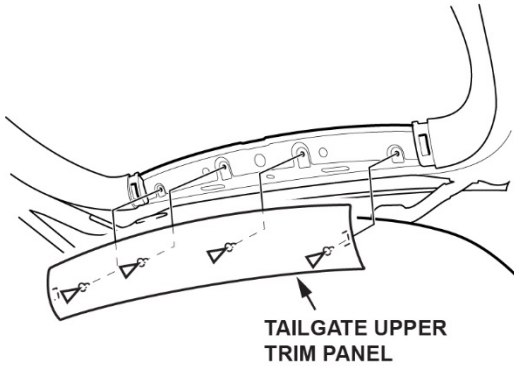
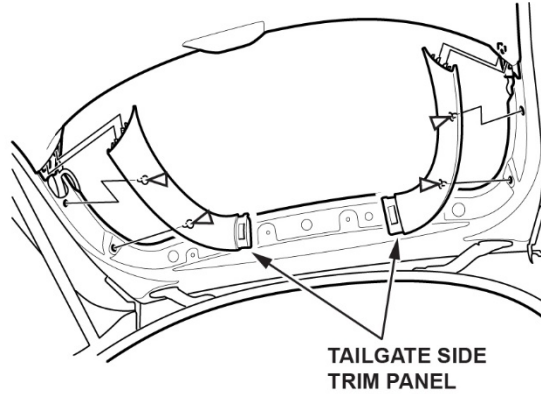
2. Remove the tailgate upper trim panel, then remove the side trim panels.

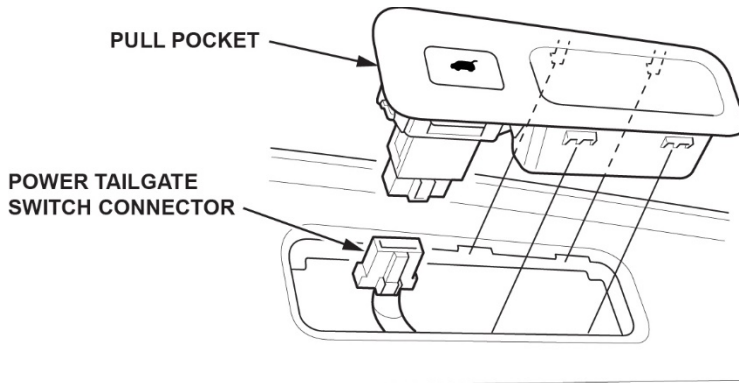
3. Remove the pull pocket, then disconnect the power tailgate switch connector.

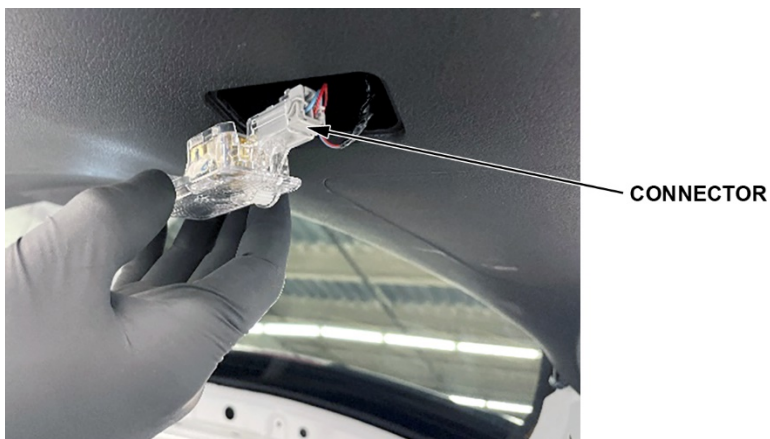
4. Remove and disconnect the tailgate light connectors.

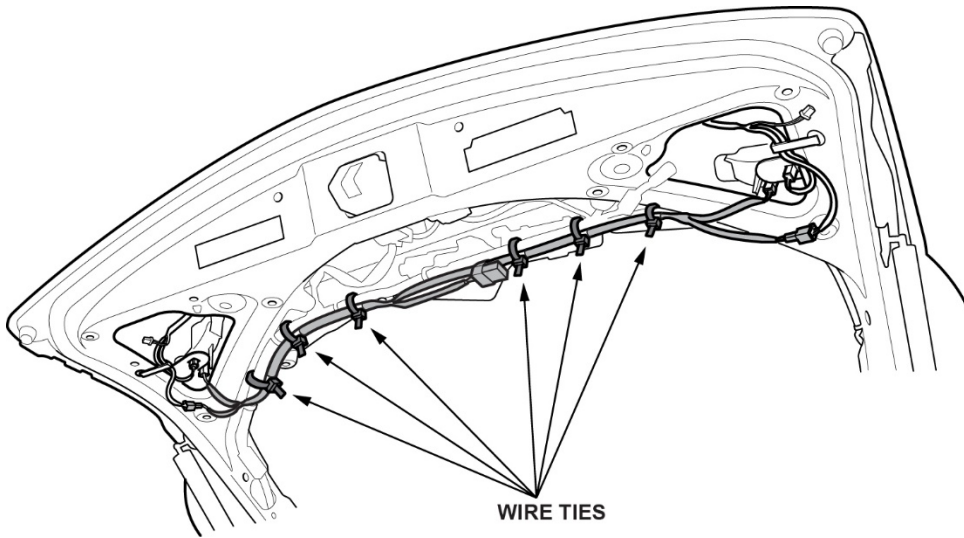
10. Starting at the center, then moving outward, use the supplied wire ties along each white piece of tape found on the new harness to secure the new inner taillight sub harness.

NOTE: Trim any excess from the wire ties.

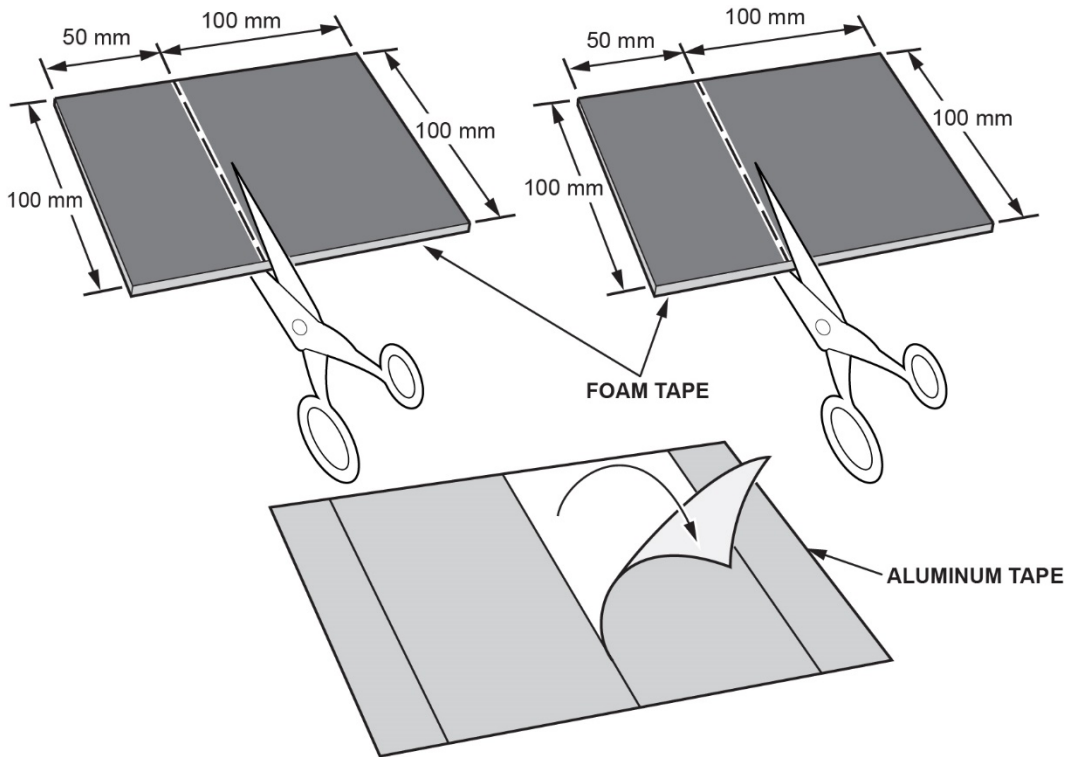
11. Cut two pieces of the foam tape (supplied in the service kit).

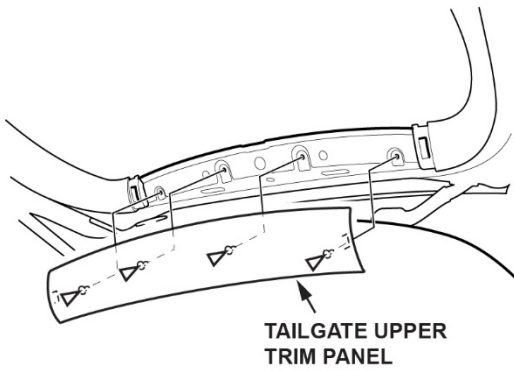
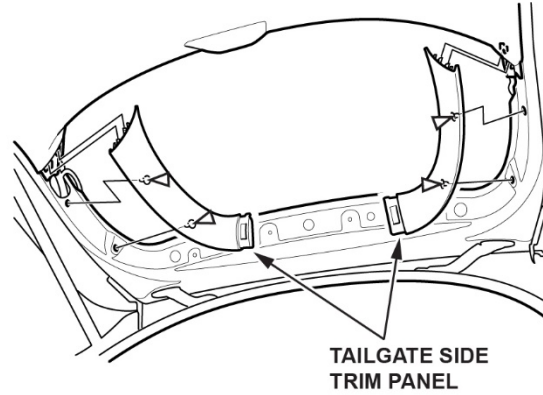
2. Remove the tailgate upper trim panel, then remove the side trim panels.

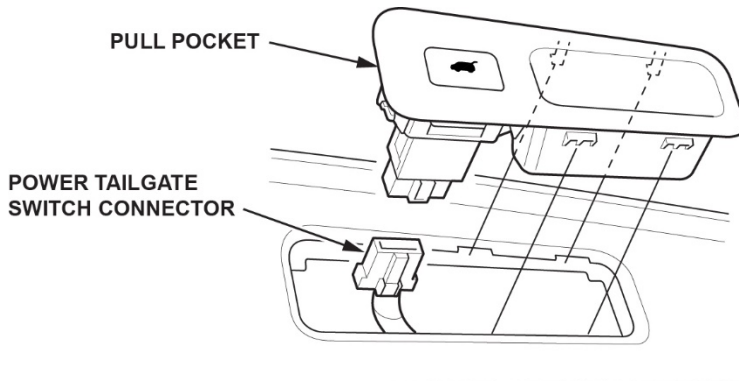
3. Remove the pull pocket, then disconnect the power tailgate switch connector.

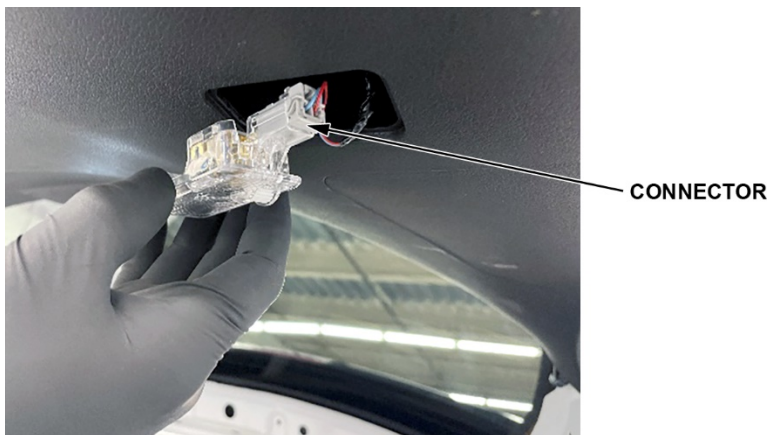
4. Remove and disconnect the tailgate light connectors.

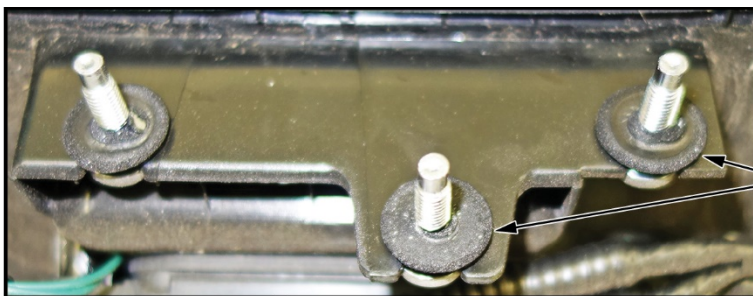
- Disconnect the license sub harness connector, remove the five nuts, release the pins from the clips, then remove the rear license trim.

INSIDE THE TAILGATE

LICENSE SUBHARNESS CONNECTOR

4.9 N·m (3.6 lb-ft)

OUTSIDE THE TAILGATE

REAR LICENSE TRIM

Be sure the grommets stay on the studs and clips.

BACKSIDE OF THE REAR LICENSE TRIM

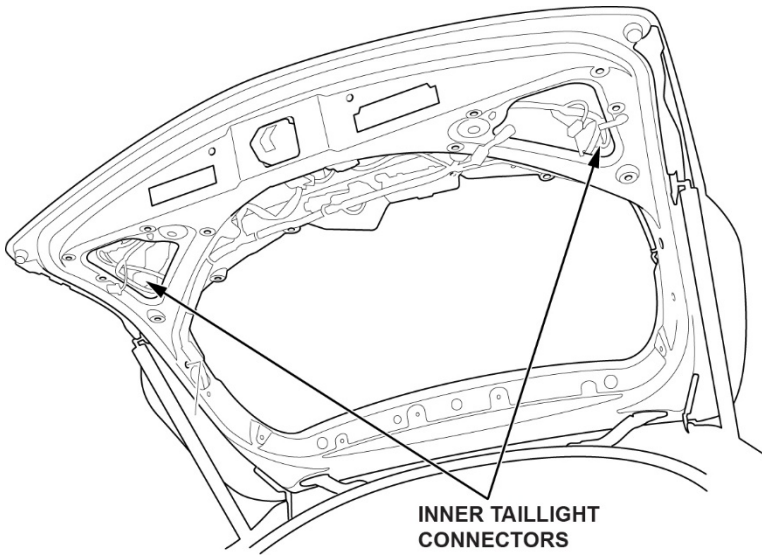
7. Disconnect both inner taillight connectors.

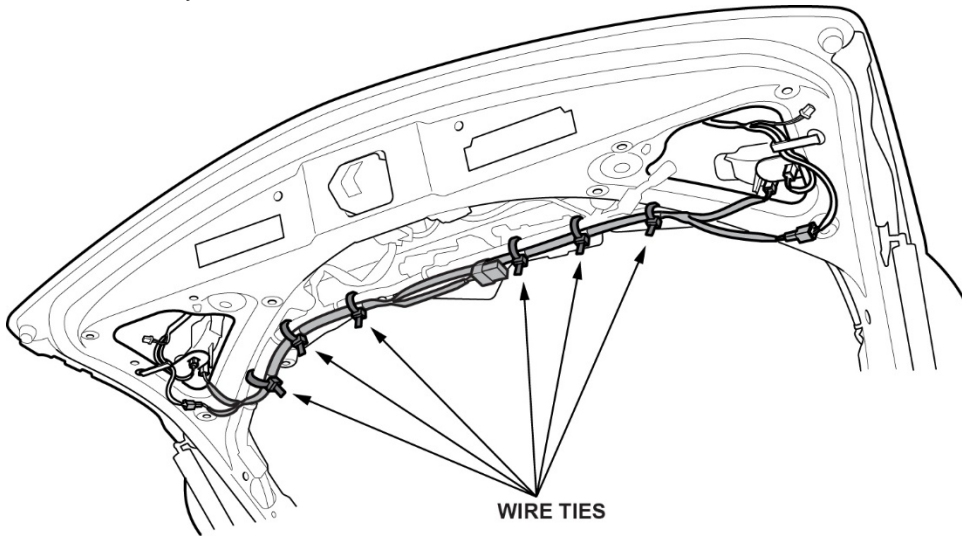
10. Starting at the center and then moving outward, use the supplied wire ties along each white piece of tape found on the new harness to secure the new inner taillight sub harness.

NOTE: Trim any excess from the wire ties.

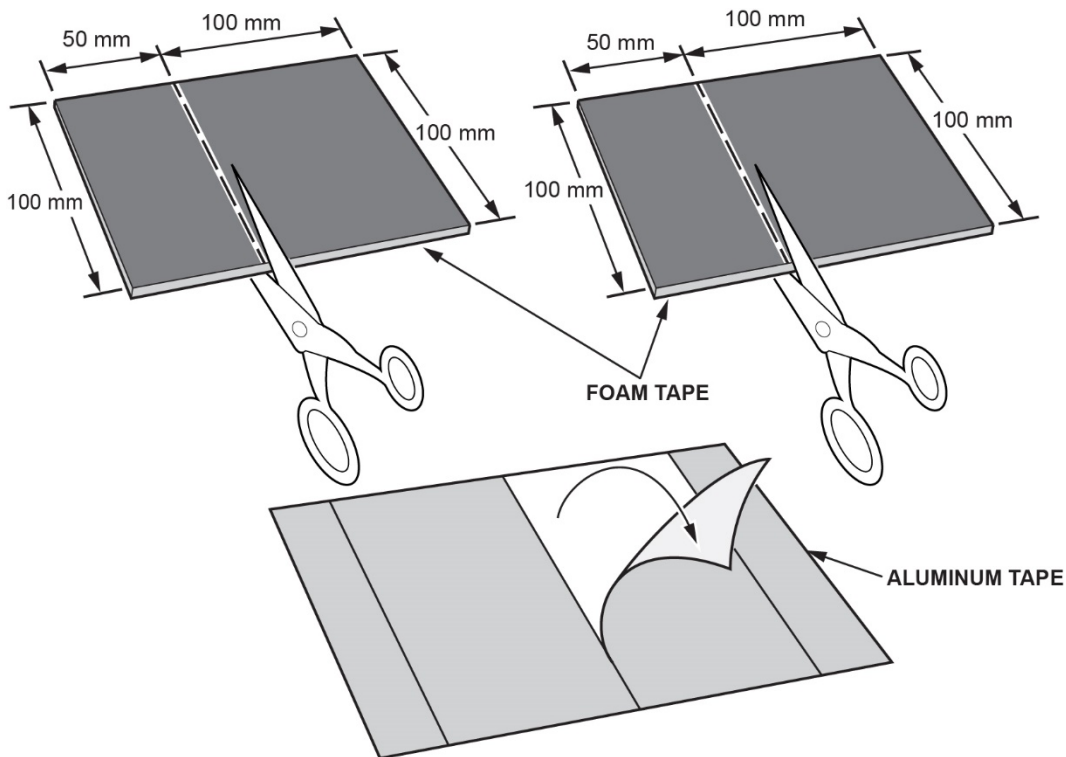
11. Cut two pieces of foam tape (supplied in the service kit).

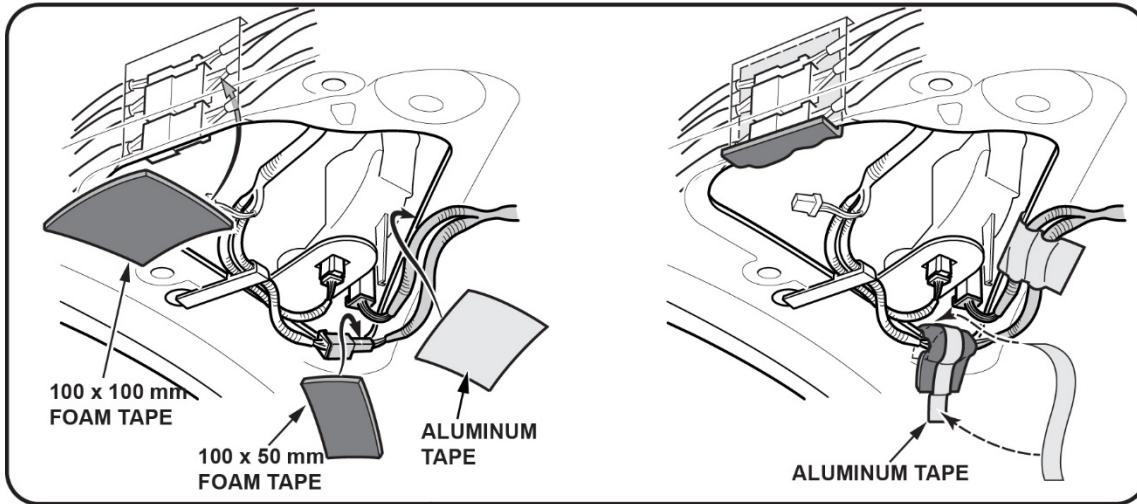
12. Clean the areas shown below with isopropyl alcohol and attach the foam tape pieces. Then, secure the harness and connectors to the body with aluminum tape as shown.

NOTE: To prevent water intrusion, make sure the foam tape covers the entire connector. The aluminum tape should wrap around the foam wrapped connector to the back side of the metal, this will prevent rattles.

LEFT SIDE

RIGHT SIDE

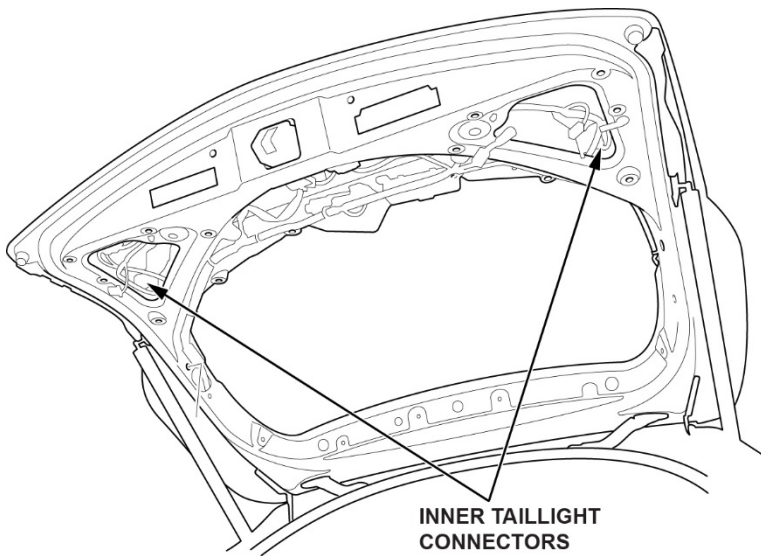
13. Disconnect both inner taillight connectors.

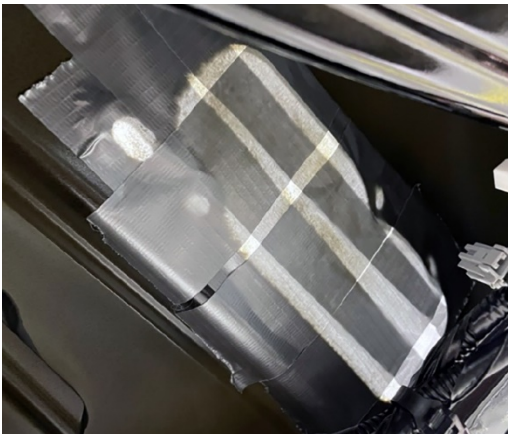
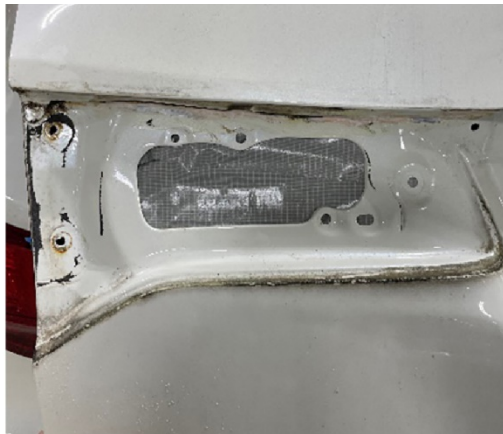
17. Once the dust sealer removal area has been marked, remove the template.
18. Seal the tailgate before doing the dust sealer removal:
 1. Place tape over the opening for the lid light.
 2. From the inside of the tailgate, place tape over the opening for the inner taillight.

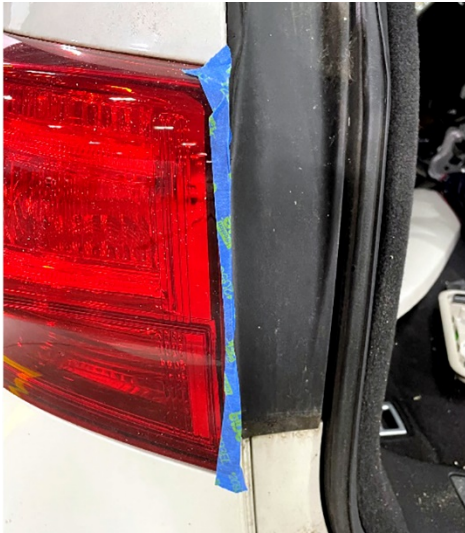
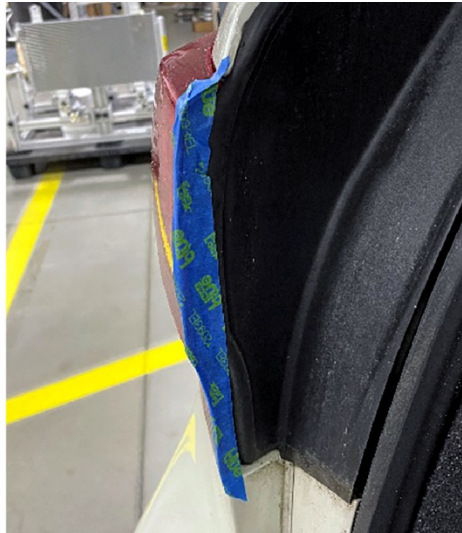
19. Place tape over the edge of the outer taillight to keep debris from getting into the housing.

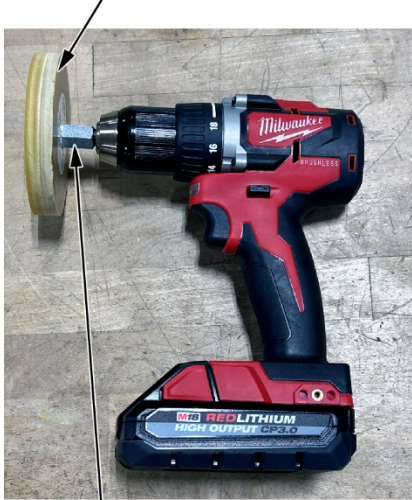
20. With the tailgate closed, and while wearing proper eye protection and gloves, use a drill (or equivalent rotary tool) with the 3M Stripe Off Wheel to remove the dust sealer between the markings.

- Ensure that the power tool being used is appropriate for the type of stripe off wheel being used.
- The maximum RPM for the recommended 3M Stripe Off Wheel is **4,000 RPM**.
- The stripe off wheel will only remove paint where there is sealer underneath the paint.

3M STRIPE OFF WHEEL

HARDWARE (SCREW)

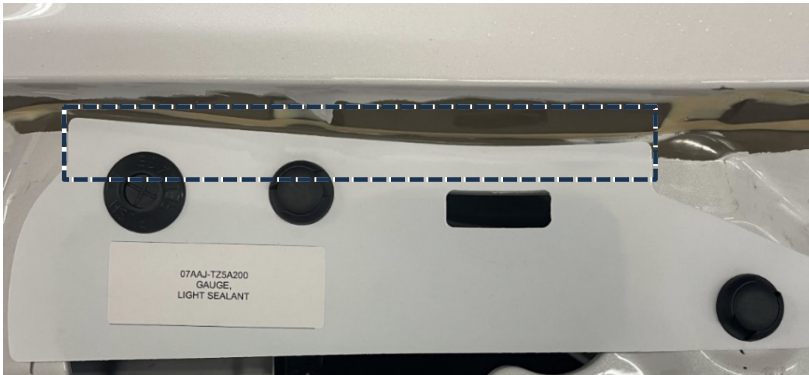
21. Use the template as a guide to ensure enough sealer has been removed.

NOTE: If the template indicates that additional sealer needs to be removed, remove the template, then continue to remove sealer as needed with the stripe off wheel.

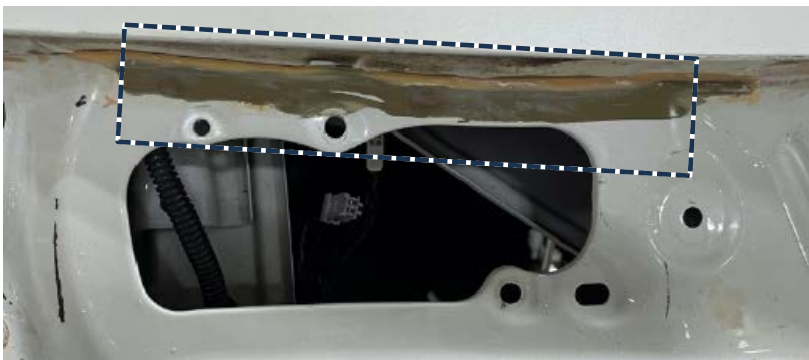
Example of finished sealer removal:

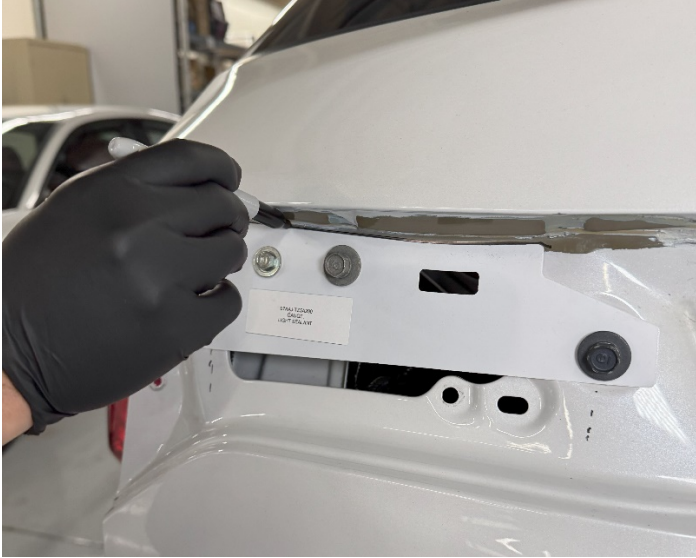
23. With the template installed, use a marker to make a line across the top edge of the template, then remove the template.

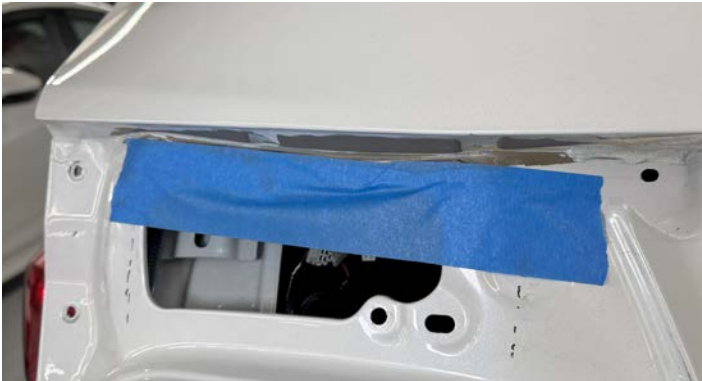
24. Place tape along the underside of the line that was drawn in the previous step.

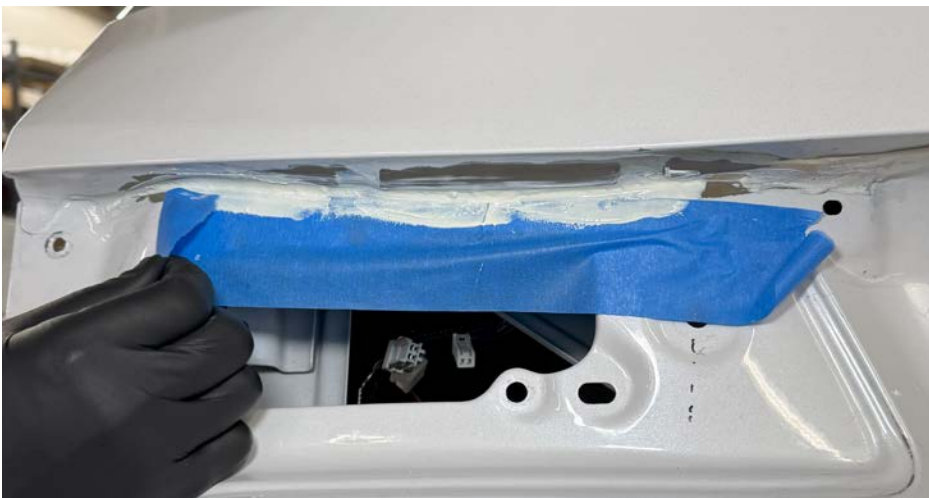
25. Apply a thin bead of Penguin Seal 353 to the area above the tape where the tailgate panels meet. While wearing a glove, run a finger along the new sealer to seal the panel joint and smooth the sealer across the area where the old sealer was removed.

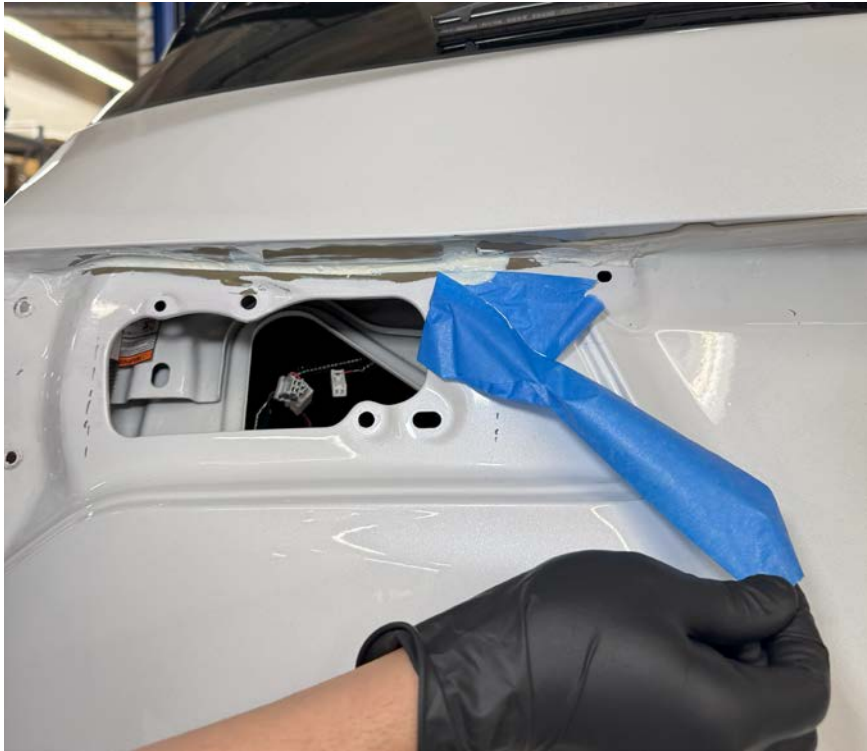
26. Immediately remove the tape below the sealer and allow 15 minutes for the sealer to dry.

NOTE: Proceed to the next step while the sealer is drying.

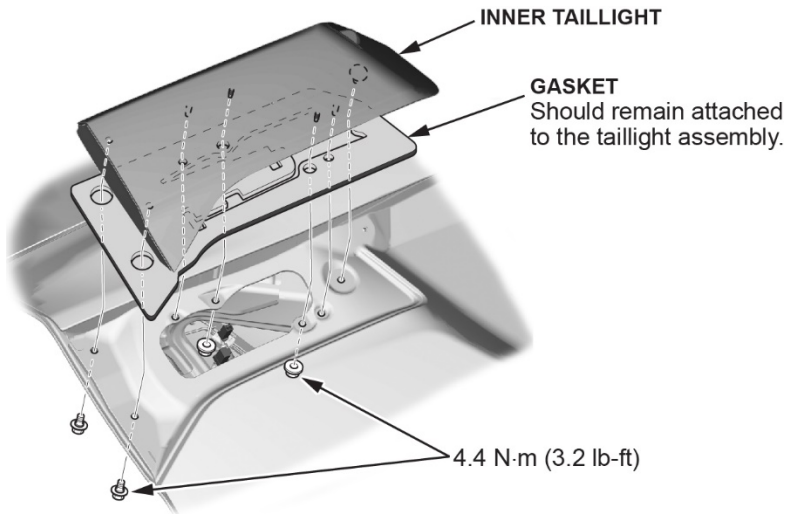
28. Install the new inner taillight(s) and connect them.

29. Make sure all the taillights come on.

30. Install all parts in the reverse order of removal.
