## Safety Recall: 2014–20 MDX and 2017–20 MDX Sport Hybrid Moisture in the Inner Taillights

Supersedes 25-001 dated April 18, 2025 to revise the information highlighted in **yellow**.

An uneven sealing surface allows moisture to enter the inner taillight(s), causing one or both of the inner taillights to malfunction.

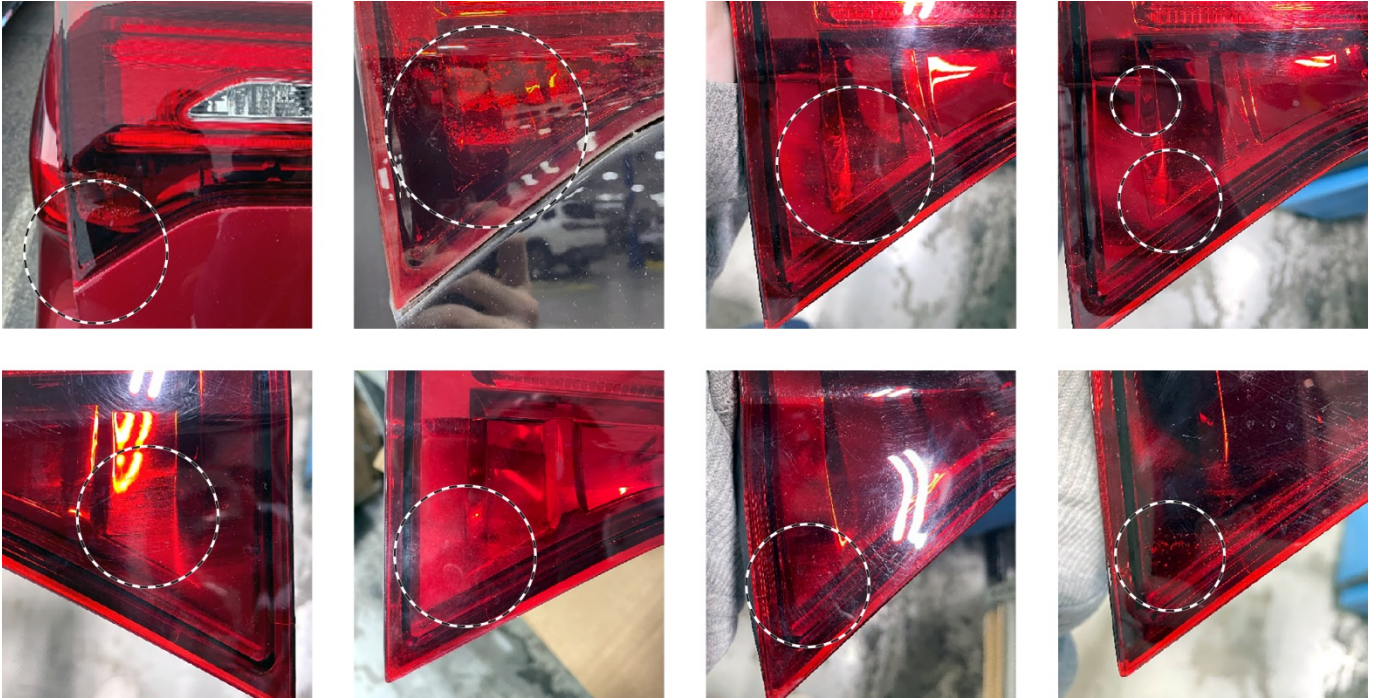
#### Method 1

4. Inspect the inner taillights for any signs of moisture inside. Below are two methods to help with this inspection.

Check to see if any of the following examples of moisture apply to the client's vehicle:

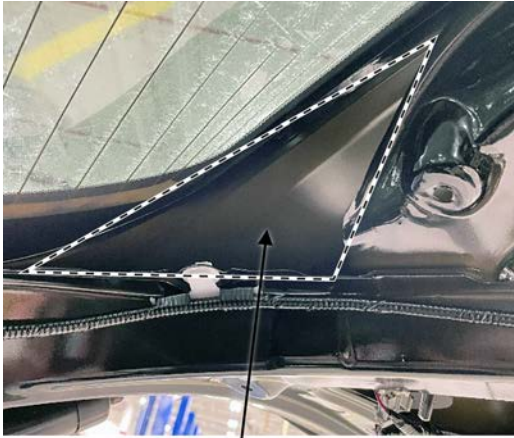
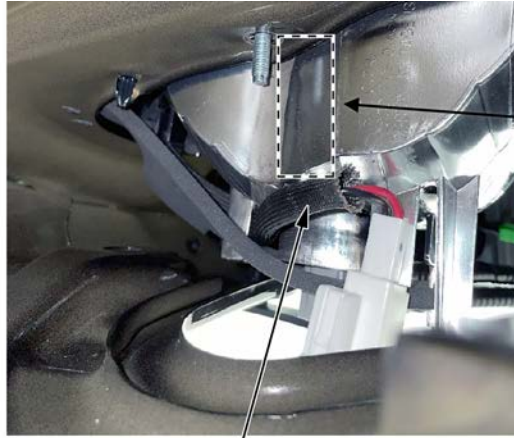
**Method 2**

Using a flashlight in the shown location on the tailgate, look for water marks on the chrome portion of the taillight or staining on the wiring harness.

TAILGATE

CHROME

HARNES

Inspection Results	Repair Direction
The inner taillights are working, and no moisture was detected.	Do <b>REPAIR A</b> to install the new sub harness.
The inner taillight(s) is not working.	Do <b>REPAIR B</b> to install the new sub harness and replace the failed inner taillight(s).
The inner taillight(s) has moisture inside.	
Both inner taillights are not working and small light fuse is blown.	Do <b>REPAIR B</b> to install the new sub harness, replace both inner taillights, and replace the fuse.

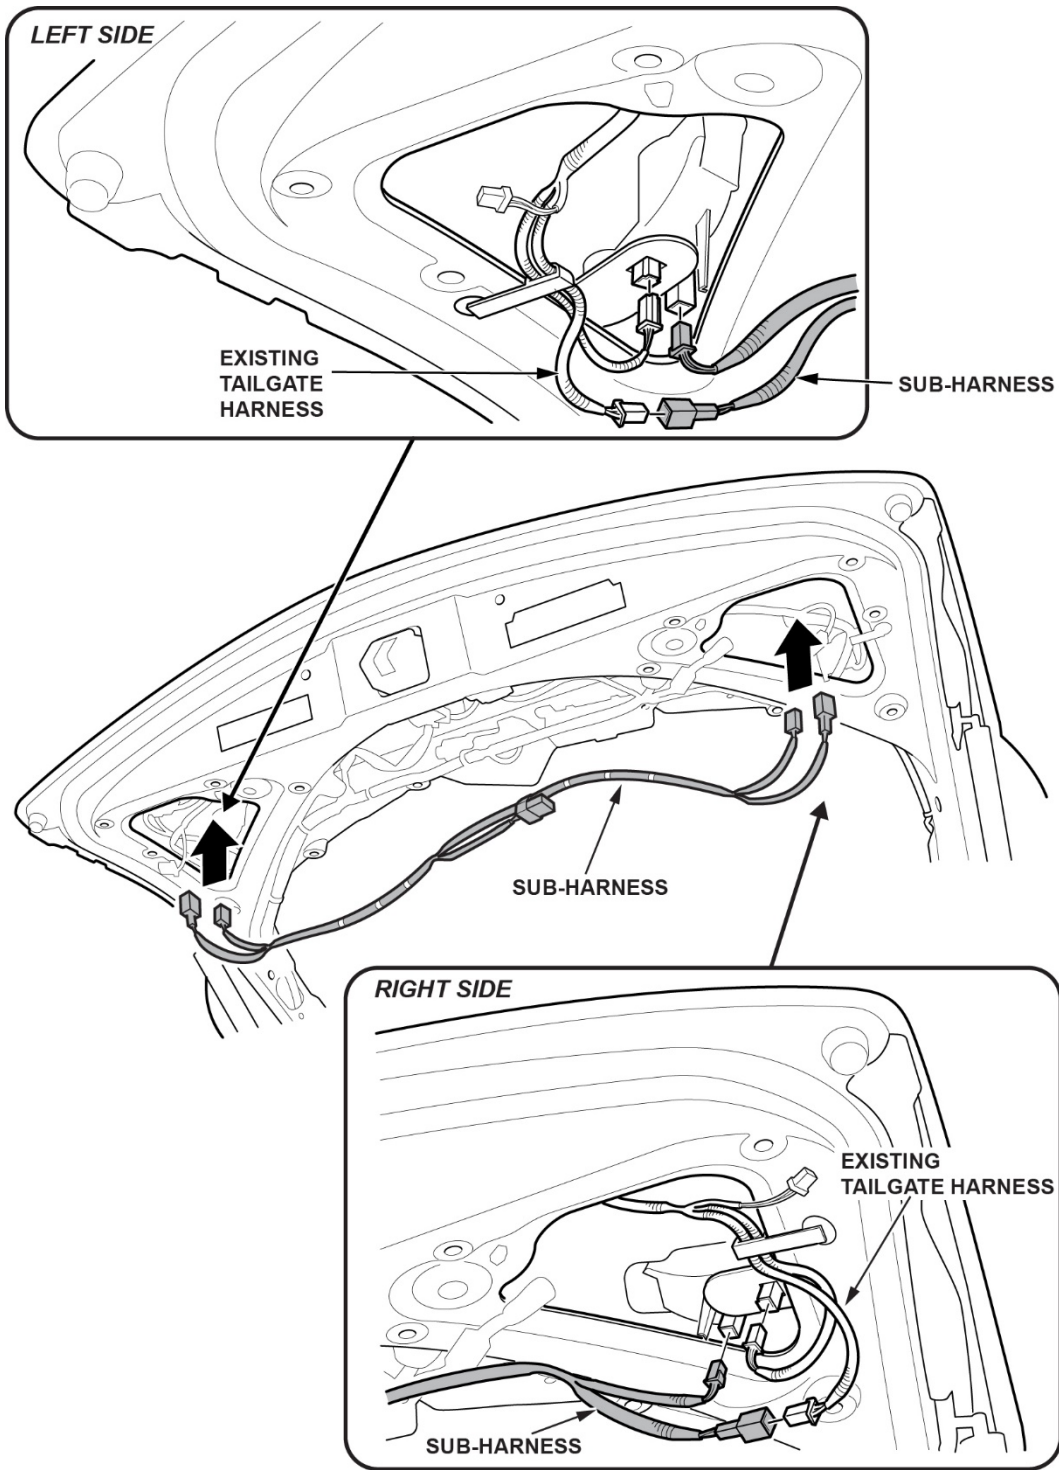
8. Install and route the new inner taillight sub harness (included in the service kit) to the existing tailgate harness.

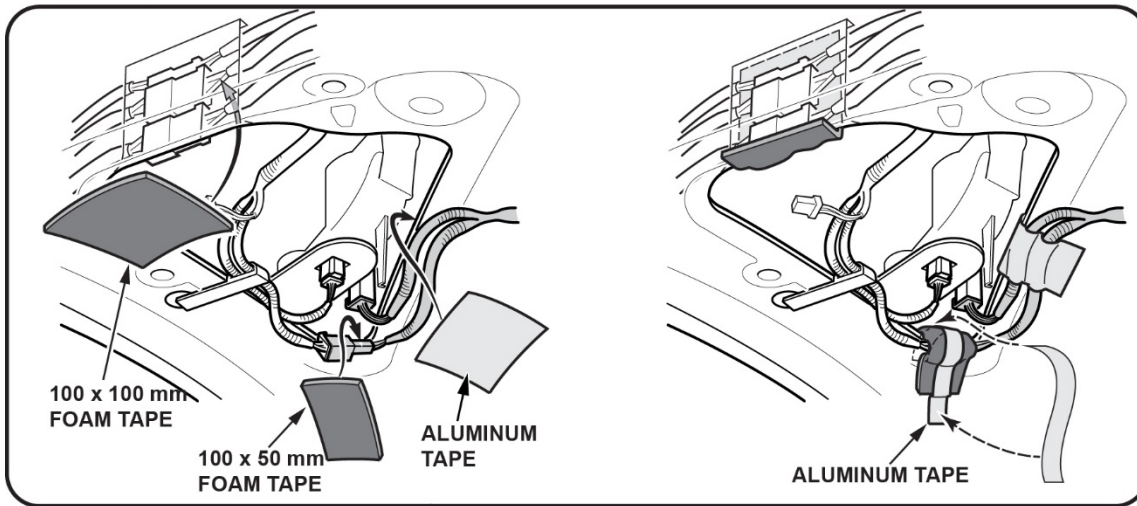
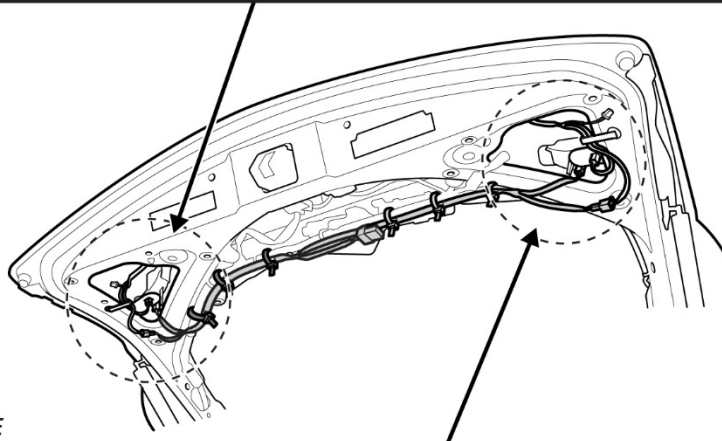
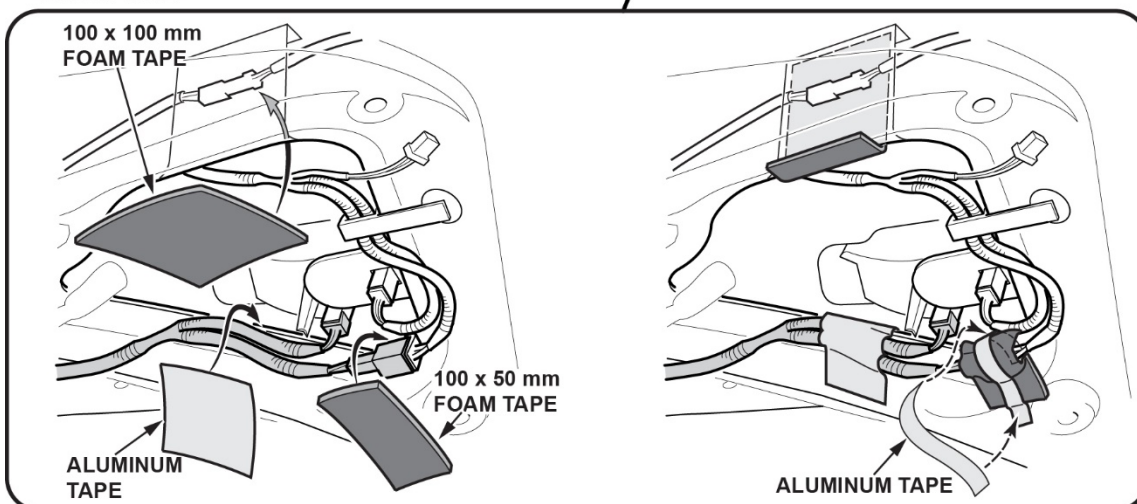
12. Clean the areas shown below with isopropyl alcohol and attach the foam tape pieces. Then, secure the harness and connectors to the body with aluminum tape as shown.

NOTE: To prevent water intrusion, make sure the foam tape covers the entire connector. The aluminum tape should wrap around the foam wrapped connector and adhere to the back side of the metal, to prevent rattles.

**LEFT SIDE**

**RIGHT SIDE**

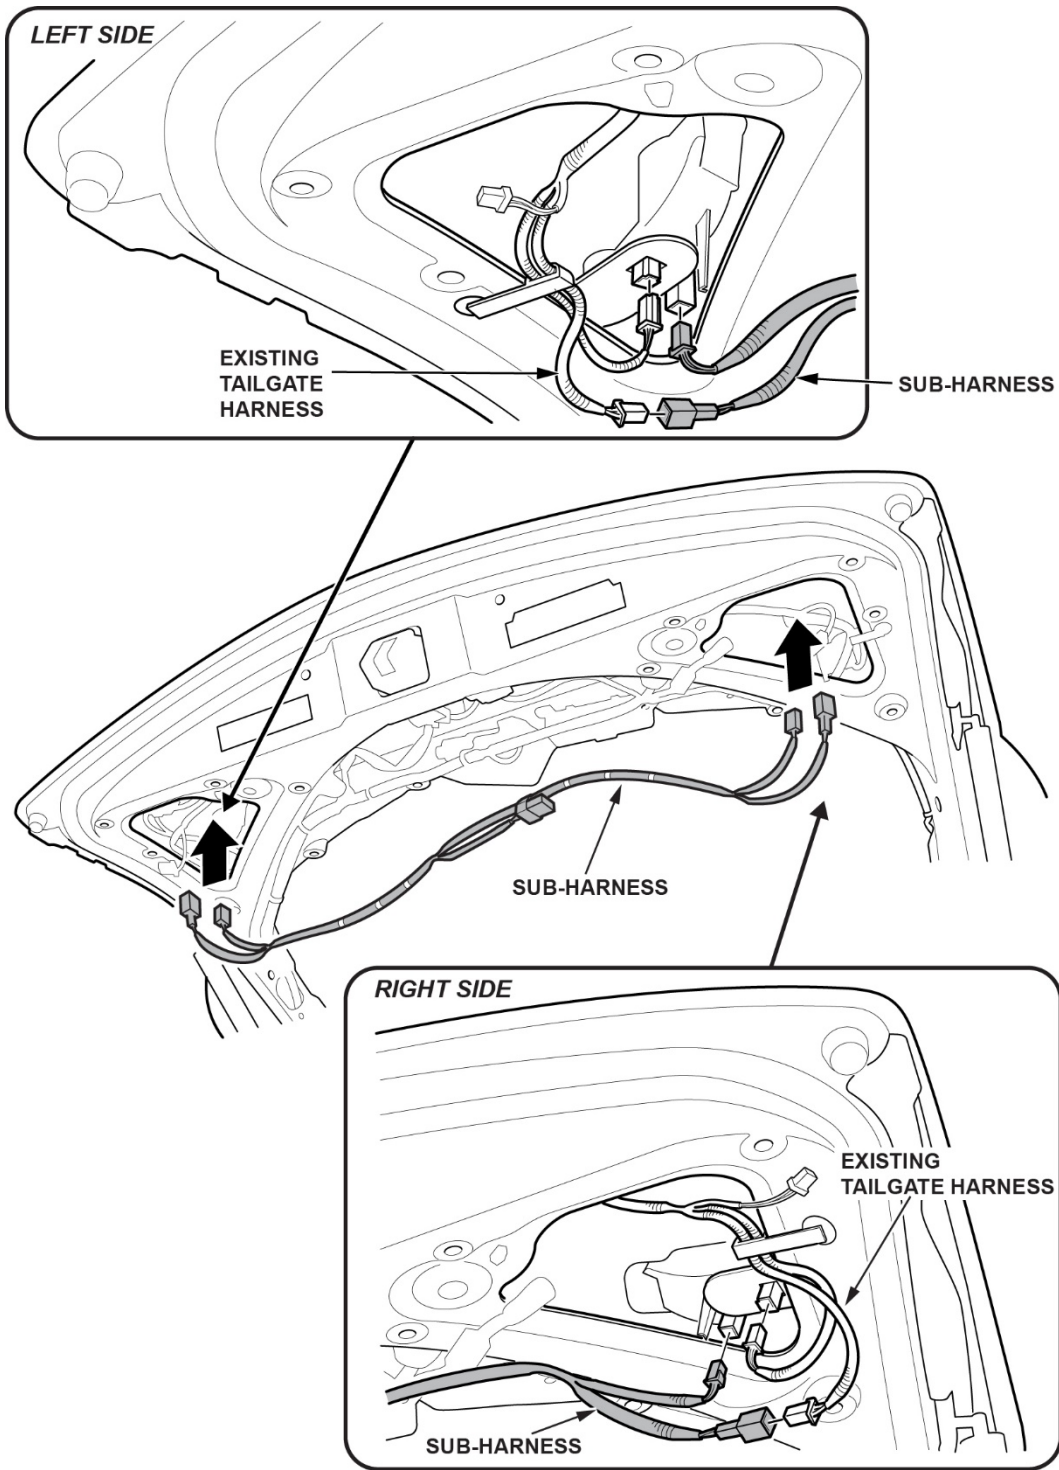
8. Install and route the new inner taillight sub harness (included in the service kit) to the existing tailgate harness.

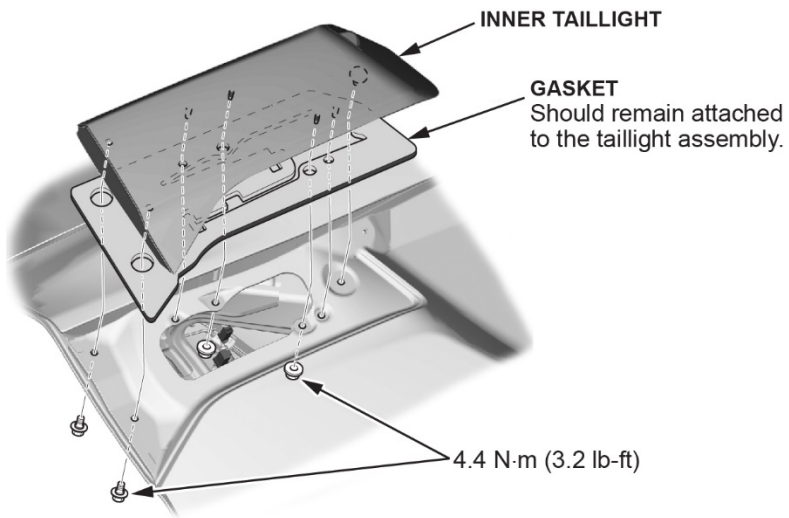
14. Remove the failed inner taillight(s) by removing the two mounting bolts and two mounting nuts.

NOTE: Be sure to completely remove the old inner taillight gasket from the tailgate surface.

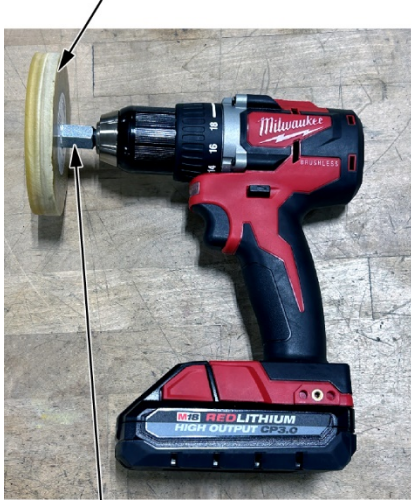
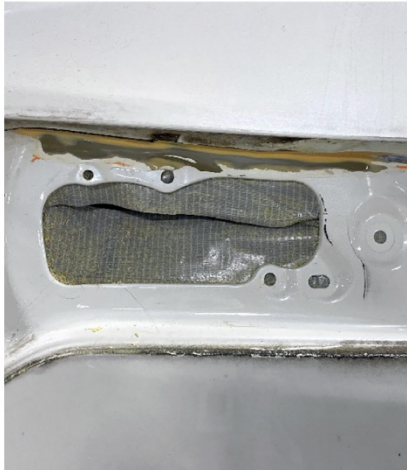
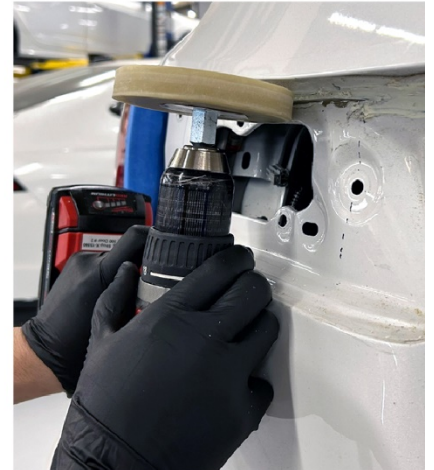
3M STRIPE OFF WHEEL

20. With the tailgate closed, and while wearing proper eye protection and gloves, use a drill (or equivalent rotary tool) with the 3M Stripe Off Wheel to remove the dust sealer between the markings.

- Ensure that the power tool being used is appropriate for the type of stripe off wheel being used.
- The maximum RPM for the recommended 3M Stripe Off Wheel is **4,000 RPM**.
- The stripe off wheel will only remove paint where there is sealer underneath the paint.

HARDWARE (SCREW)

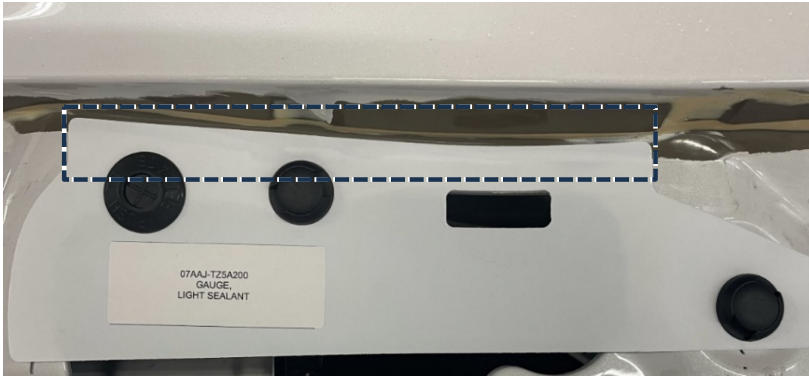
21. Use the template as a guide to ensure enough sealer has been removed.

NOTE: If the template indicates that additional sealer needs to be removed, remove the template, then continue to remove sealer as needed with the stripe off wheel.

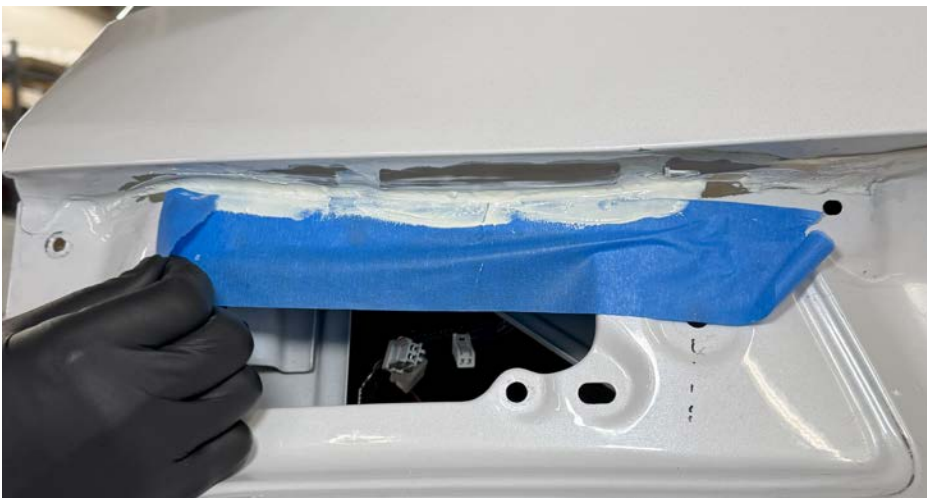
25. Apply a thin bead of Penguin Seal 353 to the area above the tape where the tailgate panels meet. While wearing a glove, run a finger along the new sealer to seal the panel joint and smooth the sealer across the area where the old sealer was removed.
