# Keystone RV Company

## SAFETY ADVISORY # 25-468

### MORryde Clip-on Step Brackets

Keystone is conducting a voluntary RECALL notification campaign in accordance with the National Highway Transportation and Safety Act. It has been decided that the vehicles in the recall population may have steps that can detach while in use. Under certain conditions during use the receiver may come loose and disengage from the bracket leading to an increased risk of personal injury.

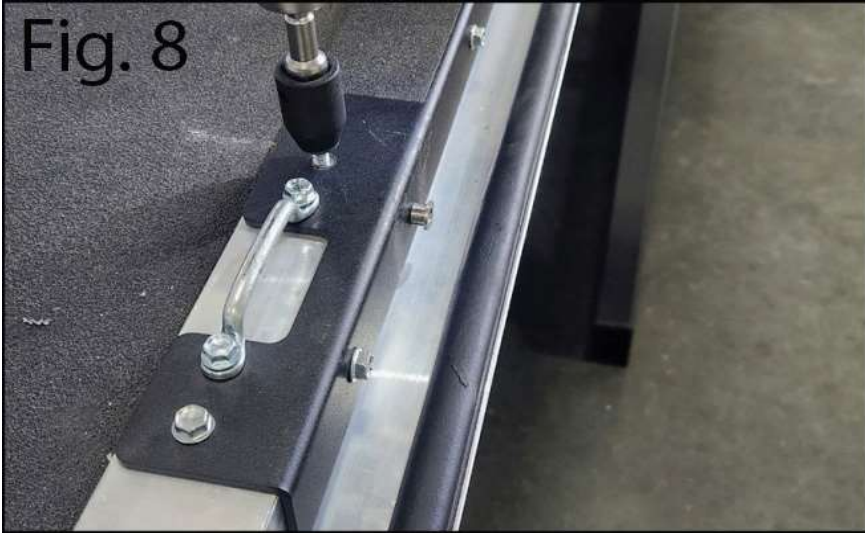
Remove the 12 mounting screws that secure the mounting bracket. Once removed, discard the original mounting bracket. See Figure 8.

Note: It is OK to use a drill/impact with 3/8" bit for the removal of each of the screws.

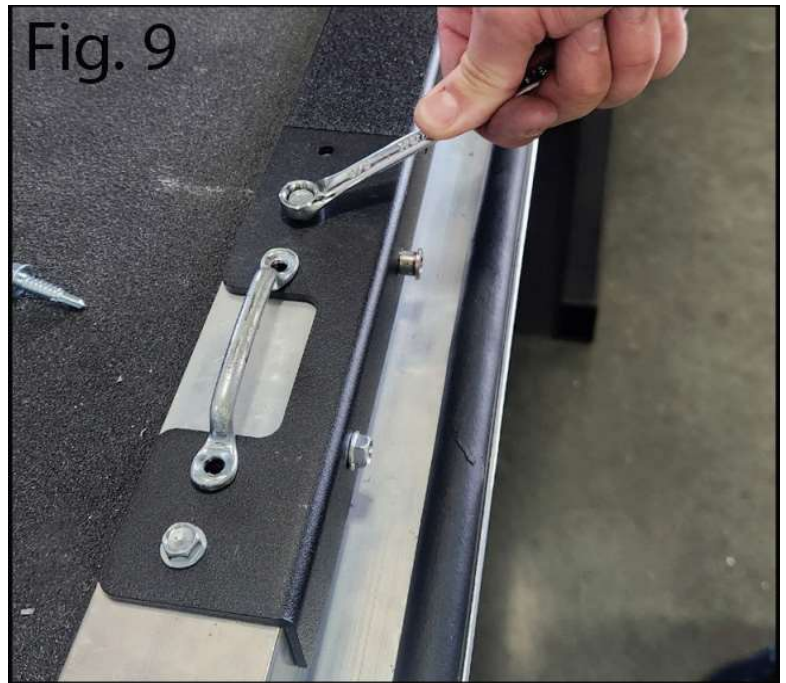
Use the replacement kit KRV # 768048 to attach the new mounting bracket. To install the new bracket, start by installing 12 mounting screws into the 12 original holes. The above-mentioned holes will line up with the holes from the bracket that was removed. See Figure 9.

Note: To avoid over-torquing these screws, it is necessary that final tightening be by hand with a 3/8" wrench.
