June 6, 2025

Version 1

Safety Recall: 2025 CR-V AWD Sport Touring Hybrid Replace Fuel Feed Hose

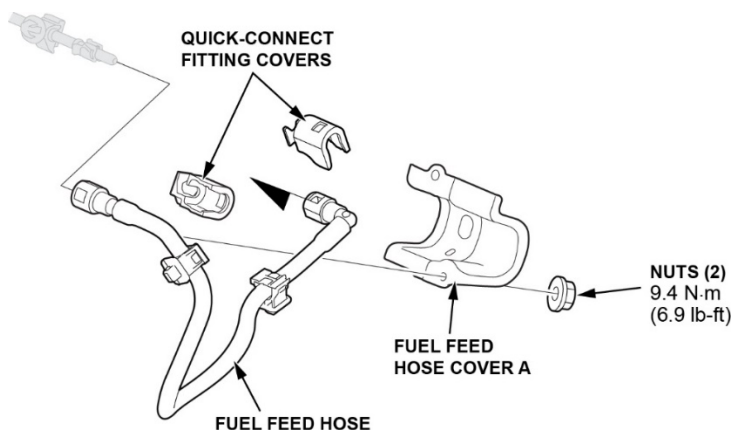
1. [Relieve Fuel Pressure.](#)
2. [Disconnect the negative 12 Volt Battery Terminal.](#)
3. Remove the Fuel Feed Hose Cover A.

NOTE: Make sure to remove the lower nut first, followed by the upper nut.

4. Remove quick-connect fitting covers.
5. Disconnect fuel feed pipe retaining clips.
6. Disconnect the quick-connect fittings on each end. Then, remove the fuel feed hose.
7. Install the new fuel feed hose with new quick-connect fitting covers.

NOTE: During install make sure you install the new ones.

8. Install all removed parts in reverse order of removal.
9. Check for fuel leaks. [FUEL LINE INSPECTION](#)
10. Install fuel feed hose cover A.
11. Do the ALL DTC Check and Clear.
12. Complete the [STEERING ANGLE NEUTRAL POSITION LEARNING](#).
