June 19, 2025

Version 3

Safety Recall: 2023–25 MDX, 2021–25 TLX Brake Pedal Pivot Pin Inspection

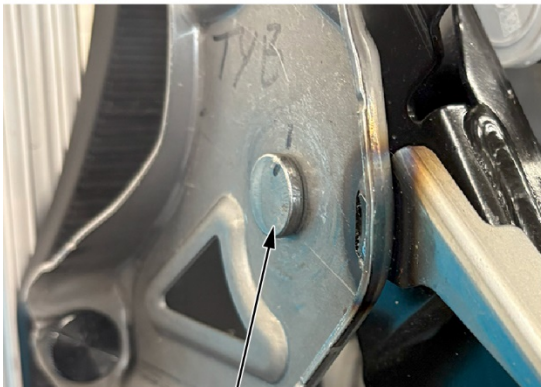
GOOD ✅

PIVOT PIN
Pin is flush. No
repair is needed.

- If the pivot pin remained flush against the brake pedal bracket, no repair is needed.
- If the pivot pin pulled away from the brake pedal bracket and is no longer flush, the brake pedal assembly must be replaced. Proceed to **IMAGE INSTRUCTIONS**.
