## Safety Recall: 2023–25 MDX, 2021–25 TLX Brake Pedal Pivot Pin Inspection

The brake pedal pivot pin may not have been properly staked during assembly. Over time, the pivot pin can potentially back out of the brake pedal bracket causing side to side movement in the brake pedal. A loose brake pedal could lead to diminished or loss of braking function and/or the brake light to remain illuminated, potentially increasing the risk of a crash or injury.

Perform an inspection of the brake pedal pin using the brake pedal pivot pin inspection tool. If the inspection fails, replace the brake pedal assembly.

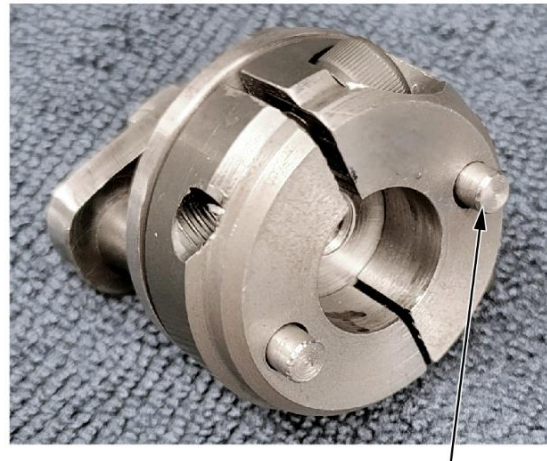
**NO GOOD** ✗

LOADING PINS  
Protruding, no good.

1. Prepare the brake pedal pivot pin inspection tool by backing out the center bolt so its loading pins are slightly recessed below the mating surface of the tool.

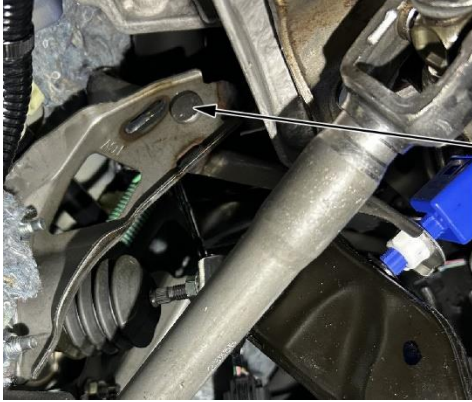
BRAKE PEDAL  
PIVOT PIN

2. Locate the brake pedal pivot pin on the left side of the brake pedal assembly.

NOTICE: Do not attach magnetic lights, tools, etc. to the brake pedal bracket or the brake pedal stroke sensor could be damaged.

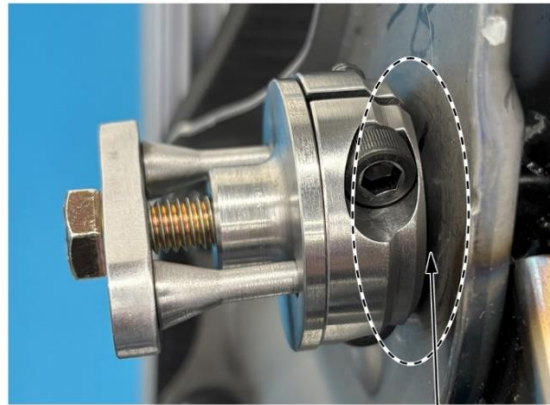
NO GOOD ✗

INSPECTION TOOL  
Not flush.

If the tool **DOES NOT** sit flush against the brake pedal bracket after multiple attempts, contact your DPSM for further instructions.

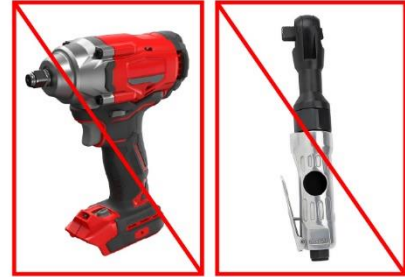
**BRAKE PEDAL PIN**  
Small gap created from pushing the bracket inwards.

- Do not use any power tools or over-torque the center bolt. Doing so will damage the brake pedal pin, bracket, and/or tool.
- Hold the inspection tool by hand. Do not use a screwdriver, pry bar, etc. to hold the tool or it could be damaged.

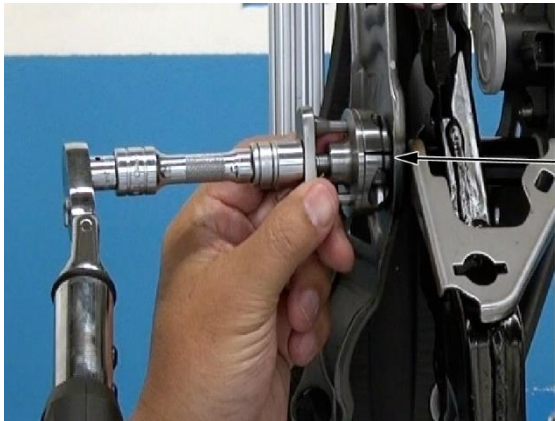
Hold tool flush to bracket.

**NOTE:** If the inspection tool slips off, begin this procedure again at step

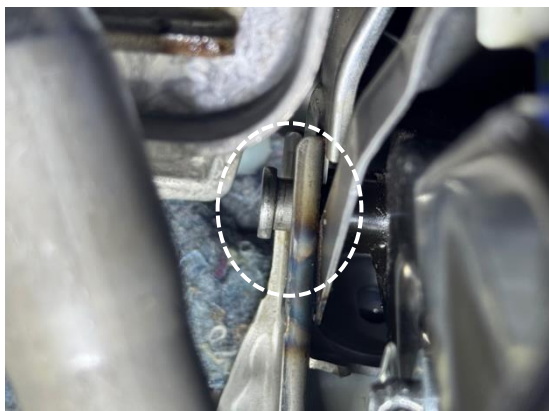
1. Take a photo showing the pivot pin pulled away from the brake pedal bracket. See example below of the angle the photo may need to be taken when in the vehicle
