June 19, 2025

Version 3

Safety Recall: 2023-25 Pilot Brake Pedal Pivot Pin Inspection

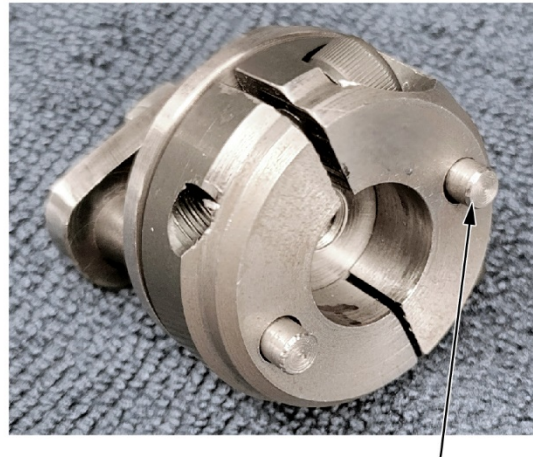
NO GOOD ✗

LOADING PINS
Protruding, no good.

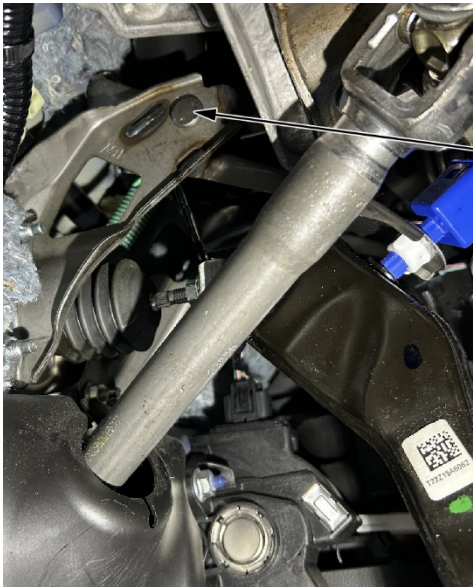
2. Locate the brake pedal pivot pin on the left side of the brake pedal assembly.

BRAKE PEDAL
PIVOT PIN

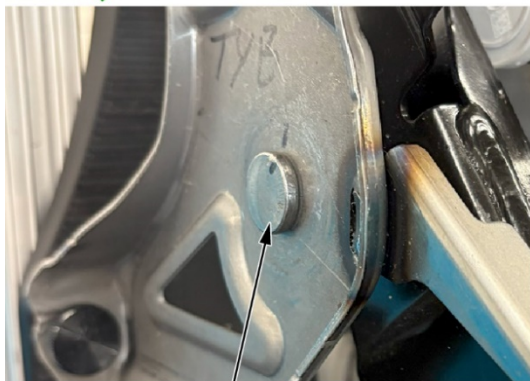
GOOD ✅

If the torque spec was achieved, pull outward a few times on the inspection tool by hand then remove the tool and inspect the pivot pin.

PIVOT PIN
Pin is flush. No
repair is needed.

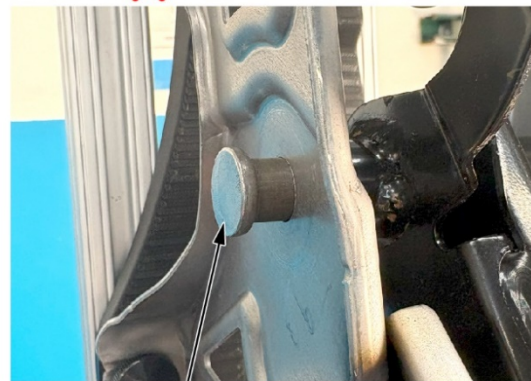
NO GOOD ❌

- If the pivot pin remained flush against the brake pedal bracket, no repair is needed.
- If the pivot pin pulled away from the brake pedal bracket and is no longer flush, the brake pedal assembly must be replaced. Proceed to **IMAGE INSTRUCTIONS**.

PIVOT PIN
Pin is pulled away, not
flush. Repair is needed.

Replace the brake pedal assembly per the service manual.

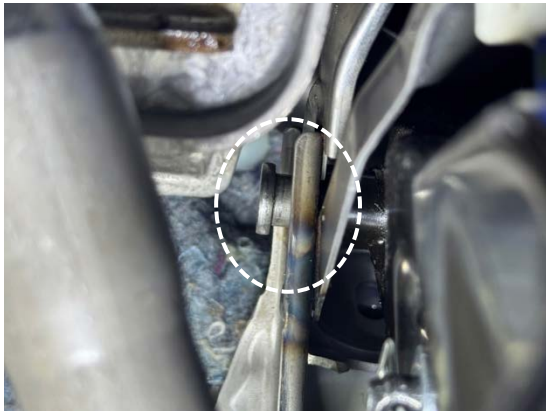
1. Take a photo showing the pivot pin pulled away from the brake pedal bracket. See example below of the angle the photo may need to be taken when in the vehicle
