Safety Recall: 2023-25 Pilot Brake Pedal Pivot Pin Inspection

APPLIES TO

Year	Model	Trim Level	VIN Range
2023–25	Pilot	ALL	Check the iN VIN status for eligibility.

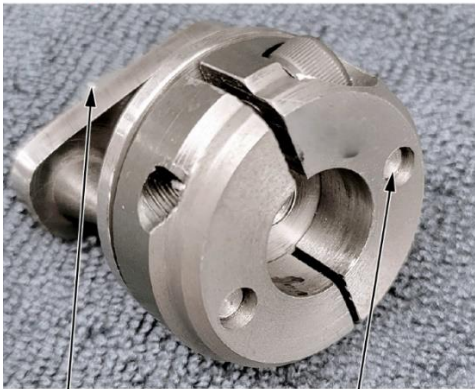
GOOD ✓

1. Prepare the brake pedal pivot pin inspection tool by backing out the center bolt so its loading pins are slightly recessed below the mating surface of the tool.

CENTER BOLT

LOADING PINS
Recessed, good.

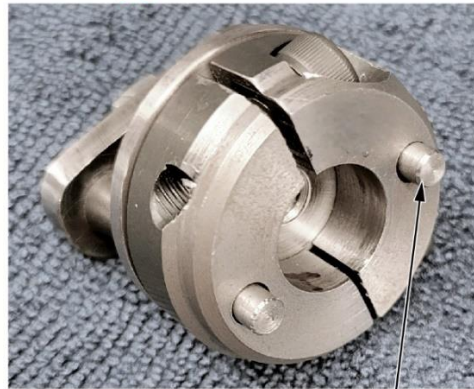
NO GOOD ✗

LOADING PINS
Protruding, no good.

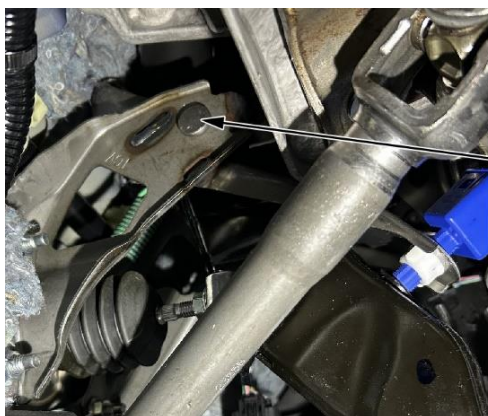
2. Locate the brake pedal pivot pin on the left side of the brake pedal assembly.

BRAKE PEDAL
PIVOT PIN

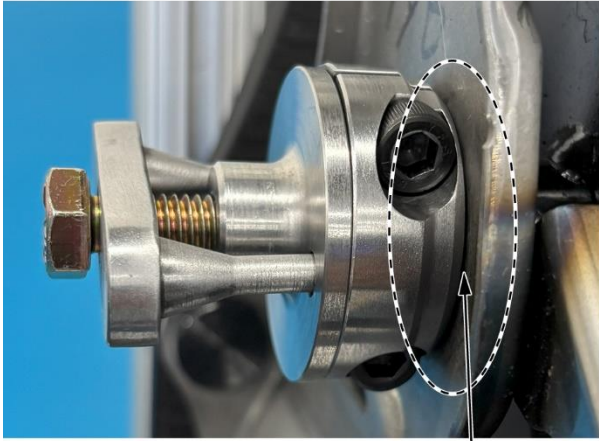
GOOD ✓

3. Place the inspection tool over the head of the pivot pin, making sure it's flush against the brake pedal bracket.

INSPECTION TOOL
Flush.

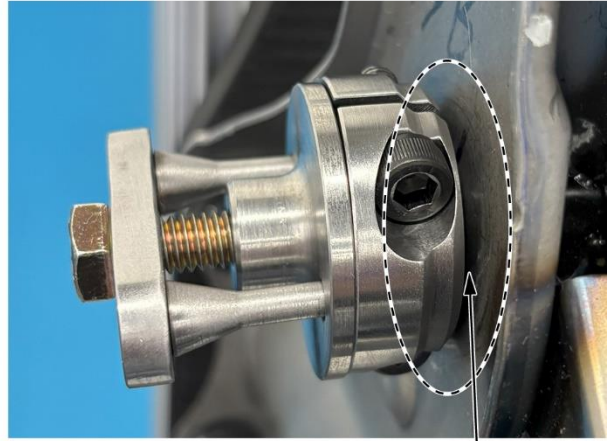
NO GOOD ✗

If the tool **DOES NOT** sit flush against the brake pedal bracket after multiple attempts, contact your DPSM for further instructions.

INSPECTION TOOL
Not flush.

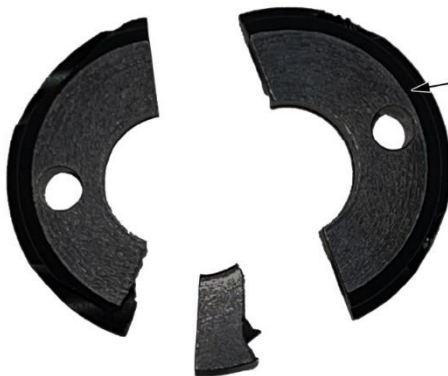
NOTICE: Do not use any power tools or over-torque the Allen head bolts. Doing so will damage the brake pedal pin and/or tool.

INSPECTION TOOL
Broken due to
power tool use.

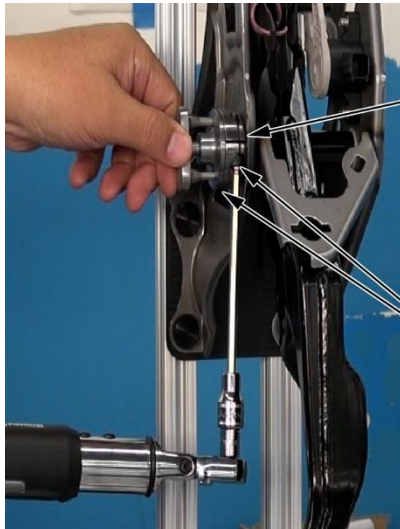
4. Rotate the inspection tool so the two Allen head bolts are positioned downward, then use a ¼ in drive torque wrench to torque the Allen head bolts to **2 lb·ft.**

NOTE: Be sure the inspection tool stays flush against the brake pedal bracket when torquing.

Hold tool flush
to bracket.

ALLEN-HEAD BOLTS

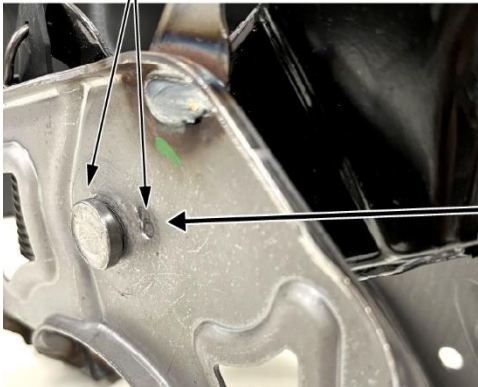
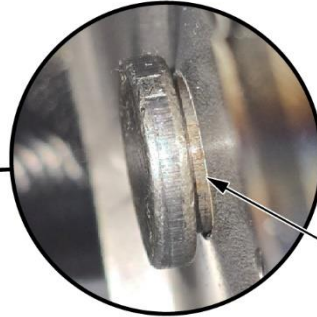
BRACKET

- Do not use any power tools or over-torque the center bolt. Doing so will damage the brake pedal pin, bracket, and/or tool.
- Hold the inspection tool by hand. Do not use a screwdriver, pry bar, etc. to hold the tool or it could be damaged.

Bracket gets pushed in and damaged after using power tools or over-torquing.

BRAKE PEDAL PIN
Small gap created from pushing the bracket inwards.

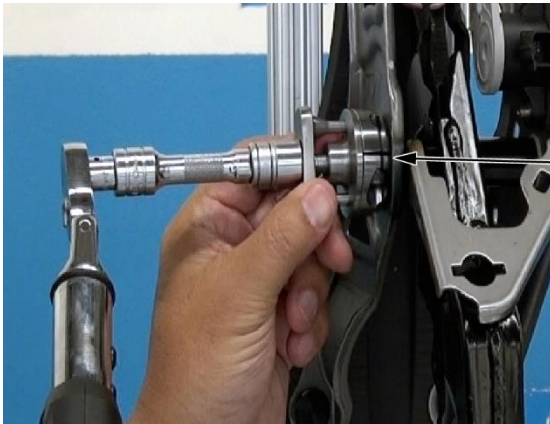
NOTE: If the inspection tool slips off, begin this procedure again at step 1.

Hold tool flush to bracket.

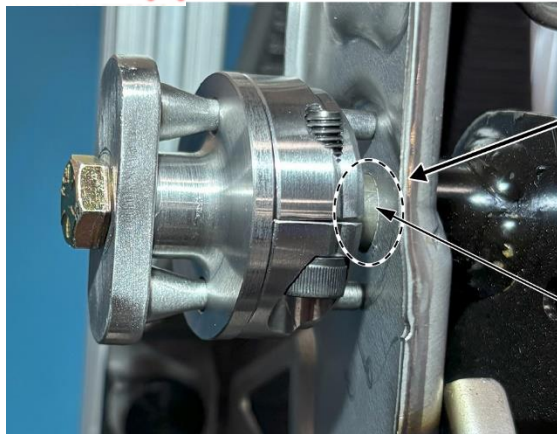
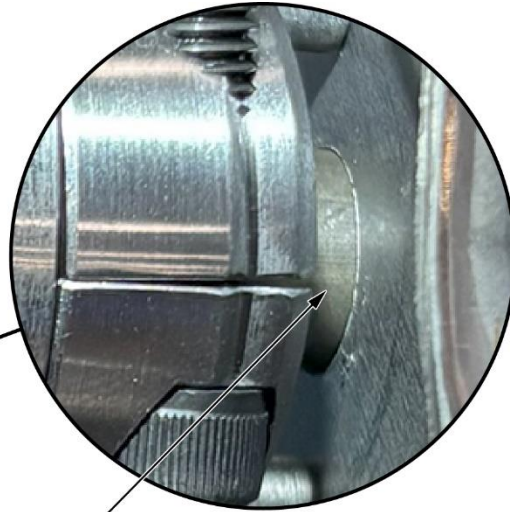
NO GOOD ❌

- If the torque spec of **2 lb·ft** was not achieved and the center bolt bottomed out, causing the inspection tool to pull away from the brake pedal bracket with the pivot pin attached, the brake pedal assembly must be replaced.

Tool pulled away.
Repair needed.

1. Replace the brake pedal assembly per the service manual.

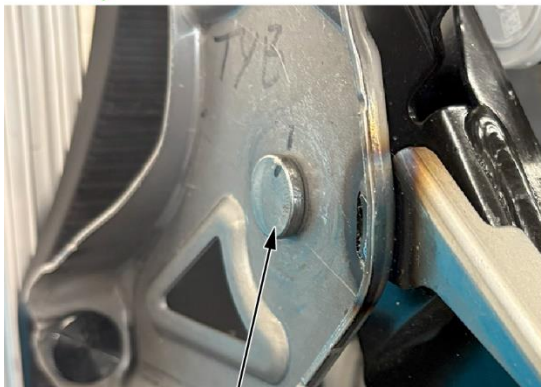
GOOD ✅

- If the pivot pin remained flush against the brake pedal bracket, no repair is needed.
- If the pivot pin pulled away from the brake pedal bracket and is no longer flush, the brake pedal assembly must be replaced.

PIVOT PIN
Pin is flush. No
repair is needed.

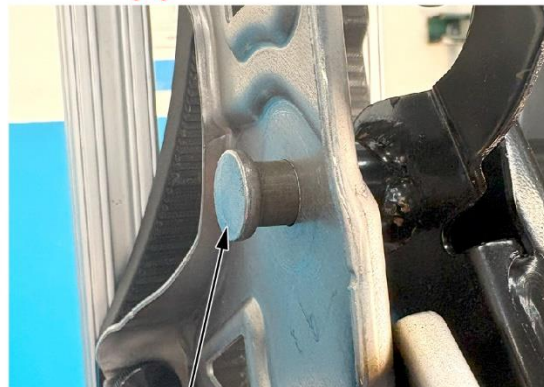
NO GOOD ❌

PIVOT PIN
Pin is pulled away, not
flush. Repair is needed.
