CR310 – Check for Correct Positioning of ABS Fuses and Corresponding Fuse Holders

Panigale V2 MY 2025 (all versions)

Streetfighter V2 MY 2025 - 2026 (all versions)

Safety Recall Campaign SRV-RCL-25-004

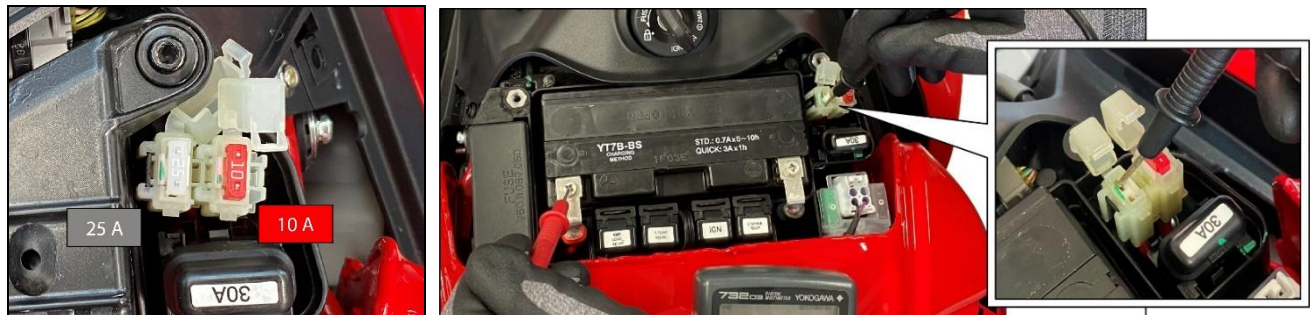
The checklist is divided into the following main operations:

1. Checking the position of the 2 ABS fuses.
2. Checking the position of the ABS fuse holders (with Multimeter set to continuity \blacktriangleleft or diode test $\rightarrow+$).
3. Check for errors using the DDS 3.0 diagnosis instrument.
4. Check the position of the ABS fuse holders using the DDS 3.0 diagnosis instrument.
5. Final operations.

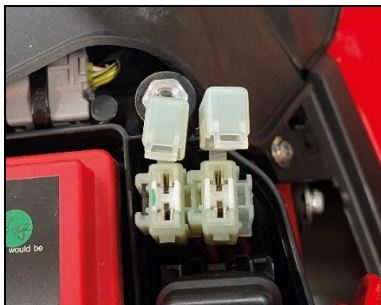
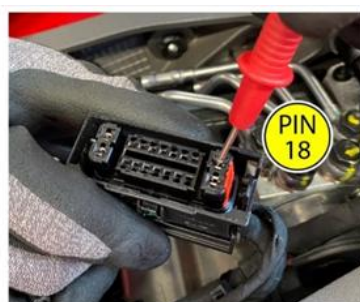
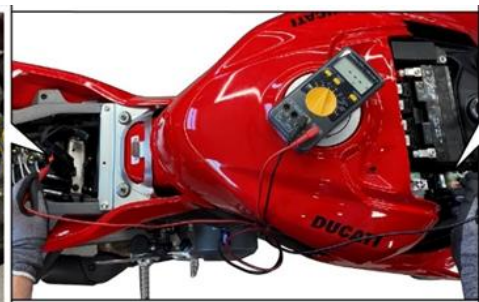
Perform the following TESTS to check whether the **fuse holder** for the **25A fuse** is connected to **PIN 18** of the ABS connector (with **Key-Off** condition):

- Disconnect the ABS connector from the ABS control unit.
- Remove the **25A (white – left)** and **10A (red - right)** ABS fuses from their fuse holder.
- Insert the positive probe into **pin 18** of the **ABS connector** and perform **TEST 1** and **TEST 2**:

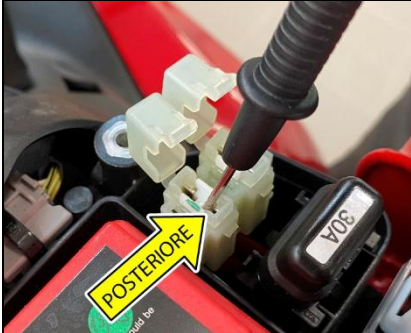
<p>TEST 1 - Insert the negative probe into the pin of the rear fuse holder (closest to the fuel tank) → Is there continuity?</p>

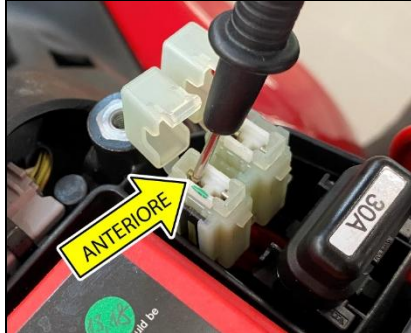
<p> <input type="checkbox"/> YES (with sound – “beep”) <input type="checkbox"/> NO (no sound) </p>	<p>TEST 2 - Insert the negative probe into the pin of the front fuse holder (closest to the instrument panel) → Is there continuity?</p>

TEST 1	TEST 2	Action
YES	NO	Fuse holder position compliant → Proceed with Step 3 . → Submit Repair TYPE 1 .
NO	YES	Fuse holder position compliant → Proceed with Step 3 . → Submit Repair TYPE 1 .
NO	NO	Fuse holder position NOT compliant → Fuse holders are reversed → Reposition the fuse holders and proceed with Step 3 . → Submit Repair TYPE 2 .
