# Keystone RV Company

## SAFETY ADVISORY # 25-477

### 3000 Series Patio Rail

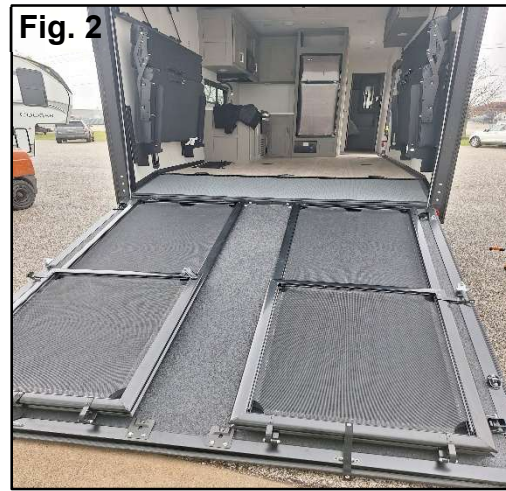
Place the ramp door in the ramp position by removing the retainer pins from the door cable brackets on both sides of the ramp door. Gently lower the ramp door to the ground. After removal, place the retainer pins back in the door cable bracket so the retainer pins do not get lost. **See Fig.1 – Fig. 2**

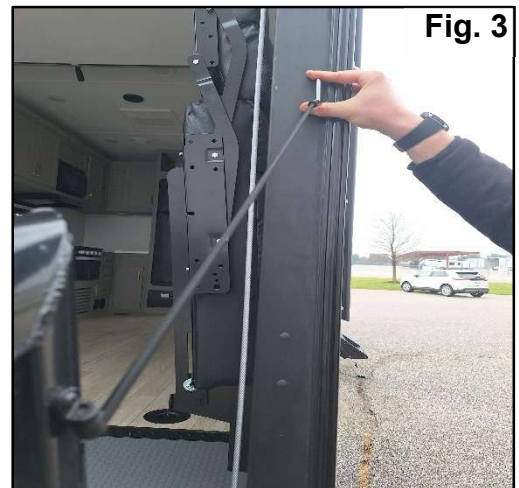
Unsnap all nylon straps from the brackets holding the patio railings to the ramp door. Raise a side patio panel assembly up into the 90-degree position from the ramp door. Unhook the bungee strap located on the outside rear of the patio railing closest to the door jamb. Place the hook of the bungee onto the footman loop (KRV # 643808 – Garage – Footman Loop – Specialty – 1.63 x 44). Place the footman loop with bungee attached onto the front of the door jamb, where tension can be felt in the bungee. Mark the location of the footman loop bracket holes with a non-permanent method. **See Fig. 3**

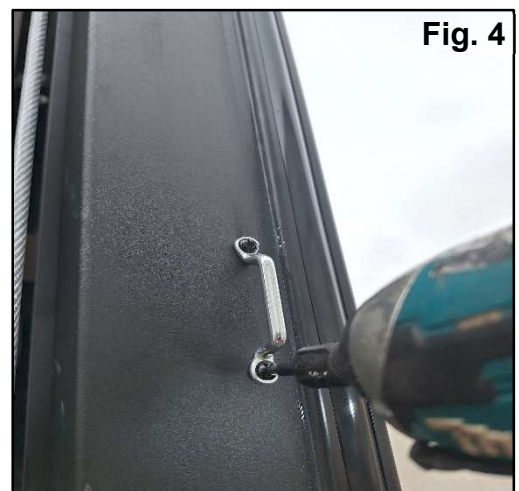
Install the footman loop (KRV # 643808) at the marked location on the front of the door jamb using two #8 x 1" pan head self-drilling screws. **See Fig. 4**

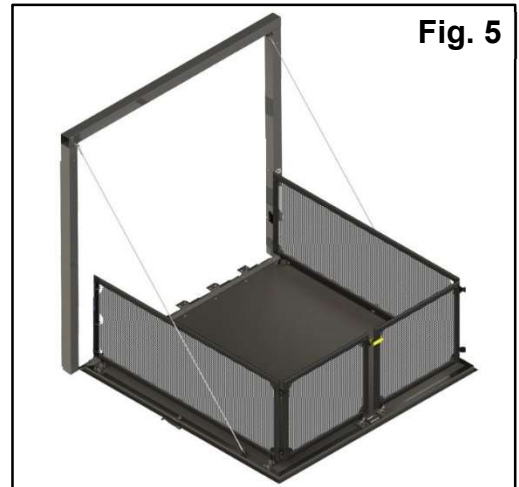
Raise both side patio panel assemblies up into the 90-degree position from the ramp door, swing the front patio panels inward towards the center of the ramp door. Slide the front patio panel legs into the keeper assembly and latch into place.

**See Fig. 5**

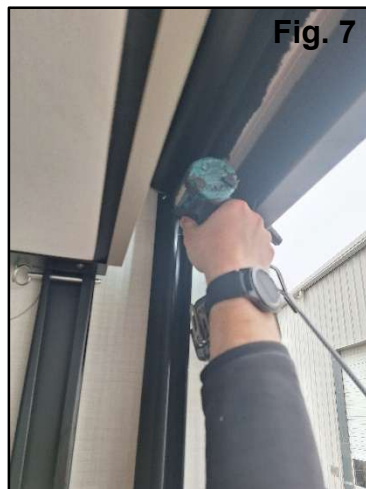
From the trailer interior, identify the pull-down screen track railing located next to the garage door jamb. The pull-down screen track railing will need to be moved to gain additional clearance for the angle bracket installation in the next step. Remove the screws securing the track railing to the wall and carefully slide the pull-down screen header and the track railing towards the front of the trailer. Be sure not to pull the track railing away from the wall once screws are removed as the pull-down screen header rests on top of the track railing. **See Fig. 6 – Fig. 8**

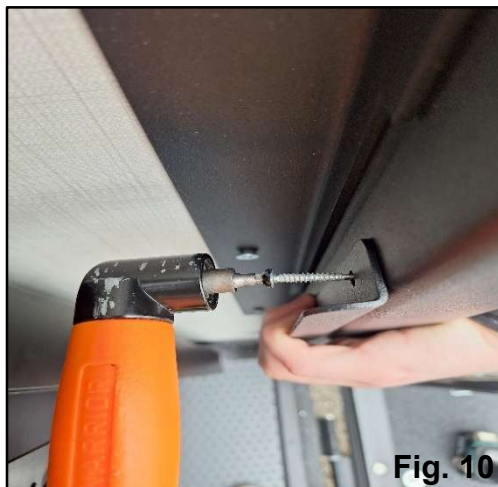
Use a quick grip clamp to position the angle bracket (KRV # 783233 - Garage - Ramp Door - Bracket Only - 3/4" x 1" x 3/4"-- L33.00 – Angle – PC Black – For Service Advisory 25-477) flush on the inside of the door jamb with the screw holes facing the inside of the jamb. Align the top of the angle bracket to match the height of the patio railing. Use a screw gun with a right-angle attachment, a short bit, and #8 x 1" pan head self-drilling screws to secure the angle bracket to the door jamb. **See Fig. 9 – Fig. 10**

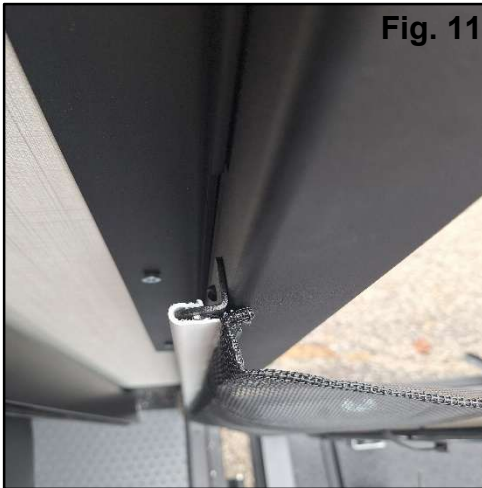
The gap panel can now be added in between the rear of the patio railing and the door jamb. Slide the rubber bulb side of the gap panel onto the extrusion edge of the angle bracket. Attach the three buckles on the other side of the gap panel around the rear side patio panel vertical post, through the holes in the screen and snap the buckles together. **See Fig. 11 – Fig. 12**
