Service Bulletin

CBR650R/RA #1
Revised: February 2026

SAFETY RECALL

2024 - 2025 CBR650R/RA WIRE HARNESS SHORT CIRCUIT

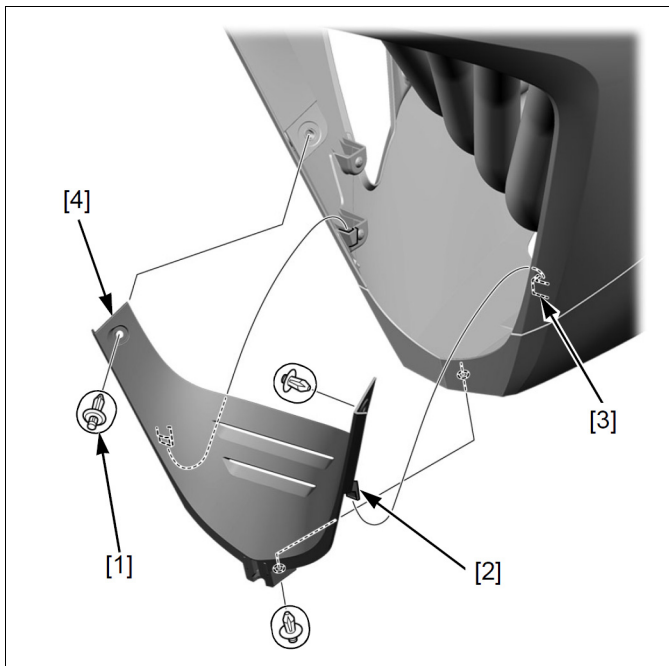
Remove the lower inner cowl:

1. Remove the trim clips [1].
2. Remove the projections [2] from slots [3], remove the
3. lower inner cowl [4].

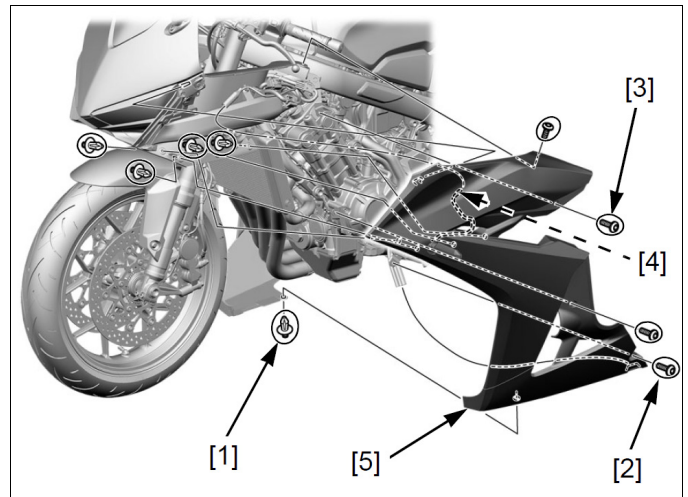
Remove the left middle cowl.

- Trim clips [1]
- Two Pan Screw 5x16mm (Black) [2]
- Two Pan Screw 5x16mm (Silver) [3]

Disconnect the gray front turn signal light 2P connector [4], then remove the middle cowl [5].

0.42 N·m (0.04 kgf·m, 0.3 lbf·ft)

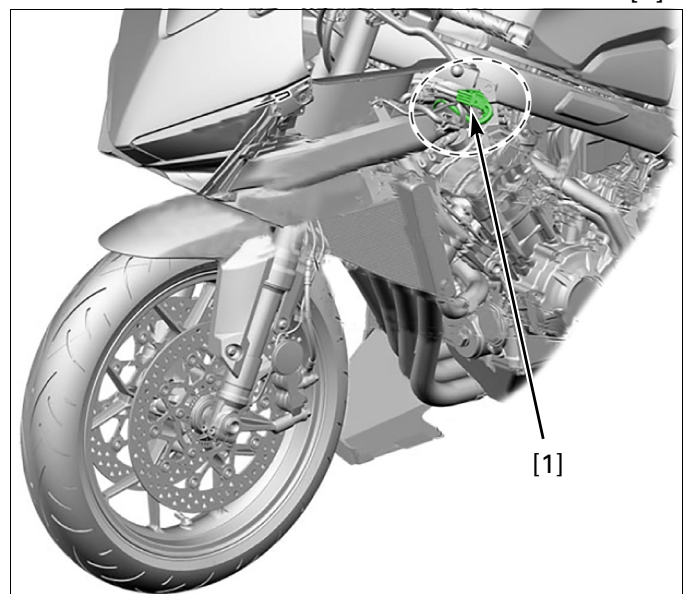
Locate the Left Handlebar Switch Harness [1].

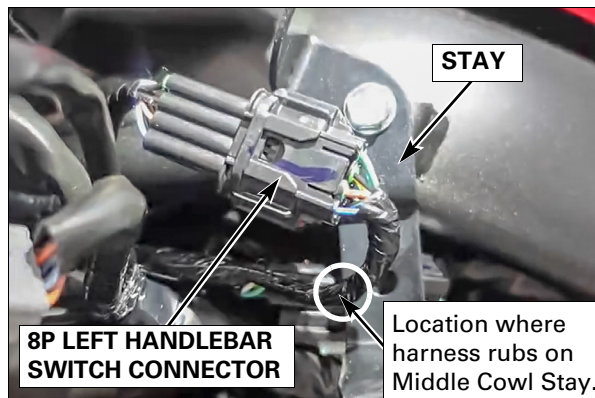
Inspect the Left Handlebar Switch Harness following the steps below to ensure there is ZERO wear or damage on the harness tape or wires near the middle cowl stay.

1. Disconnect the 8P Left Handlebar Switch connector.
2. Inspect the wire harness insulation in the location shown for signs of damage to the wire harness tape or wires.

- If there is no damage whatsoever to the harness, go to **Repair A** on [page 5](#).

If no damage was found on the switch harness tape, reroute the harness following the steps below, and then file a **KT7A** warranty claim using the information shown in WARRANTY CLAIM INFORMATION on [page 2](#).

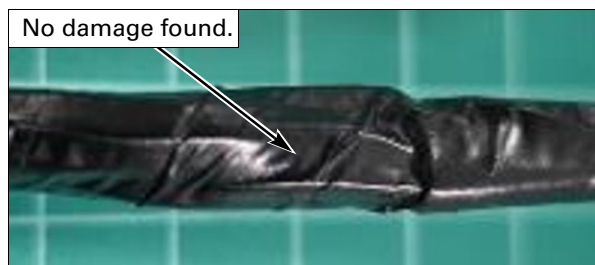
- If there is wear or damage to the harness tape only, and there is no damage to any wire insulation, and no copper wires are visible, go to **Repair B** on [page 6](#).

If there is wear or damage to only the harness tape, and no damage found on the wire insulation or stranded copper wire, apply additional electrical tape to the area shown, and then reroute the harness following the steps below. File a **KT7B** warranty claim using the information shown in WARRANTY CLAIM INFORMATION on [page 2](#).

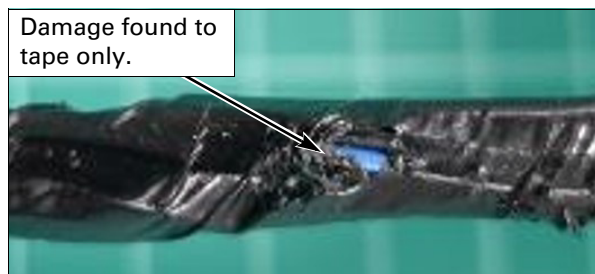
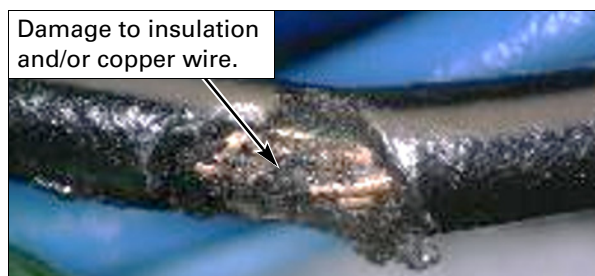
- If there is visible damage to any wiring insulation, or the stranded copper wiring is visible or broken, go to **Repair C** on [page 7](#).

If there was any wear or damage found on the wire insulation or stranded copper wire during the inspection, the main wire harness must be replaced.

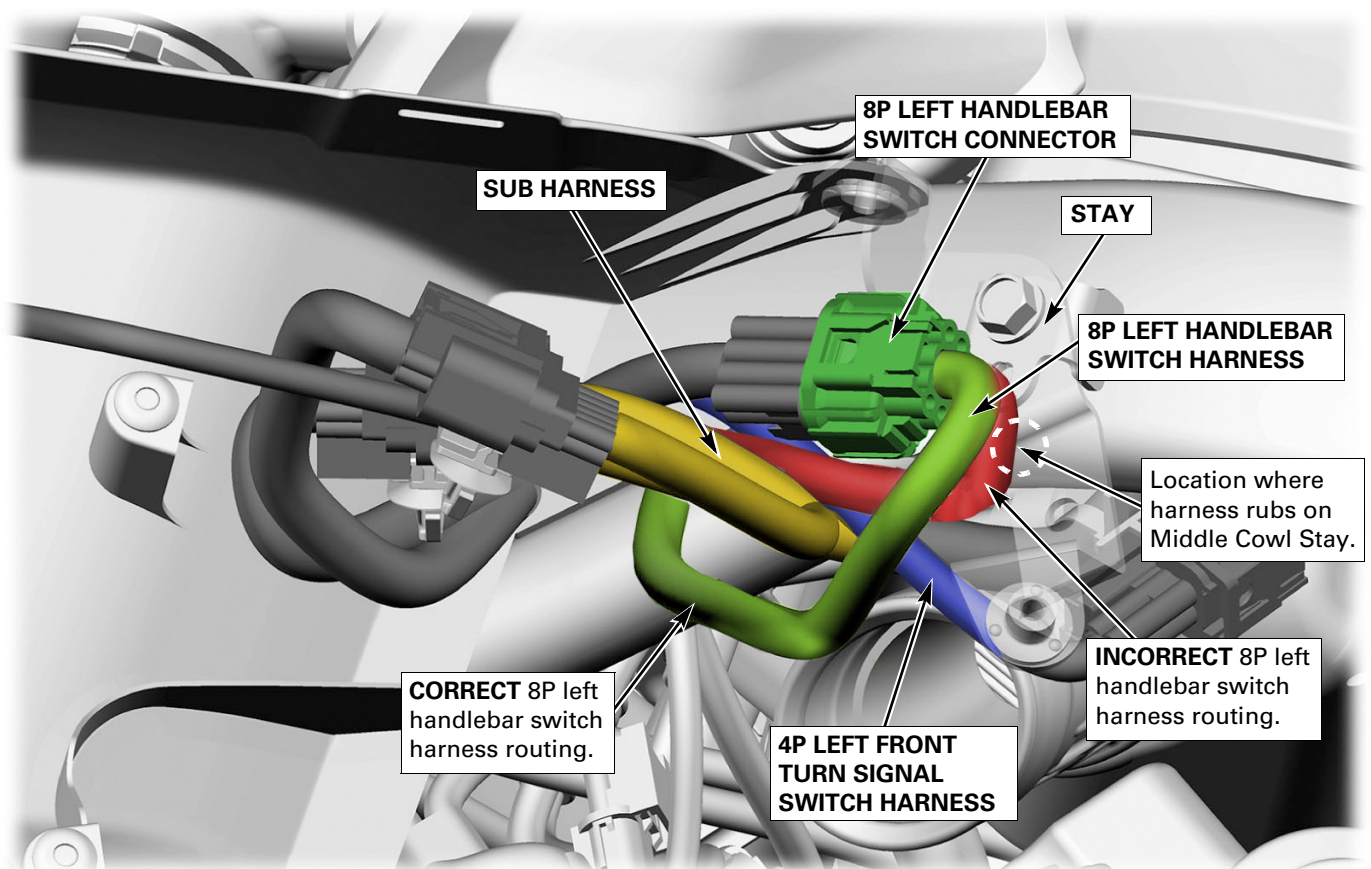
1. Route the 8P Left Handlebar Switch harness and connector (highlighted in green) underneath the front sub harness (highlighted in yellow).
2. Ensure the 8P Left Handlebar Switch harness and connector are routed in front of the 4P Left Front Turn Signal Switch Harness (highlighted in blue).
3. Slightly untwist and re-situate the Front Sub Harness, as demonstrated in the video link below.
4. Reconnect the 8P Left Handlebar Switch Harness connector.
5. Be sure the 8P Left Handlebar Switch harness does not contact the Left Middle Cowl stay.
6. Reassemble the motorcycle in the reverse order of disassembly.

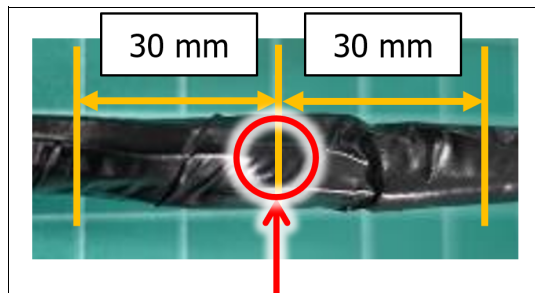
1. Wrap new electrical tape over the existing harness tape:

- The new tape should extend 30 mm (1.2 in.) on both sides past the location where the damaged tape was found.
- Wrap the tape around the harness at least two or three times to ensure a proper protective covering for the wires.

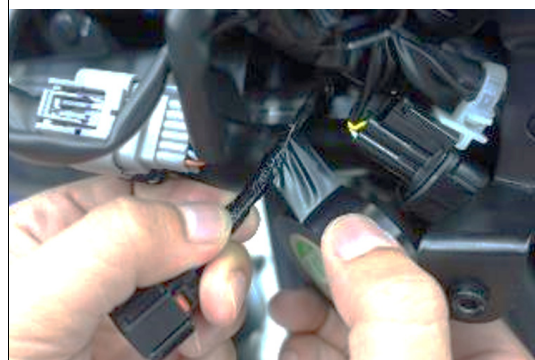
2. Route the Left Handlebar Switch harness and 8P connector (highlighted in green below) underneath the front sub harness (highlighted in yellow).

3. Ensure the Left Handlebar Switch harness and 8P connector are routed in front of the 4P Left Front Turn Signal Switch Harness (highlighted in blue).

4. Slightly untwist and re-situate the Front Sub Harness, as demonstrated in the video link below.

5. Reconnect the 8P Left Handlebar Switch Harness connector.

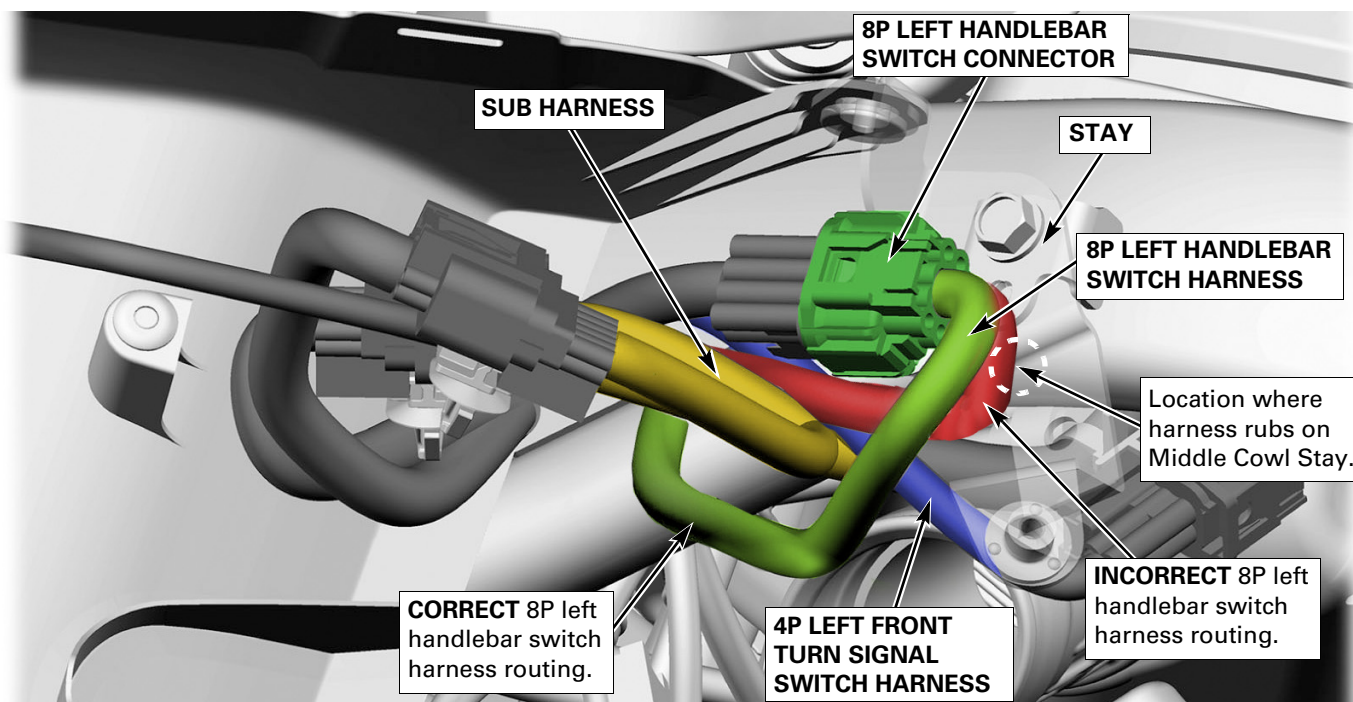
6. Be sure the Left Handlebar Switch harness does not contact the Left Middle Cowl stay.

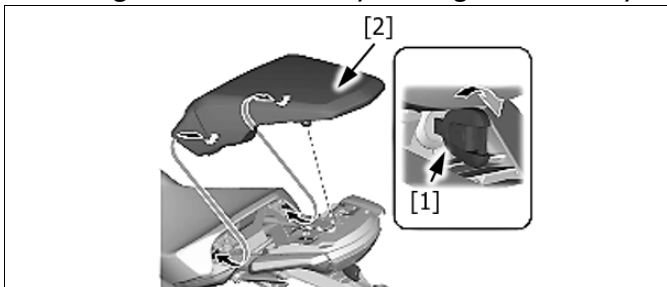
1. Remove as much fuel from the fuel tank as possible and save it in a suitable clean container for reuse.
2. Remove the passenger seat by unhooking the passenger seat lock using the ignition key [1], and then pulling the seat [2] rearward.

Apply grease to the passenger seat catch hook sliding area if necessary during reassembly.

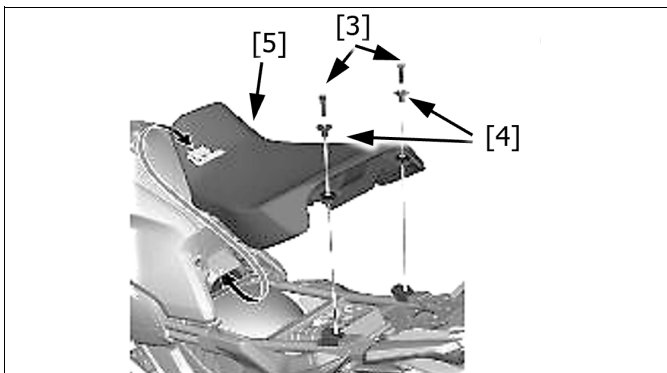
3. Remove the rider seat.
Remove the mounting socket bolts [3] and collars [4].
Remove the rider seat [5] by pulling it rearward.

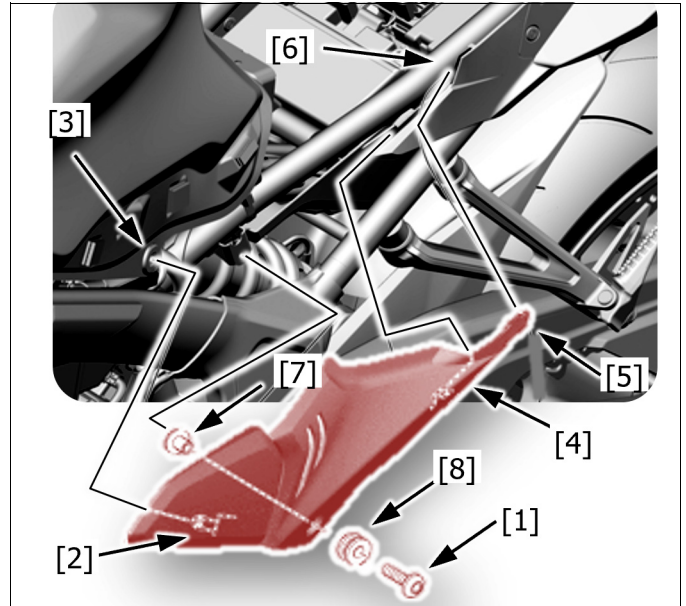
4. Remove the R. and L side cover.
Remove the socket bolts [1].
Release the boss [2] from the grommet [3] of the fuel tank.
Remove the side cover [4] by releasing the tab [5] from the slot [6] of the rear cowl.
Remove the collar [7] and mounting rubber [8].

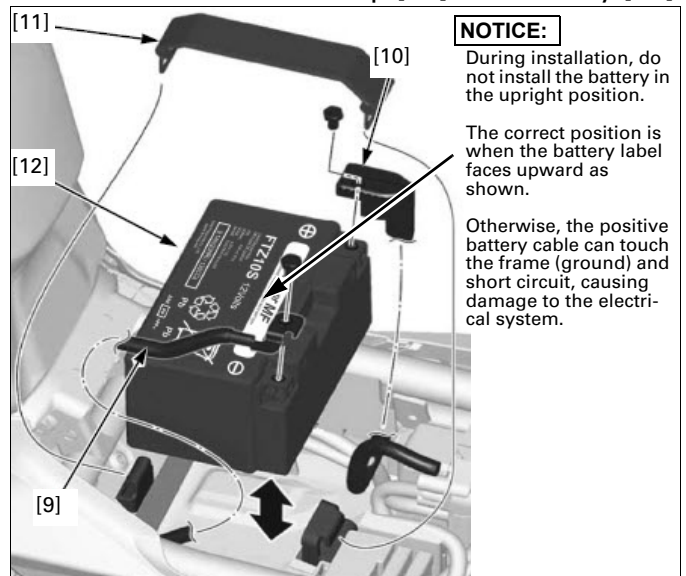
5. Remove the battery.
Turn the ignition switch OFF.
Disconnect the negative (-) cable [9] by removing the terminal bolt.
Disconnect the positive (+) cable [10] by removing the terminal bolt.
Remove the rubber strap [11] and battery [12].

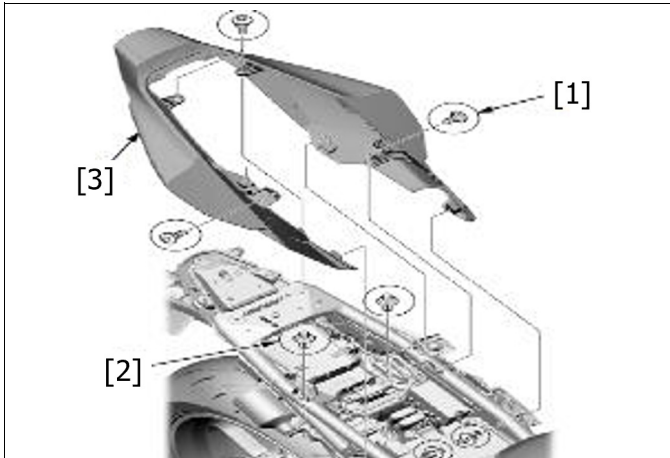
- Remove 4 socket bolts [1]
- Remove 4 trim clips [2]
- Remove Rear cowl Assy. [3]

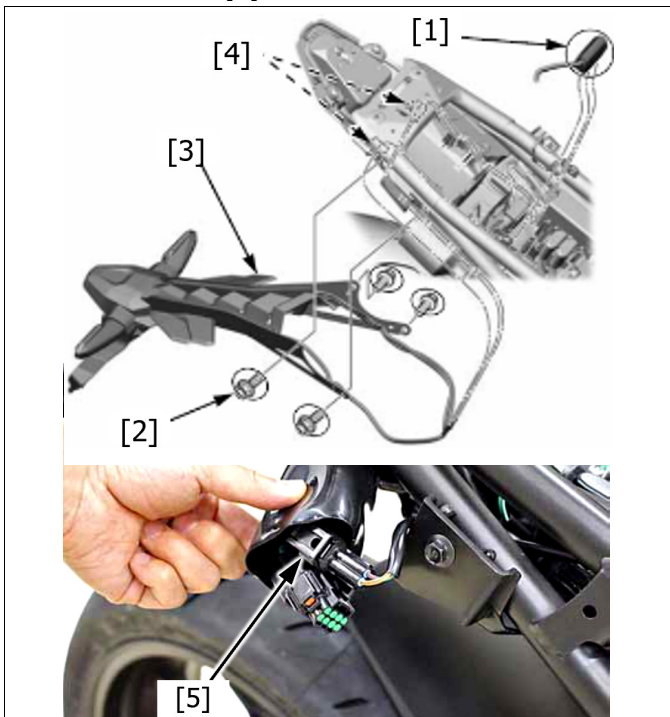
Disconnect the following connectors [1]:

- Rear turn signal light 2P (left: Orange, right: Light blue)
- Brake/taillight 3P
- License light 2P
- Remove the bolts [2] and rear fender stay [3] by pulling the wires out from the holes [4] of the rear fender B.

Bolt Torque: 15 ft-lb (21 N•m)

- Disconnect the starter relay switch 2P (Black connector) [5]

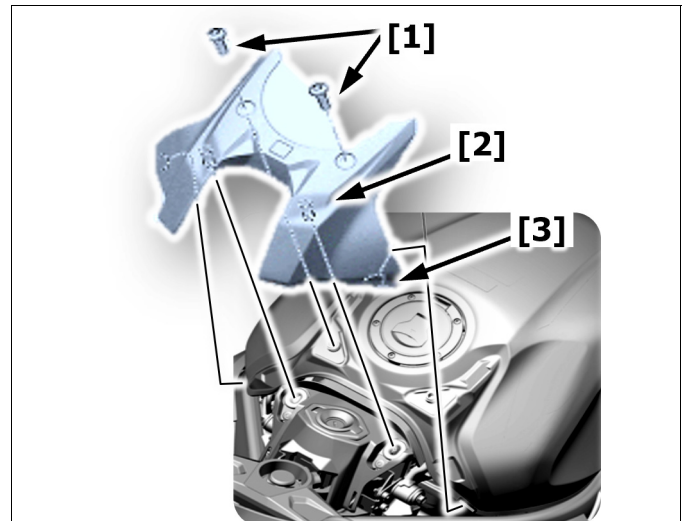
Remove the two socket bolts [1].

Remove the boss [2] and hook [3], remove the tank cover.

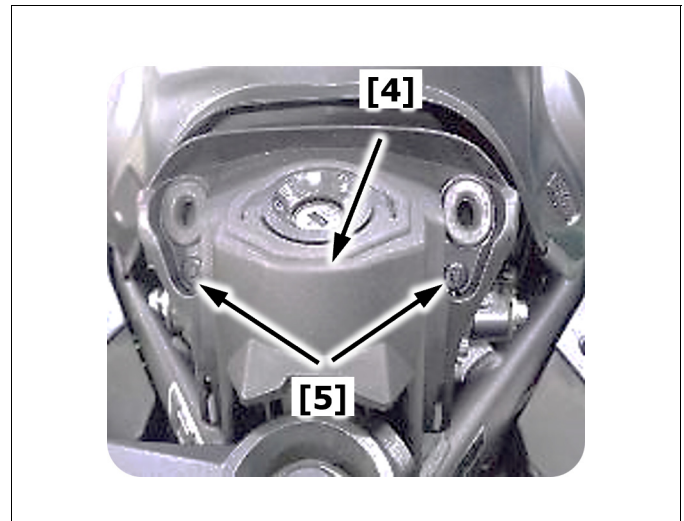
- Remove the clip, BPR seal [4]
- Remove the COVER,COMB SW. [5].

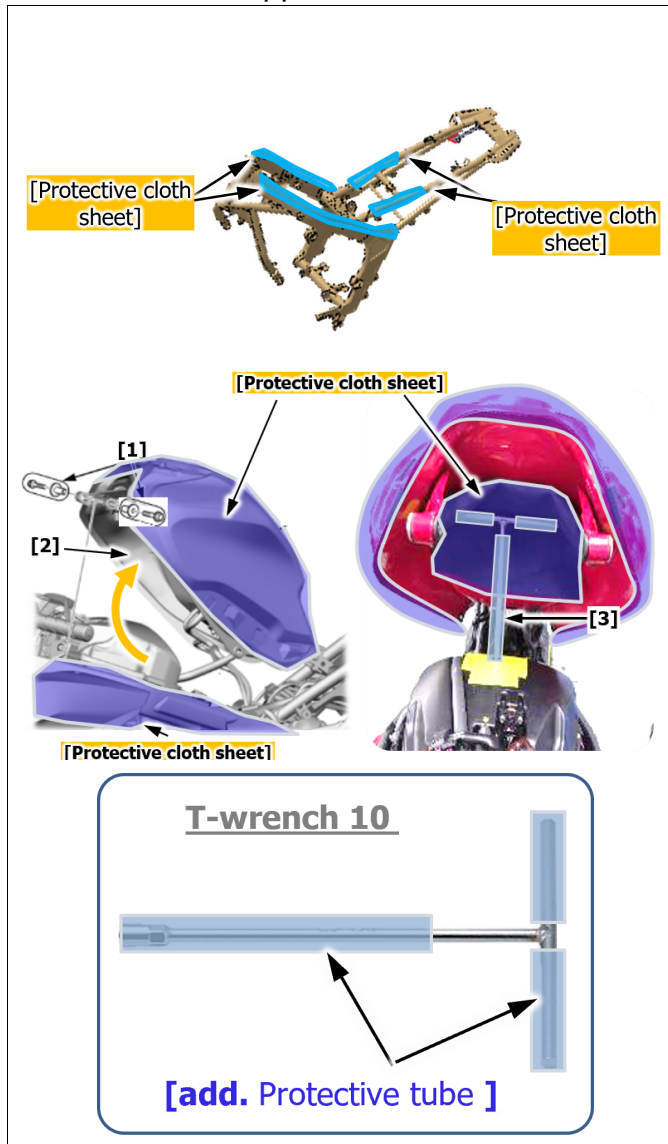
10. Temporarily lift the fuel tank. You must use protective sheet cloth to prevent scratching the tank and surrounding painted areas.

Remove the left and right 6x40 flange bolts [1].

6 x 40 mm Bolt Torque: 7 ft-lb (10 N•m)

Lift the fuel tank [2] using a 10mm T-handle wrench [3] to support it, as shown.

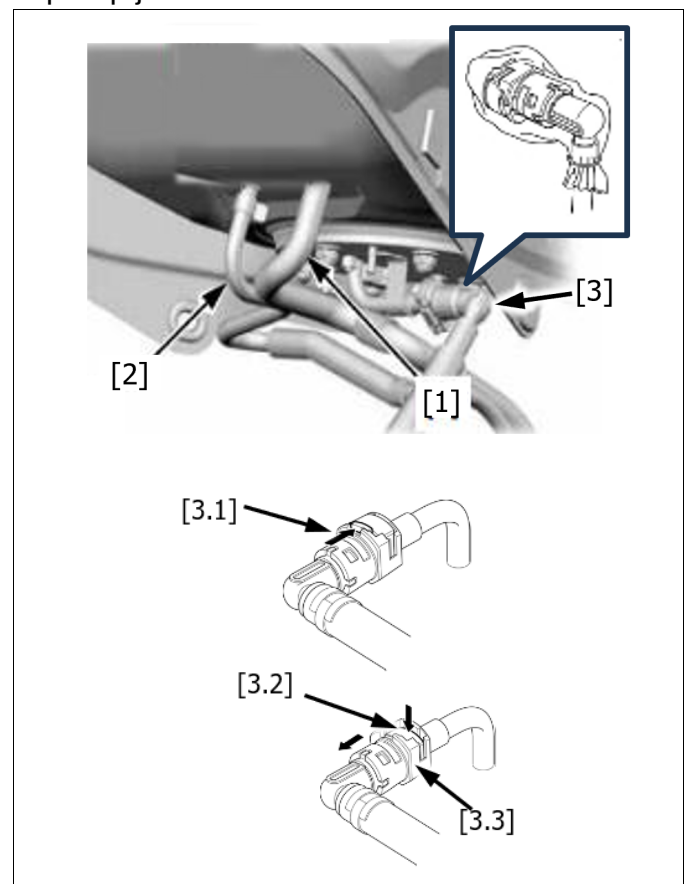
Disconnect Fuel tank drain hose [1].

Disconnect fuel tank-to-EVAP canister hose [2].

Disconnect Fuel feed hose [3].

Push the retainer tab [3.1] forward.

Press down the retainer [3.2] and hold.

Disconnect the connector [3.3] from the fuel pump joint.

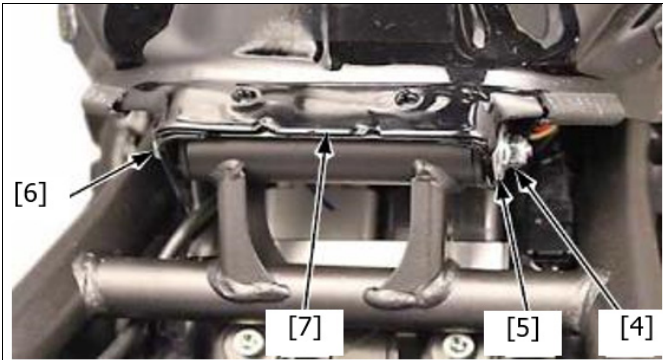
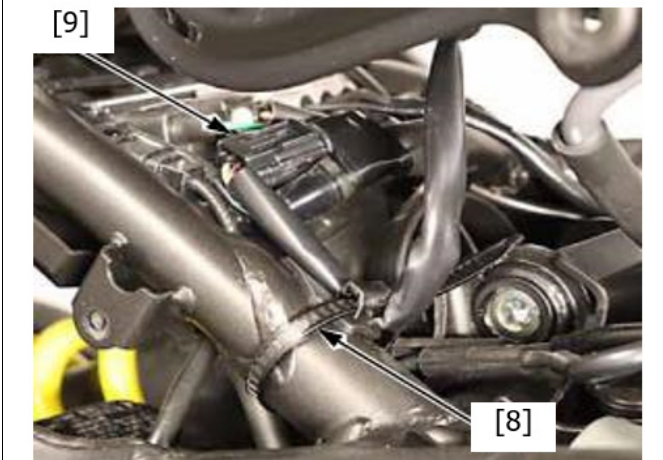
Remove the nut [4], washer [5], bolt [6] and fuel tank [7].

Nut Torque: 9 ft-lb (12 N•m)

Remove the wire band [8].

Disconnect the fuel pump 3P (Black) connector [9] and remove it out of the rear fender B.

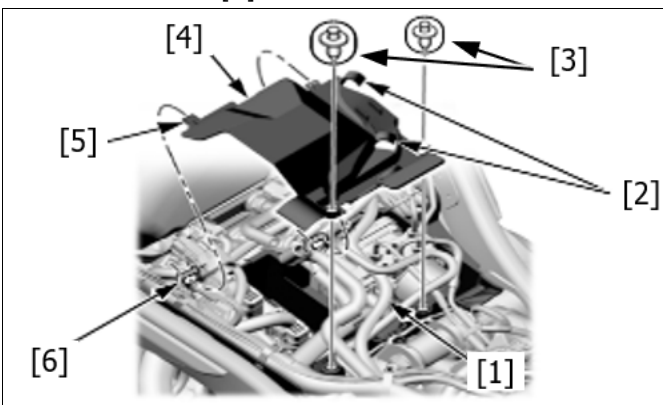
Release the radiator siphon hose [1] from the wire guides [2].

Remove the two clips [3].

Remove the ABS modulator cover [4] by releasing the tab [5] of the ABS modulator tray from the slot [6].

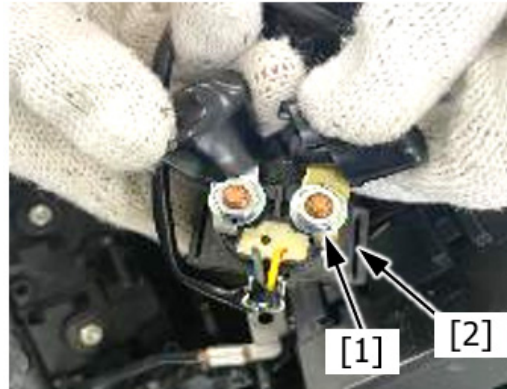
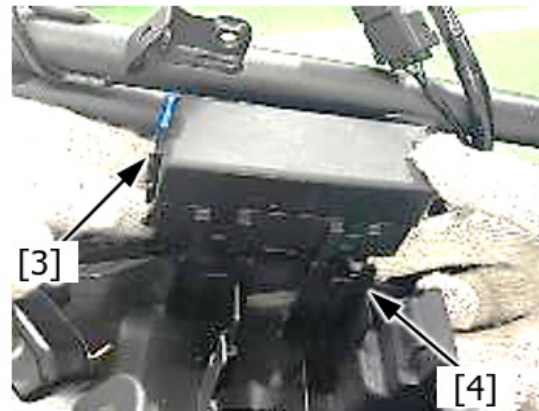
13. Remove the starter relay nuts [1], and then remove the starter relay from rear fender B [2].

Remove fuse box [3] out off rear fender B [4].

Nut Torque: 3.6 ft-lb (4.9 N•m)

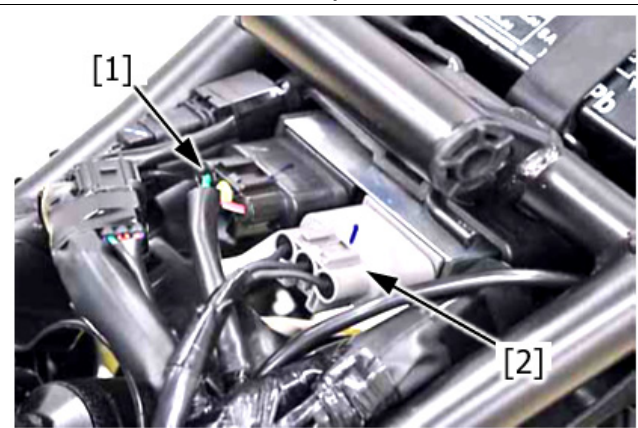
Disconnect the regulator/rectifier 3P (Black) [1] and alternator 3P (Gray) [2] connectors.

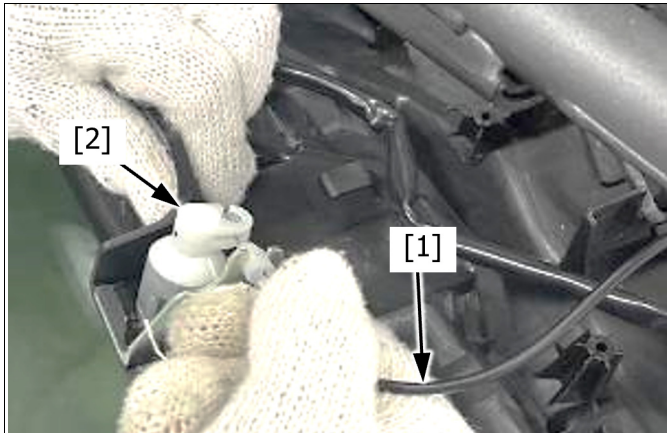
15. Disconnect cable seat lock [1] out of key seat lock [2].

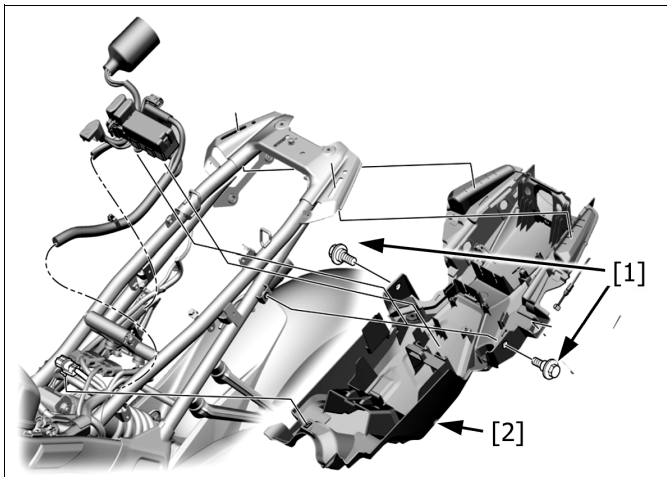
Remove the two bolts [1].

Release the securing tab from the wire harness that attaches to the front of rear fender B from the underside.

Slide rear fender B [2] downward and remove it out of the frame.

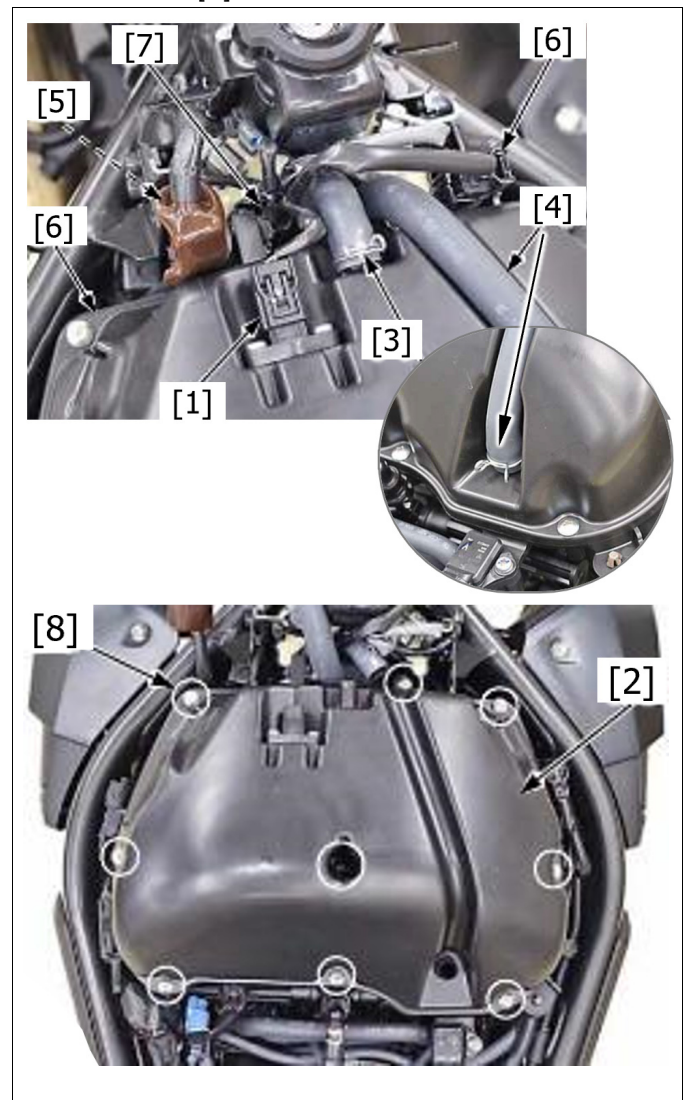
Disconnect the IAT Sensor 2P (Black) connector [1]

Disconnect the following from the air cleaner lid [2];

- Crankcase breather hose [3]
- Air supply hose [4]
- Ignition switch 2P (Brown) connector [5]
- Immobilizer receiver 4P (Black) connector [6]
- Wire clip [7]

Remove the nine tapping screws [8] and air cleaner lid [2].

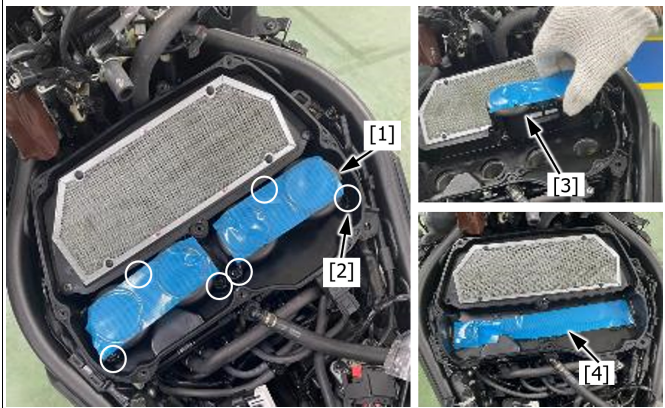
Apply adhesive tape onto the intake duct to prevent foreign objects from falling into [1].

Remove the 6 tapping screws [2].

Remove the intake duct [3].

Apply adhesive tape to the air cleaner case holes to prevent foreign objects from falling into them [4].

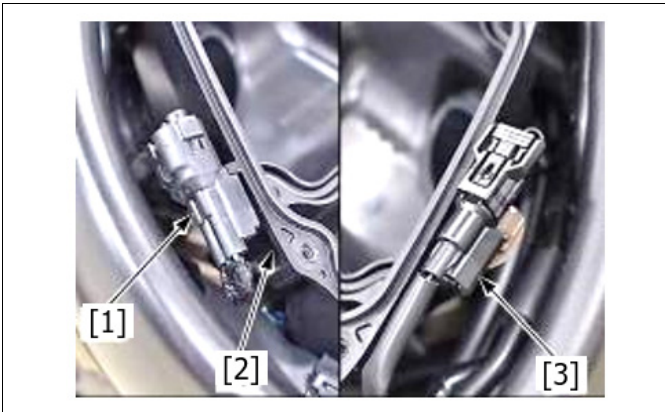
Disconnect optional 2P (Black) connector [1] from the air cleaner housing [2].

Disconnect EOP switch 1P (Black) connector [3] from the air cleaner housing.

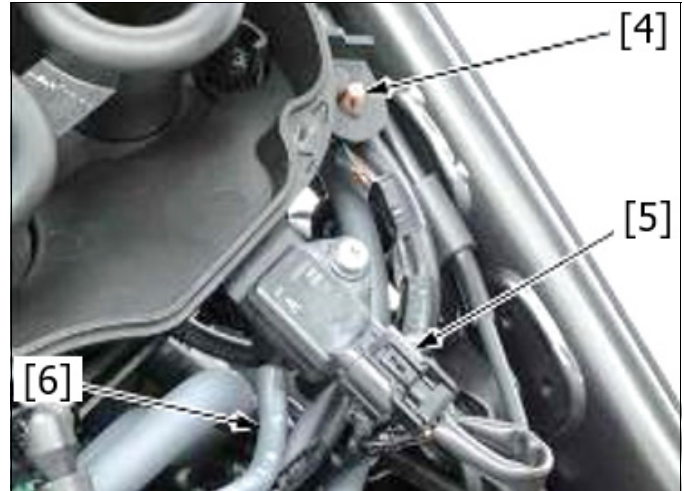
Disconnect wire clip [4].

Disconnect the MAP sensor 3P (Black) connector [5] and vacuum hose [6] from the air cleaner housing.

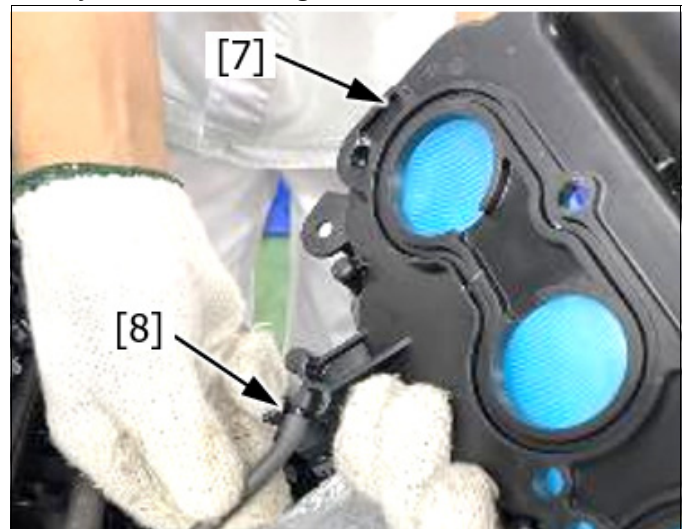
Remove air cleaner case [7].

Remove PB tube [8] and apply adhesive tape to the throttle body openings to prevent foreign objects from falling into them.

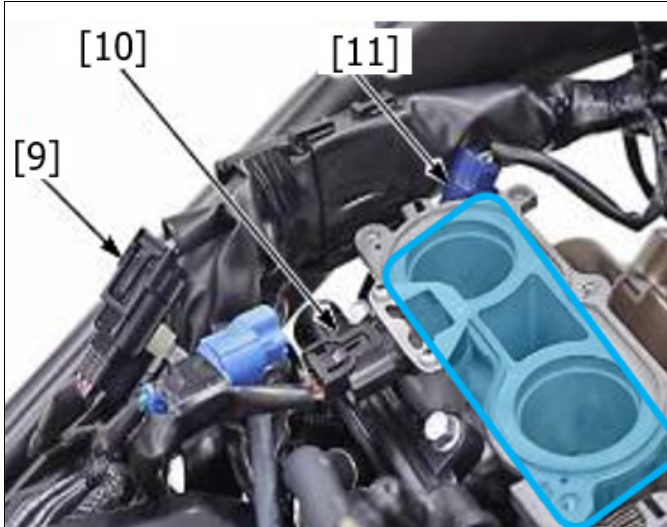
Disconnect Fuel injector sub harness 6P (Black) connector [9].

Disconnect IACV 4P (Black) connector [10].

Disconnect TP sensor 3P (Blue) connector [11].

During installation, replace the throttle body seals on the underside of the airbox with the new parts provided in the wire harness kit.

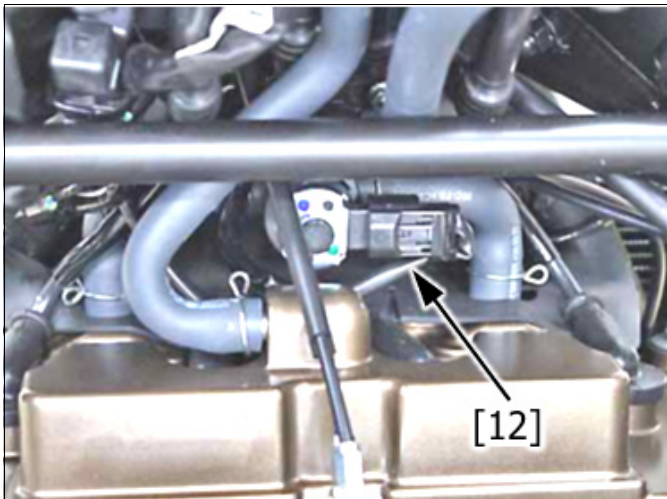
Disconnect the PAIR control solenoid valve 2P (Black) connector [12].

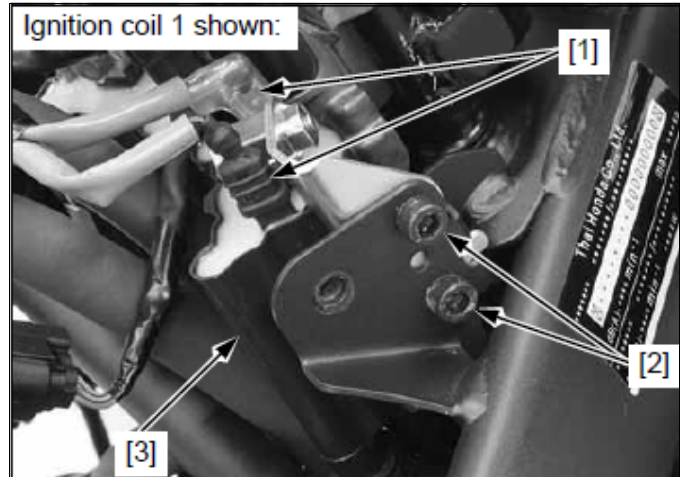
Disconnect the only ignition coil wire connectors [1] by without the need to disconnect the spark plug cap

Remove the 4 socket bolts [2] and release the ignition coil stay assembly [3] from the frame.

Ignition coil 1 (Cyl. No.1, 4):

Pink/blue (+) and Ground (-)

Ignition coil 2 (Cyl No.2, 3) [3]:
Pink/black (+) and Ground (-)
[2] Bolt Torque: 7 ft-lb (10 N•m)

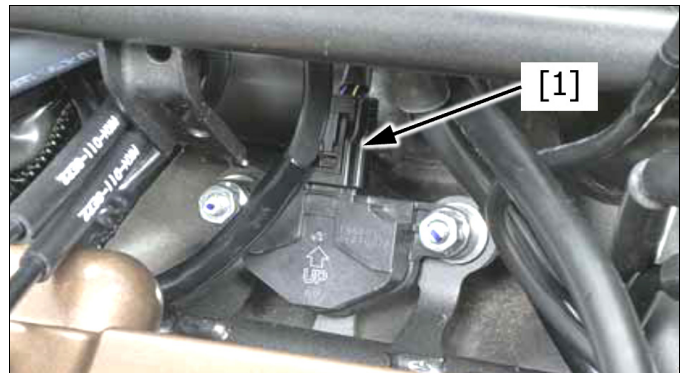
Disconnect the bank angle sensor 2P (Black) connector [1].

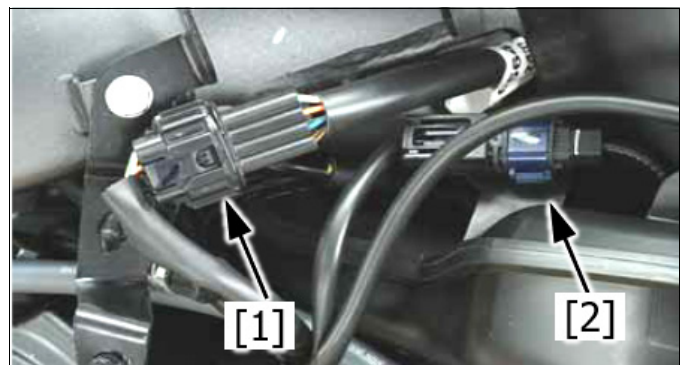
Disconnect the engine stop switch [1].

Release the front wheel speed sensor 2P (Black) connector [2] from the right intake air duct and disconnect it.

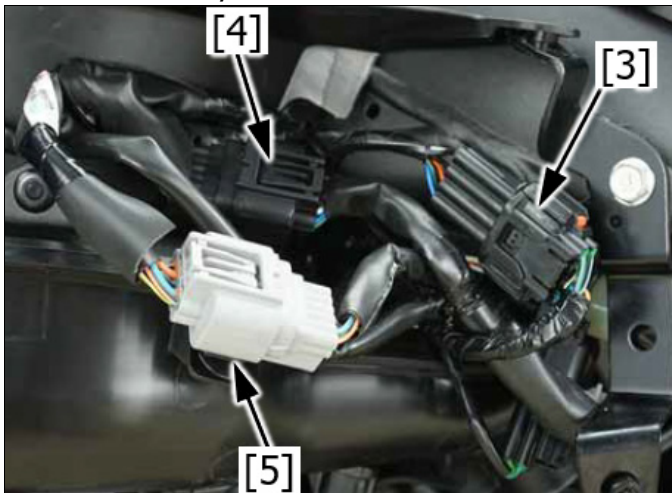
Disconnect the left handlebar switch 8P (Black) connector [3], front sub harness 12P(Black) [4] and 12P (Gray) connector[5].

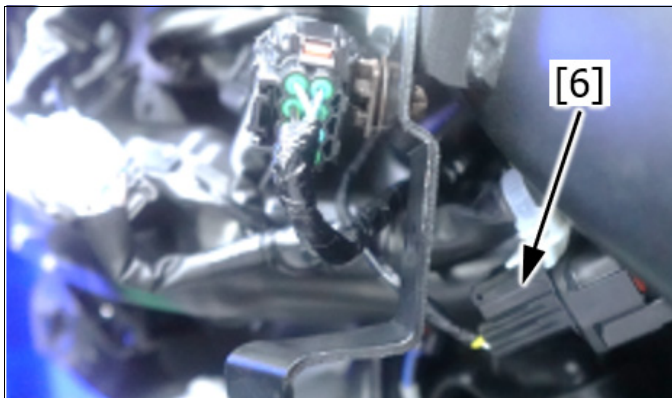
Disconnect the left handlebar switch 4P (Black) connector [6].

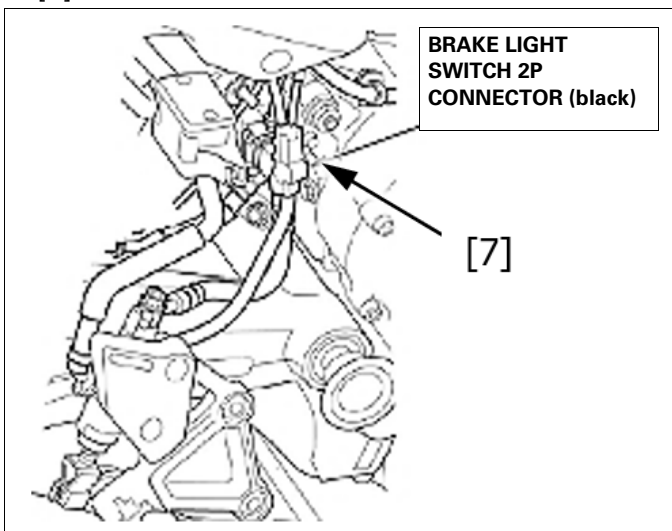
Disconnect rear brake light switch 2P (Black) [7].

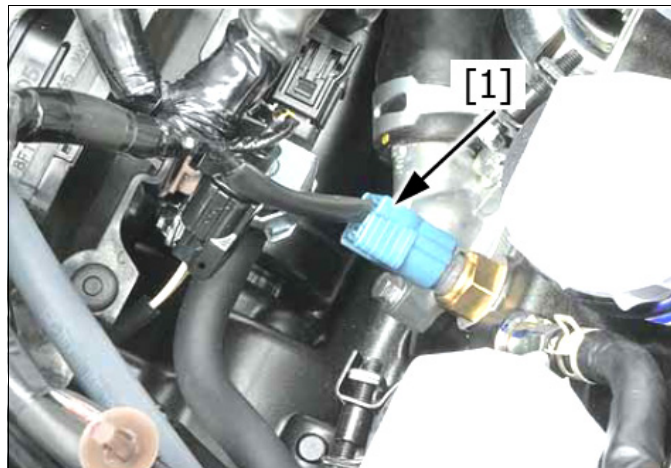
Disconnect the ECT sensor 2P (Blue) connector [1].

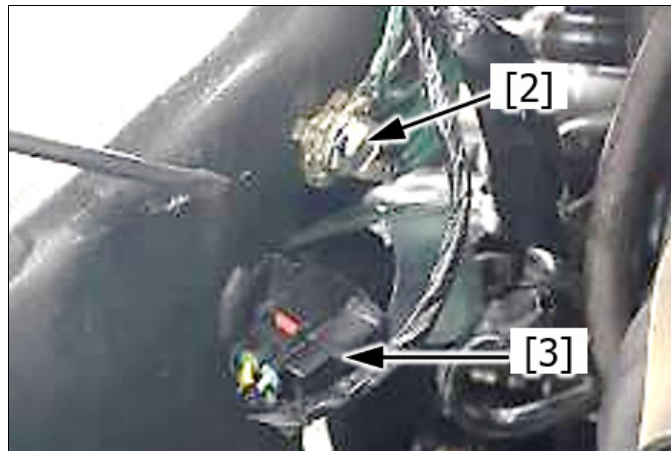
Remove the bolt [2] attaching the frame ground wire terminal.

Ground Bolt Torque: 7 ft-lb (10 Nm)

Disconnect the gear position switch 8P (Black) [3].

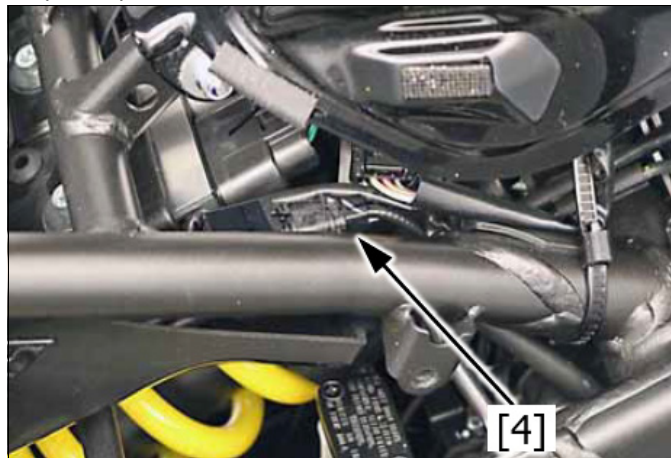
Disconnect the rear wheel speed sensor 2P (Black) connector [4].

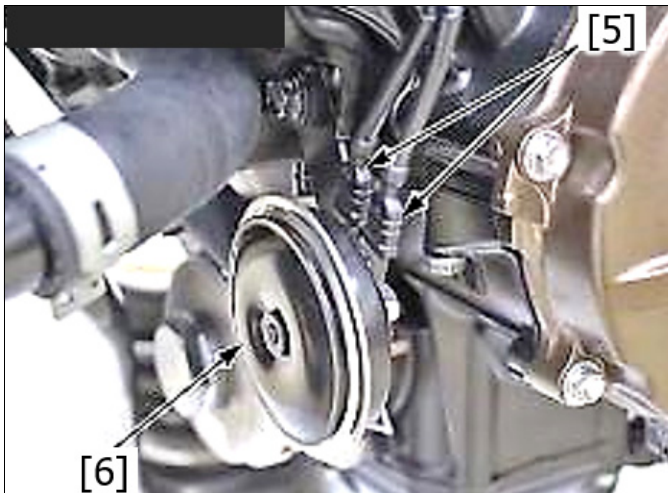
Disconnect the connectors [5] from the horn [6].

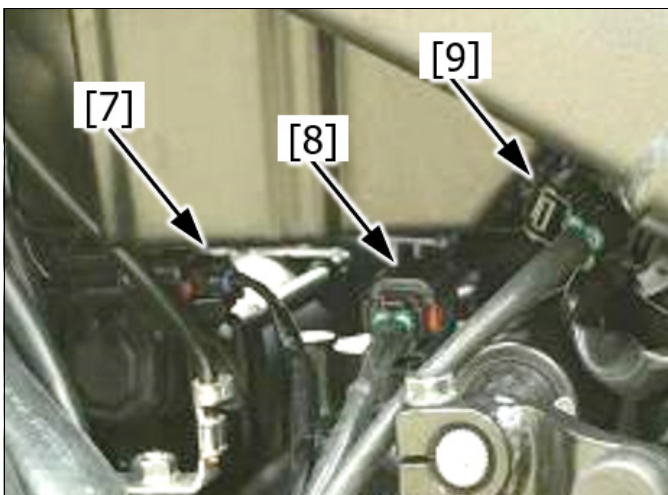
Disconnect the side stand switch 2P (Black) connector [7].

Disconnect the A/F sensor 4P (Black) connector [8] and remove the A/F sensor wire out of the frame.

Disconnect the O2 sensor 4P (Black) connector [9] and remove the O2 sensor wire out of the frame.

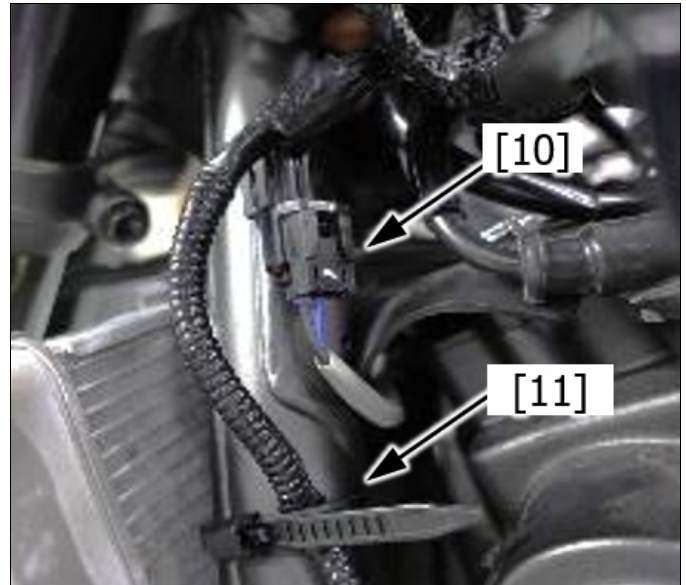
Disconnect the Radiator Fan connector [10] and remove cable tie [11].

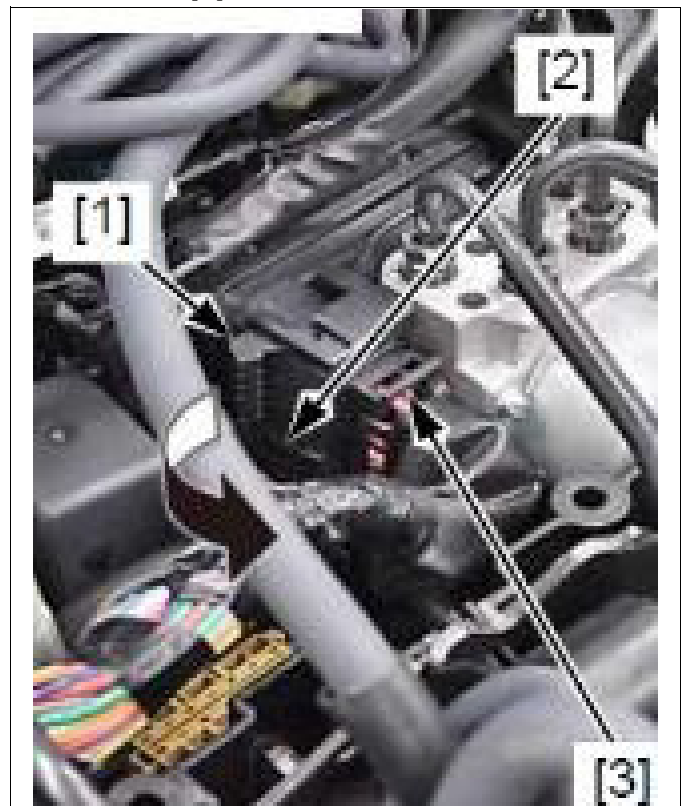
On the 18P ABS modulator connector, turn the lock lever [1] to the side shown while pressing the lock tab [2] to release it.

Be sure the lock lever is turned all the way.

Disconnect the ABS modulator 18P (Black) connector [3].

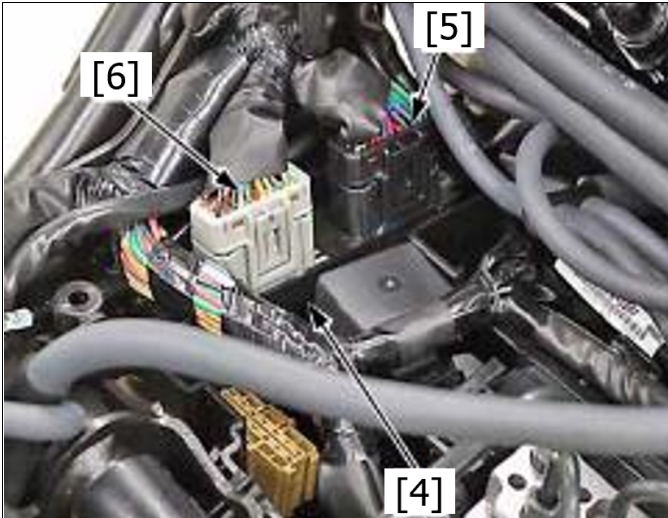
Pull out the ECM [4] from the ABS modulator tray.

Disconnect the ECM 33P (Black) [5] and 33P (Gray) [6] connectors.

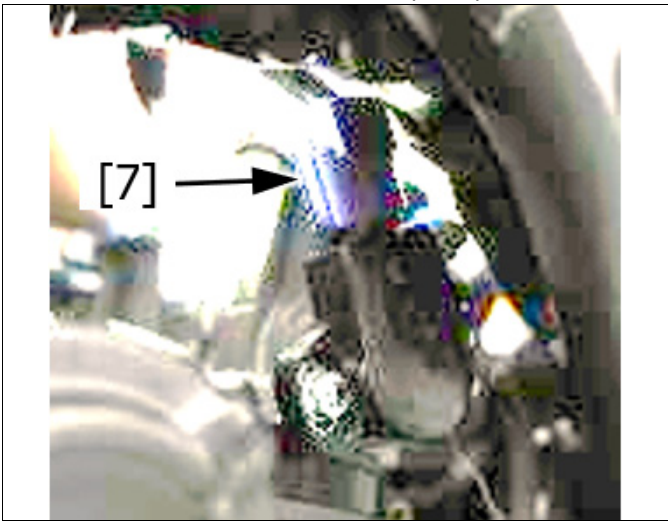
Disconnect the TP sensor 3P (Blue) connector [7].

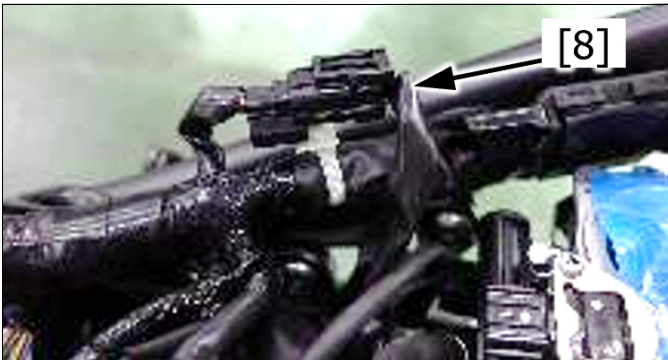
Disconnecting the injector sub harness connector [8].

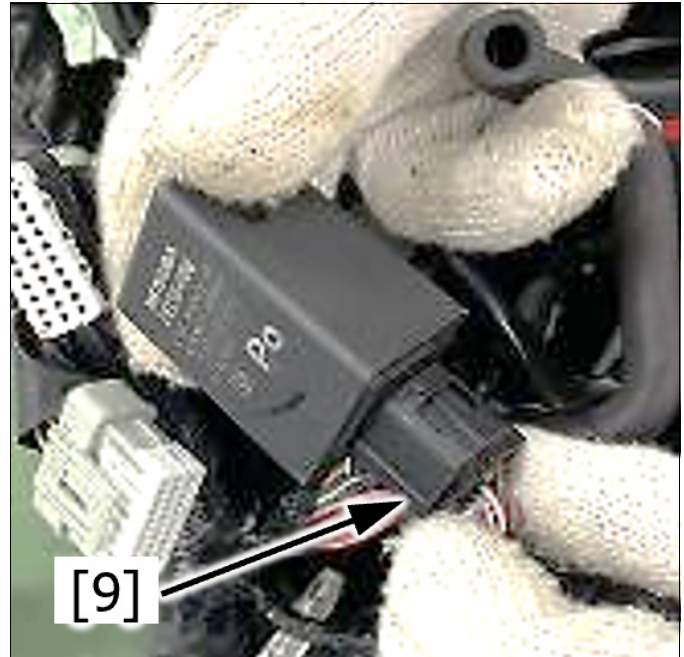
Remove the winker relay [9] by hand.

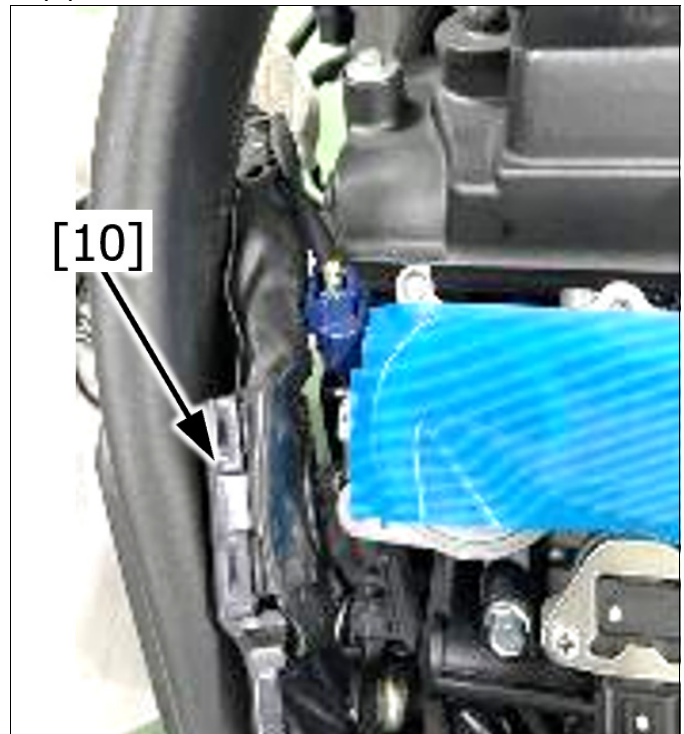
Remove harness wire [10] from the Frame main pipe.

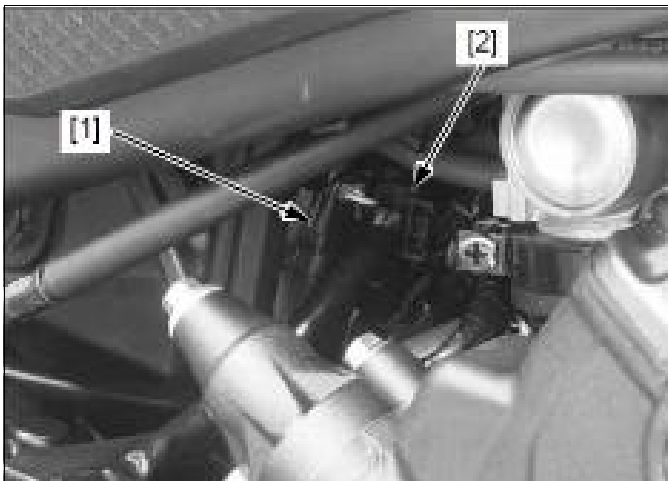
Disconnect the clutch angle sensor 6P (Black) connector [1] and E-clutch actuator 4P (Black) connector [2].

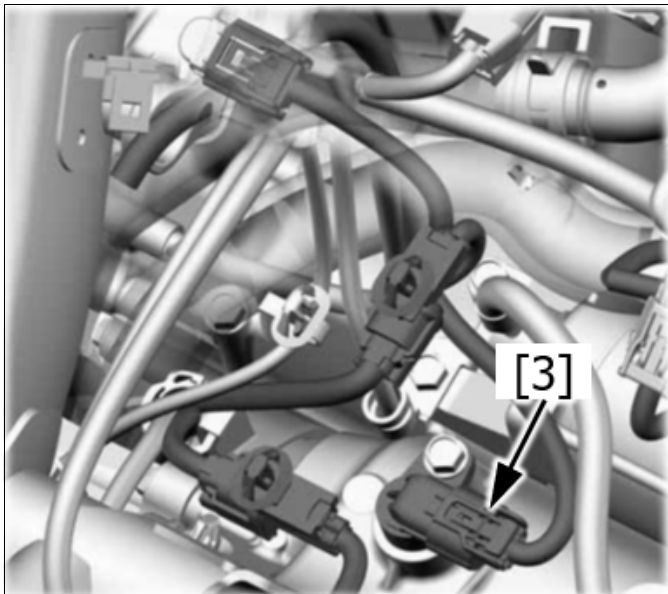
Disconnect the countershaft speed sensor 3P (Black) connector [3].
