Service Bulletin

CBR650R/RA #1
Revised: February 2026

SAFETY RECALL

2024 - 2025 CBR650R/RA WIRE HARNESS SHORT CIRCUIT

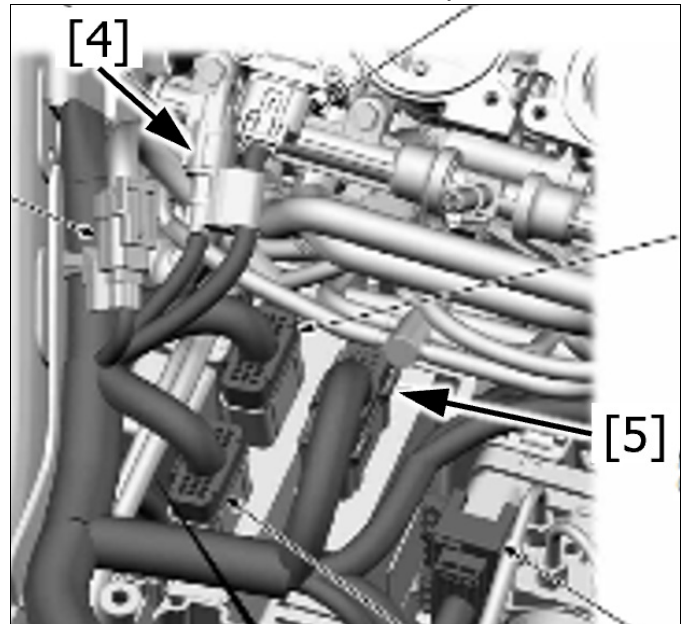
Disconnect the shift stroke sensor 3P (Black) connector [4] and MCU 39P (Black) connector [5].

The wire harness should now be free and can be removed from the motorcycle.
