R26AA

IMPORTANT SAFETY RECALL

DATE: March 19, 2026
TO: U.S. DEALERS
SUBJECT: R26AA: Improper Window Markings on Lippert Windows

This document refers to the procedure for adding etched identification to a glass window.

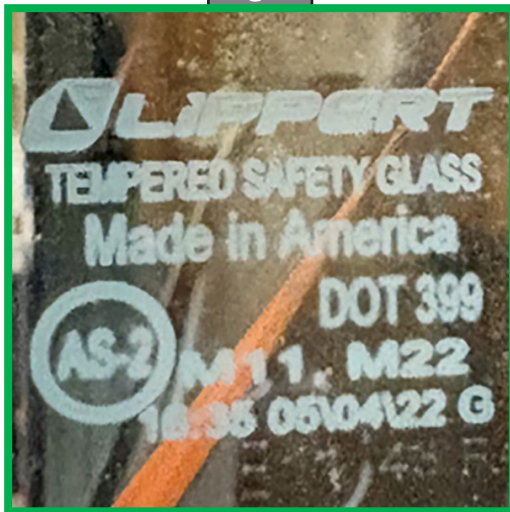
Fig. 1

1. Visually inspect the upper and lower glass of each bus window. Look for the DOT logo.
 - a. Sash Window - Correct (Fig. 1)
 - b. Sash Window - Incorrect (Fig. 2)
2. Note each window where the DOT logo is not compliant (Fig. 2).
 - a. Driver's Window - Correct (Fig. 3)
 - b. Driver's Window - Incorrect (Fig. 4)

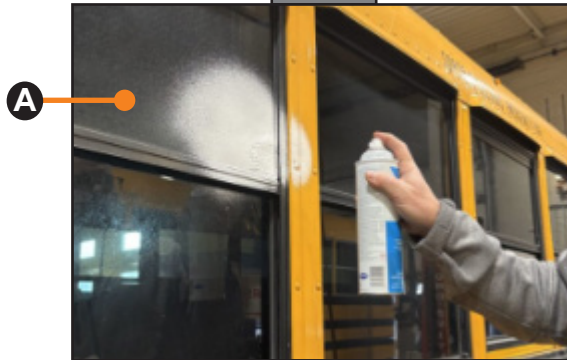
Fig. 5

1. Clean the glass (Fig. 5A) using glass cleaner to ensure good adhesion of the template.

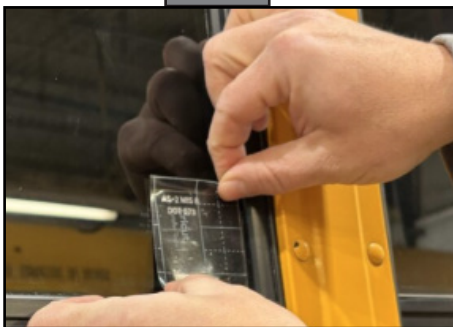
Fig. 6

2. Apply stencil (Fig. 6) directly above the DOT marking on the glass.
3. Remove the backing of the stencil and affix to the window using the bottom corner and right side of the frame as reference points (Fig. 6).

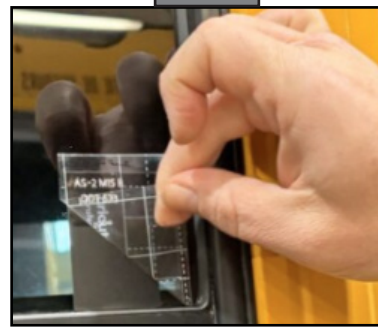
Fig. 7

4. Once the sticker is well adhered to the glass, remove the transfer tape to expose the template (Fig. 7).

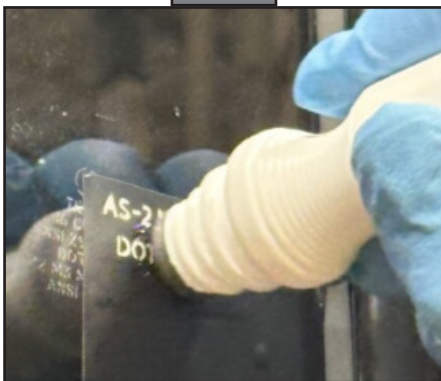
Fig. 8

1. Liberally apply the etching compound to the lettering portion by squeezing the bottle and tapping the lettered area of the stencil (Fig. 8).
2. Let the compound stand for 1 minute and reapply.
3. Let the reapplied etching compound stand for 5 minutes. Remove the excess compound with lukewarm water and a clean soft cloth.

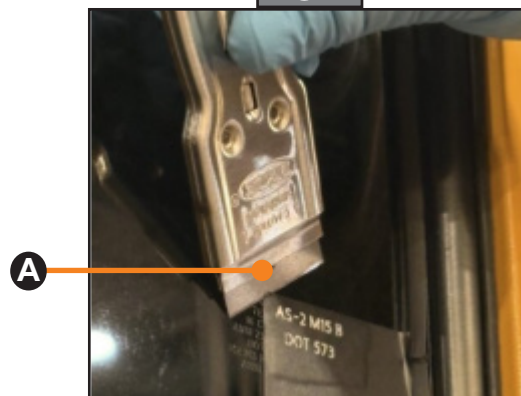
Fig. 9

4. Remove the stencil (Fig. 9).

NOTE: If necessary, use the included plastic razor blade to remove the stencil (Fig. 9A).
