IMPORTANT SAFETY RECALL

NHTSA Recall # 26V137

INSPECTION & CORRECTION
DOCUMENT

OPERATION: [HOW TO CHECK AND FIX THE REAR BRAKE LINES ON CHEVY BUSES](#)

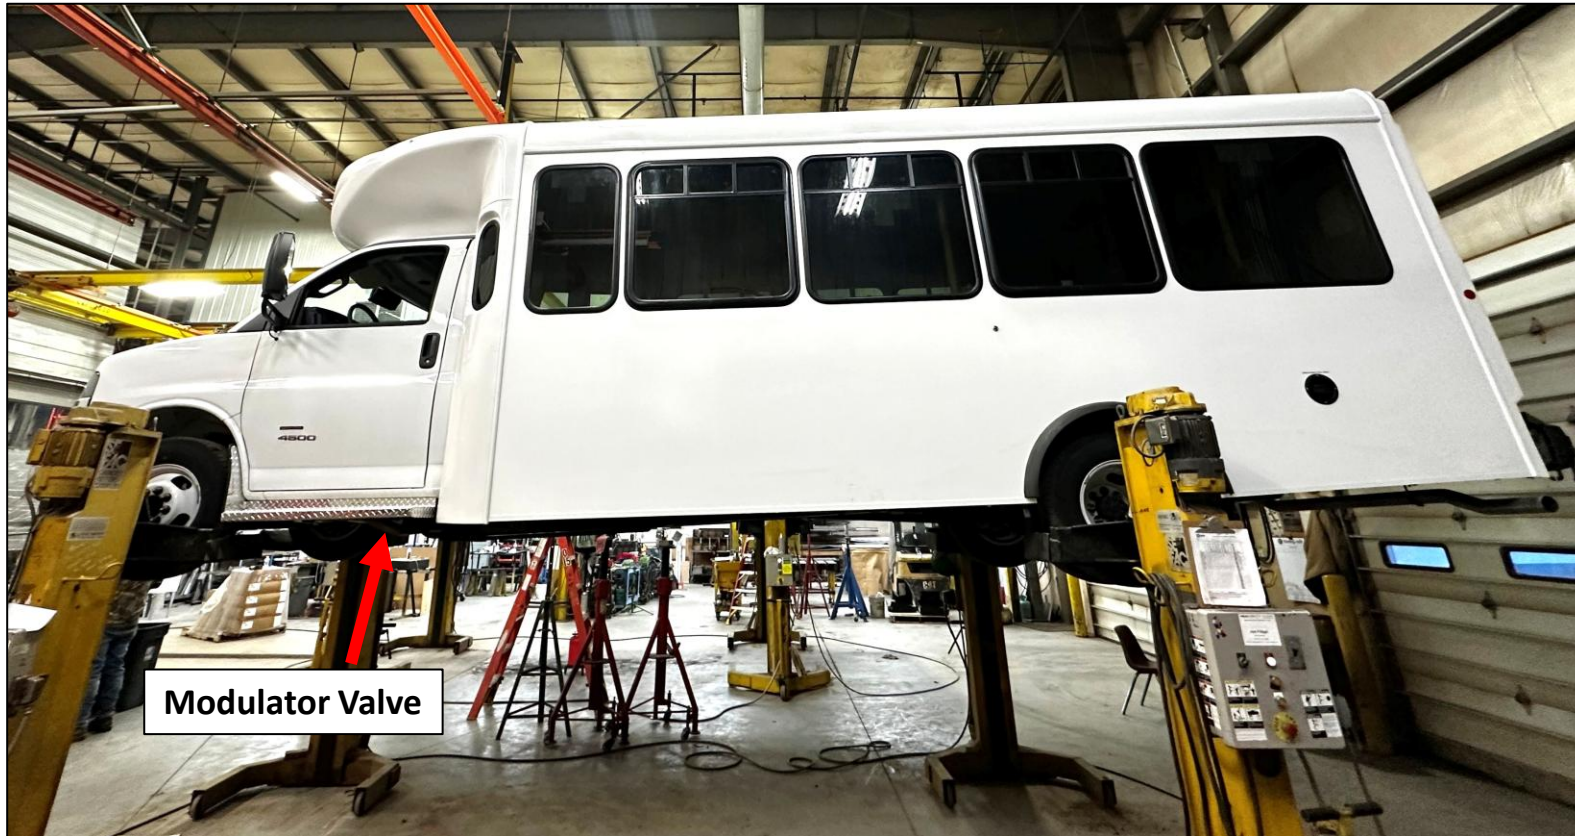
IMG. 1

- Step #1 Verify the brake fluid is full, then use a vehicle lift and raise the bus in the air to access the modulator valve and the brake lines under the bus. (IMG. 1)

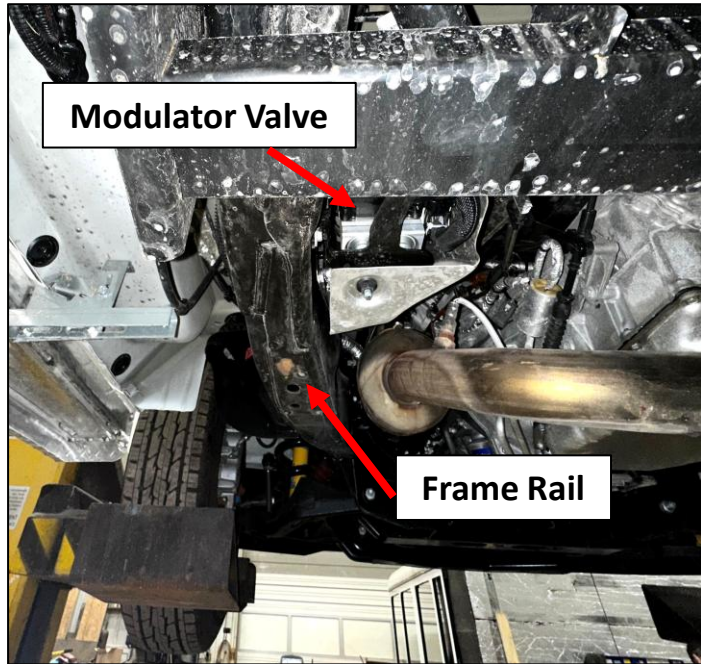
IMG. 2

Step #2 Locate the modulator valve under the driver side near the front of the bus, behind the frame rail. (IMG. 2, 3, & 4)

Under driver side of bus looking towards the front of the bus.

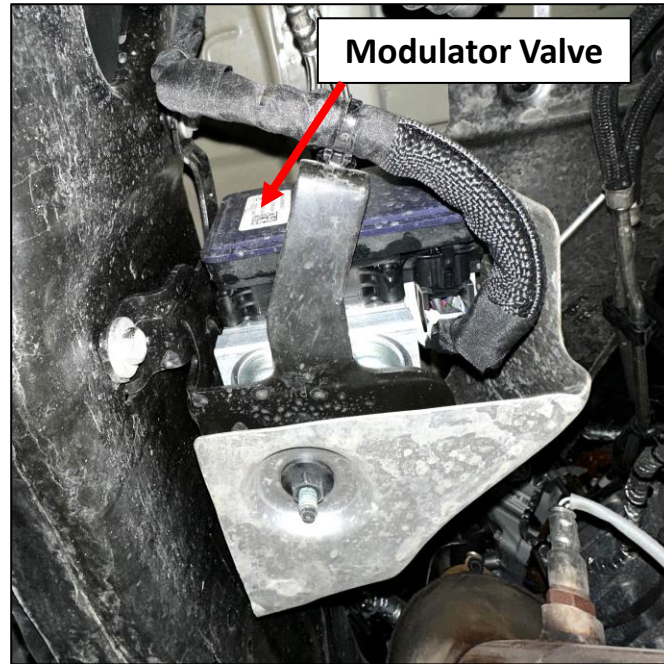
IMG. 3

Under the bus looking up at the modulator valve.

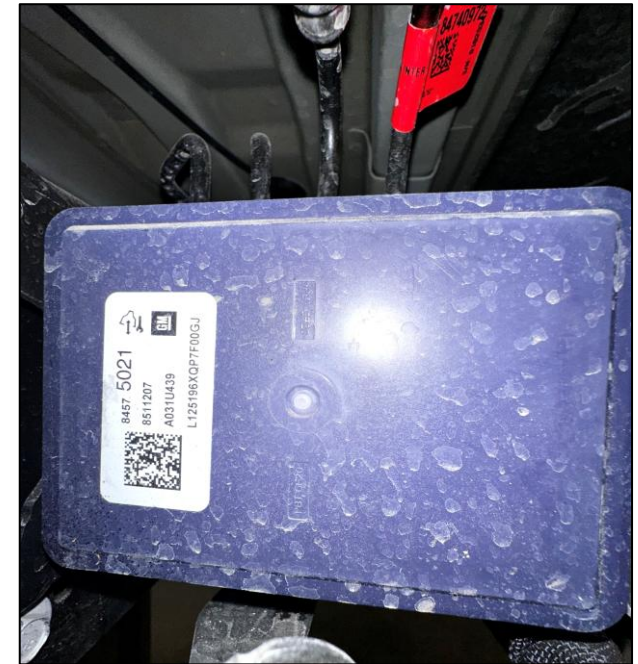
IMG. 4

Modulator Valve

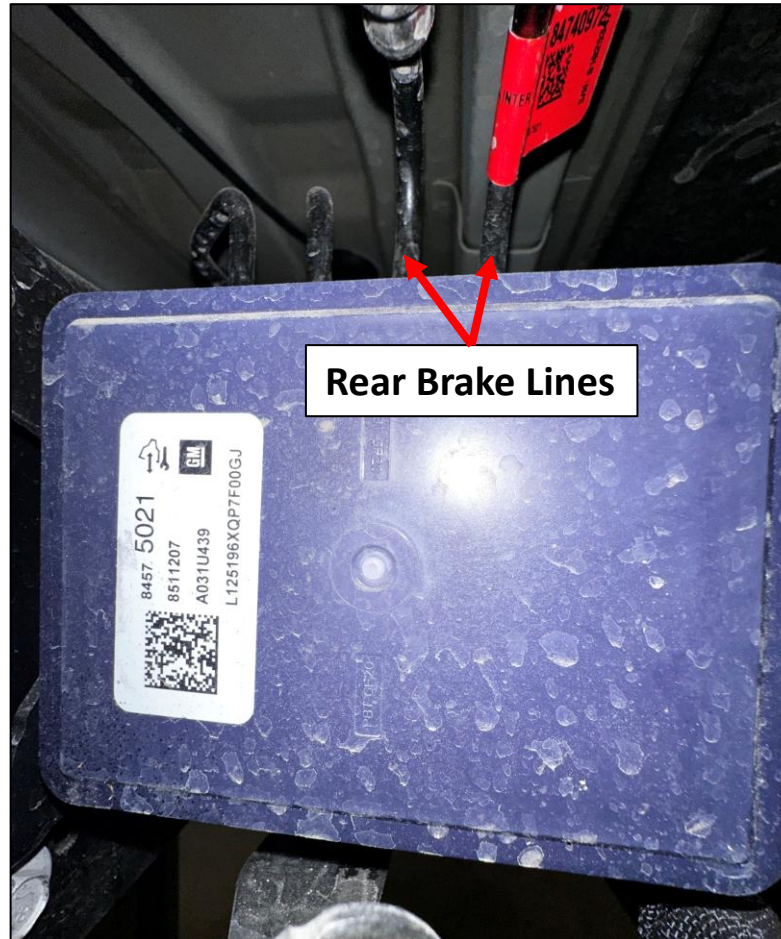
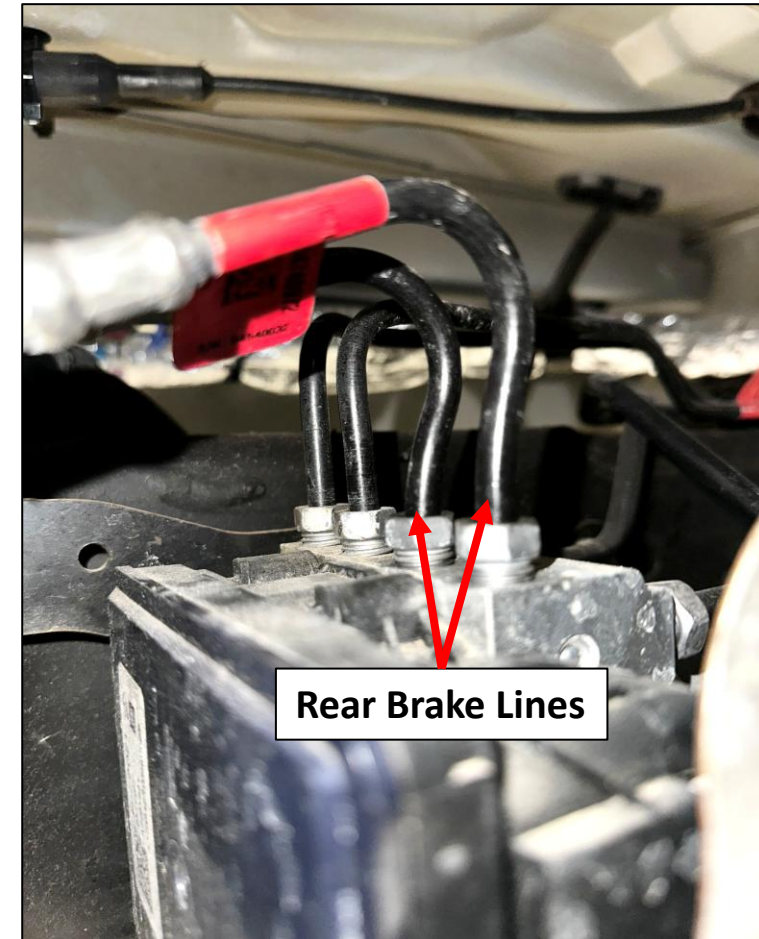
Step #3 On top of the modulator valve there are 4 ports with brake lines. Looking towards the front of the bus, the 2 brake lines furthest to the right are the rear brake lines.

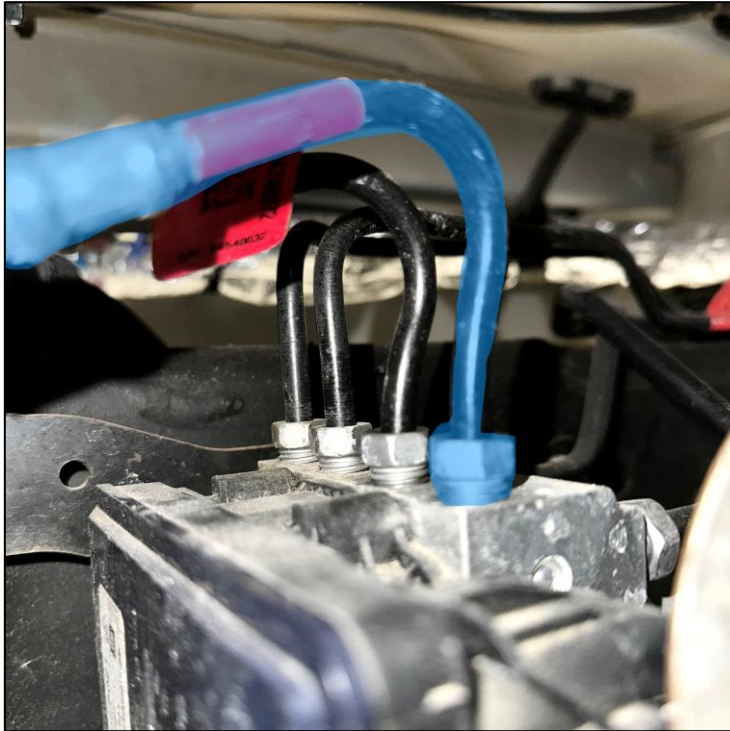
IMG. 7

Step #4 Follow the brake line (highlighted blue) that is attached to the port furthest to the right when facing the front of the bus, all the way to the back of the bus where it is connected to a bracket. (IMG. 7)

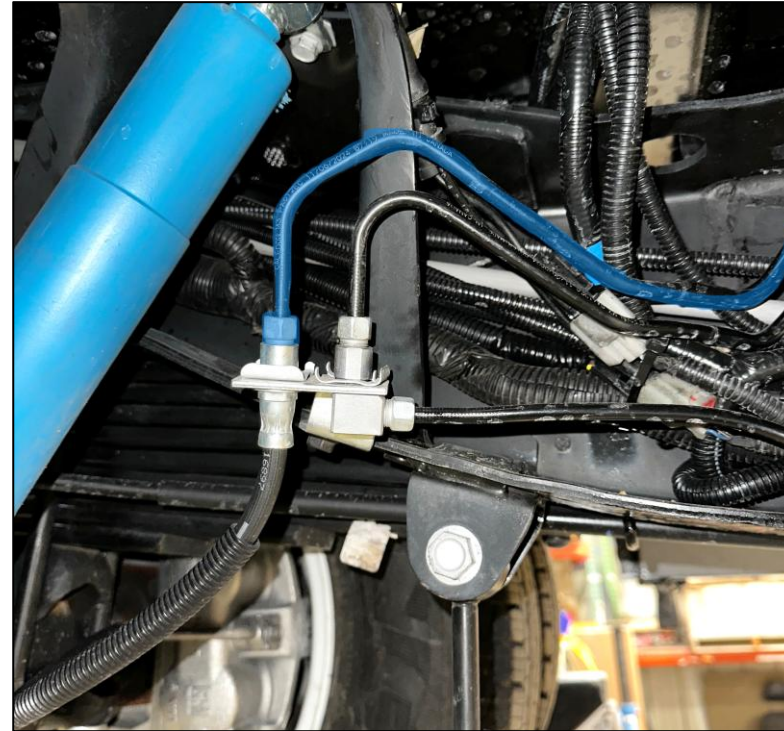
IMG. 8

Step #5 This brake line should be attached to the rear roadside brake. (IMG. 8)

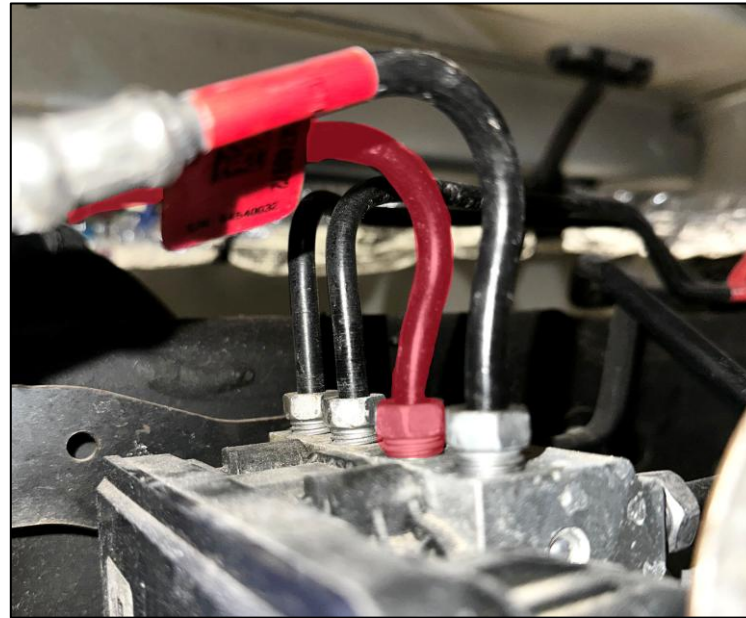
IMG. 9

Step #6 Follow the brake line (highlighted red) that is attached to the port 2nd furthest to the right when facing the front of the bus, all the way to the back of the bus where it is connected to a bracket. (IMG. 9)

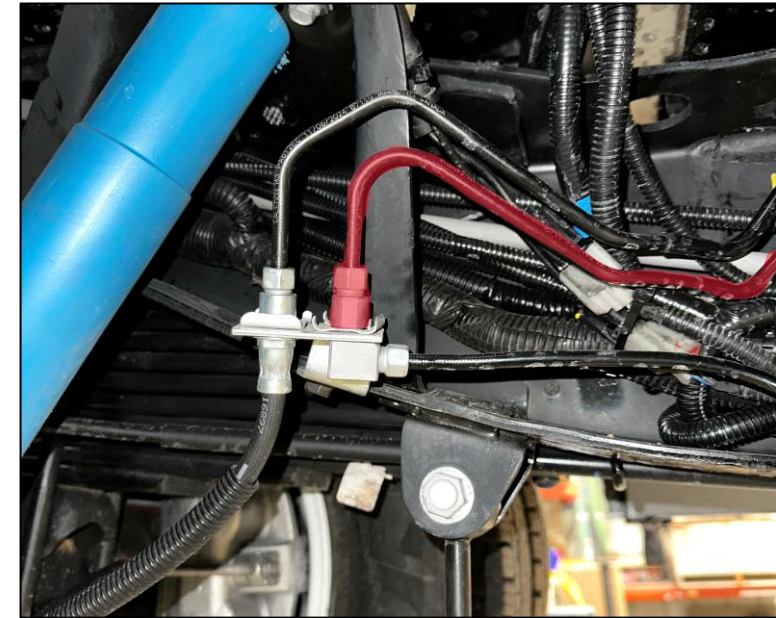
IMG. 10

Step #7 This brake line should be attached to the rear curbside brake. (IMG. 10)

If the brake lines are connected to the correct ports, no further action is required.

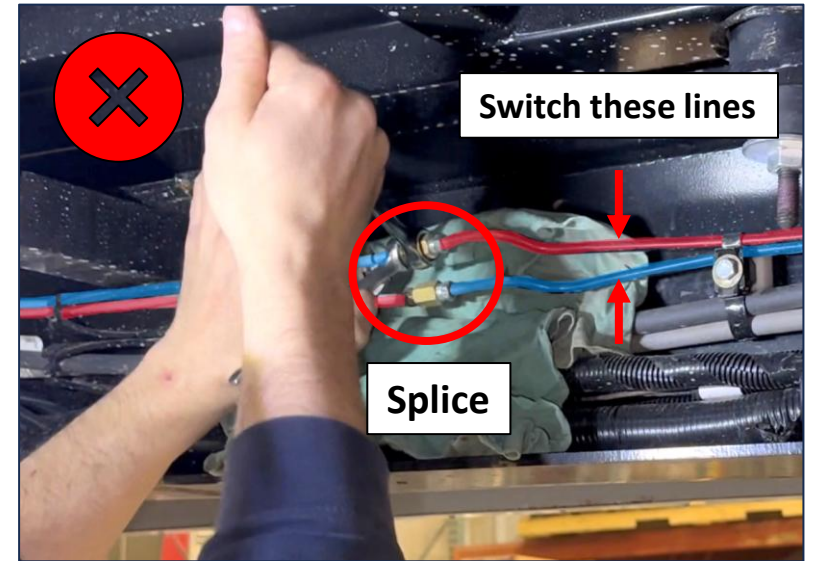
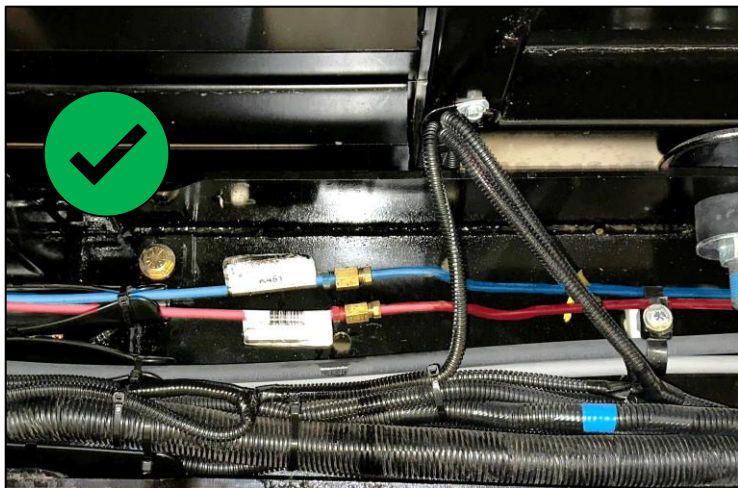
IMG. 11

- Step #1** If the brake lines are connected to the wrong ports, they will need to be corrected.
- Step #2** Locate the brake line splice near the center of the bus. (IMG. 11)
- Step #3** Using a $\frac{7}{16}$ " wrench and a 14mm wrench, loosen and disconnect the brake line connectors. (IMG. 11)

- Step #4** Switch the lines around and reconnect the correct brake lines to each other. The brake line highlighted blue should go on the top and the brake line highlighted red should go on the bottom. Verify that the brake lines are not touching the frame and that the lines are not touching. (IMG. 11 & 12)
- Step #5** Bleed the rear brakes as required and refill the master cylinder to the correct level.

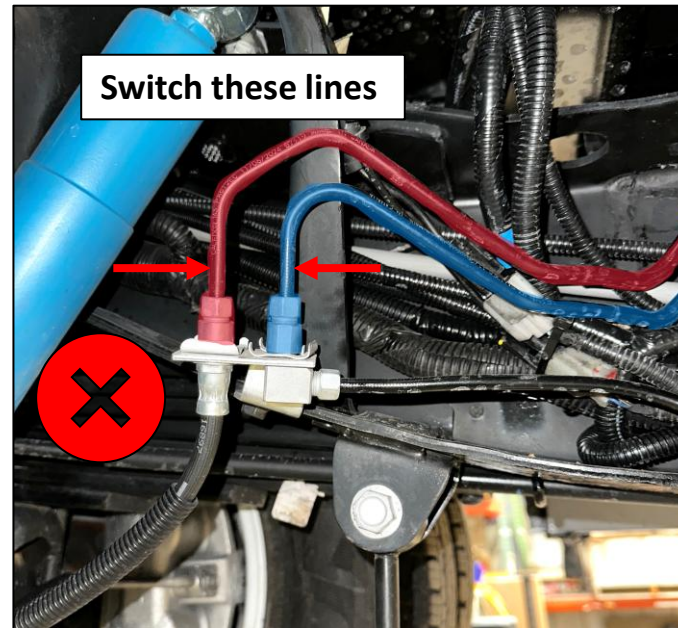
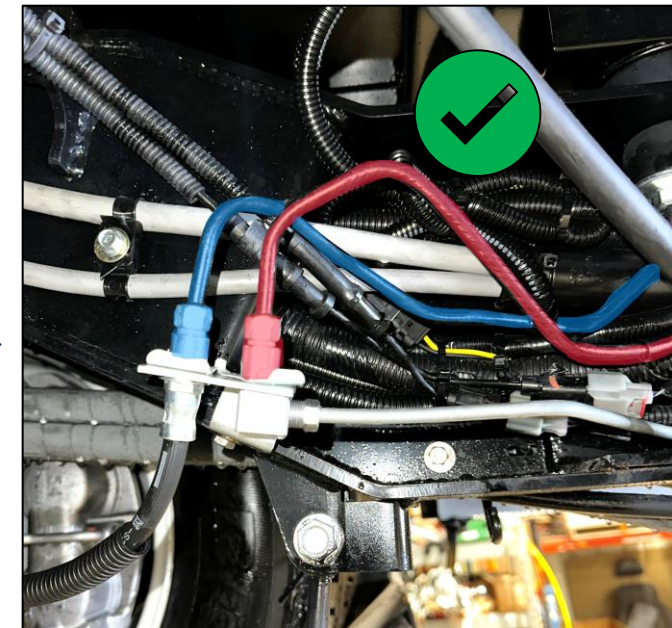
IMG. 13

Step #1 If the brake line splices are off set, the brake lines will need to be switched at the bracket which is located near the back driver side tire. (IMG. 13)

Step #2 Using a 7/16" wrench and a 14mm wrench, loosen and disconnect the brake line connectors.

Step #3 Switch the lines around and reconnect the correct brake lines to each other. The brake line highlighted blue should go on the left and the brake line highlighted red should go on the right. (IMG. 13 & 14)

Step #4 Bleed the rear brakes as required and refill the master cylinder to the correct level.
