Safety Recall Launch Notification

Campaign #	NHTSA ID	Description	
2026040002	26V172	26P9190320	Replace Rear Center Seat Belt

CAMPAIGN NO.	2026040002
CAMPAIGN DESC.	26P9190320
NHTSA ID	26V172
SUBJECT	Replace Rear Center Seat Belt
MODEL(S)	GLC (254 platform)
MODEL YEAR(S)	2026
CAMPAIGN POPULATION	20

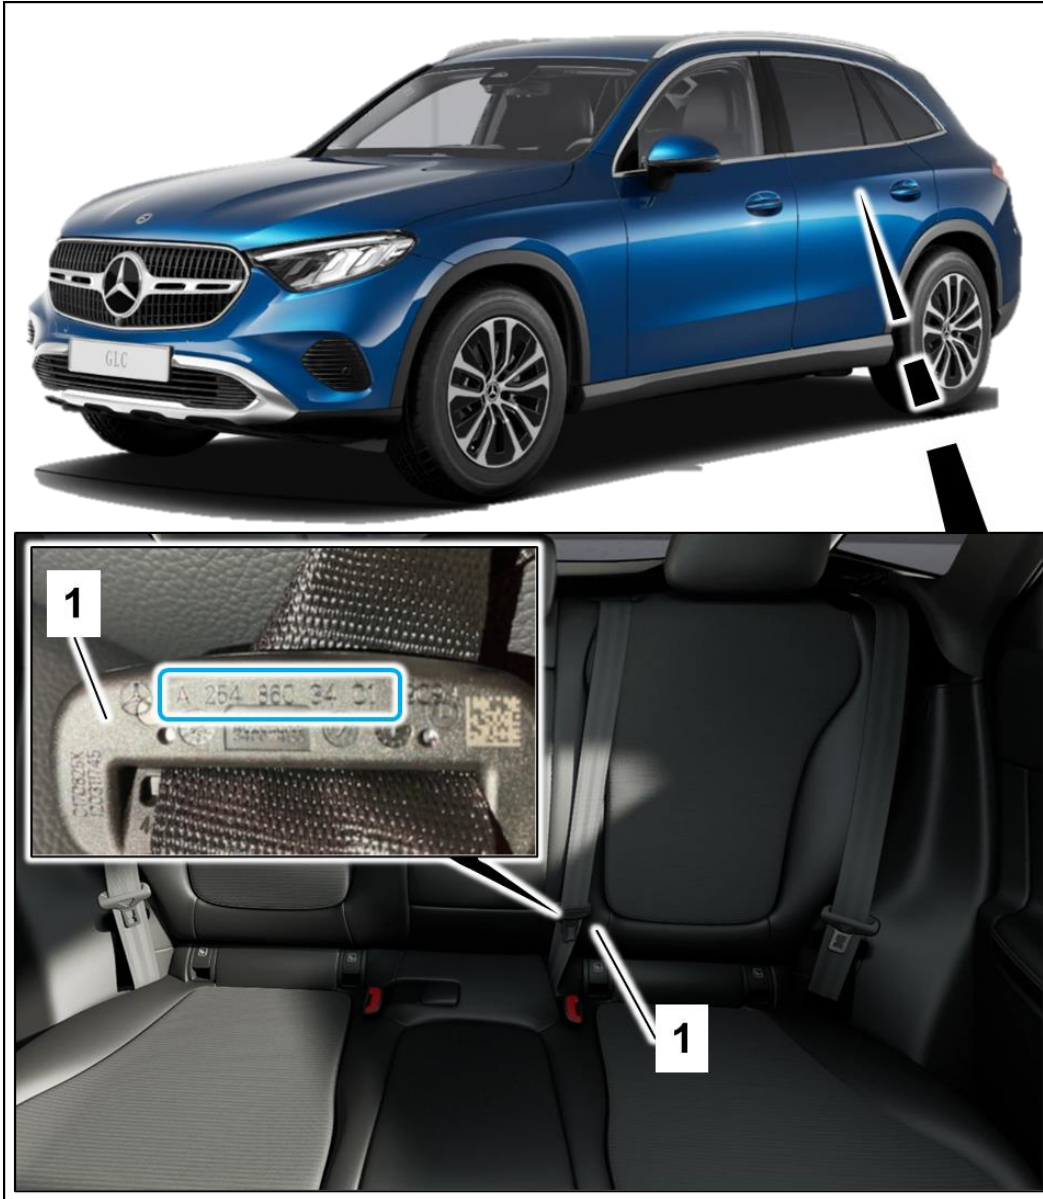
Figure 1

1. Check part number of belt tongue (Figure 1, 1) on the center seat belt in rear passenger compartment.

- a. If the installed belt tongue (Figure 1, 1) does **not** have **part number A 254 860 36 01 (model 254.3) or A 254 860 23 00 (model 254.6)**: Perform **Work Procedure**.
- b. If the installed belt tongue (Figure 1, 1) has **part number A 254 860 36 01 (model 254.3) or A 254 860 23 00 (model 254.6)**: **No further action required**.
