Bentley Bulletin

26-048

Subject: RECALL CAMPAIGN – Bentley Bentayga Incorrect Information on Tire Placard (RE26/05)

Topic	Tyre Label Replacement Bentayga SWB 25MY (RE26/05)
Market area	United States E05 Bentley USA and rest America (6E05)
Brand	Bentley
Transaction No.	2081340/1
Campaign number	RD84
Note	
Type	
US code

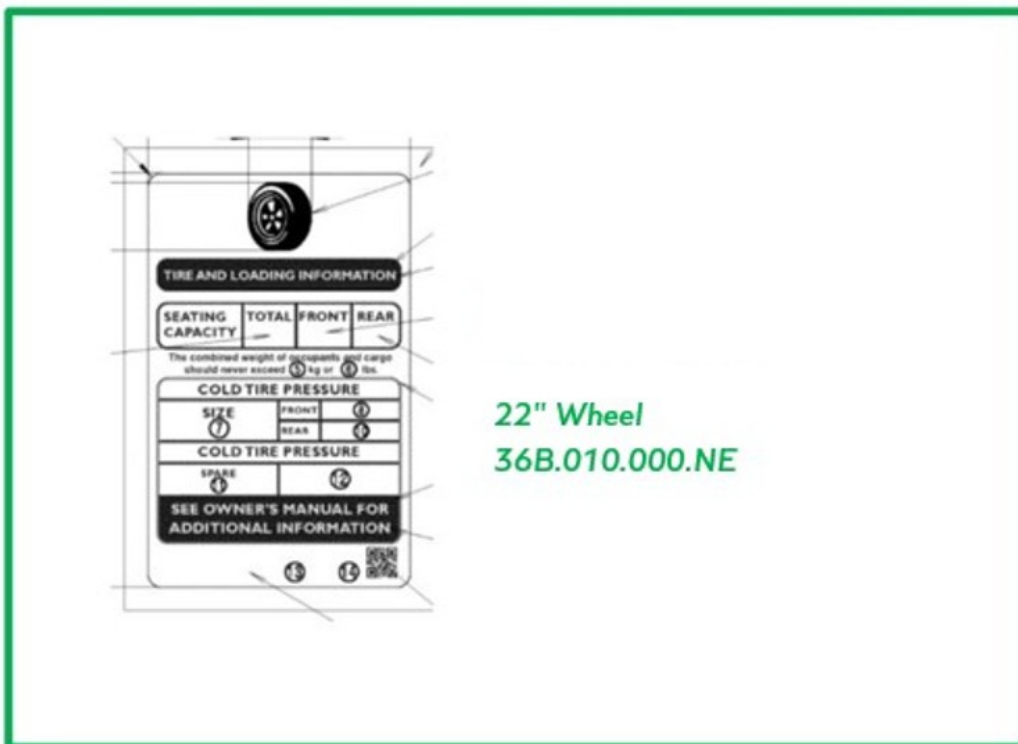
A small number of vehicles were equipped with tyre information placards that do not correspond to the wheel size installed on the vehicle. In affected cases, a 21" wheel placard was fitted to vehicles built with 22" wheels.

Figure 1. Correct label Condition

Label replacement must be conducted on all affected vehicles.

DO NOT remove the old label until the new label is available to be fitted

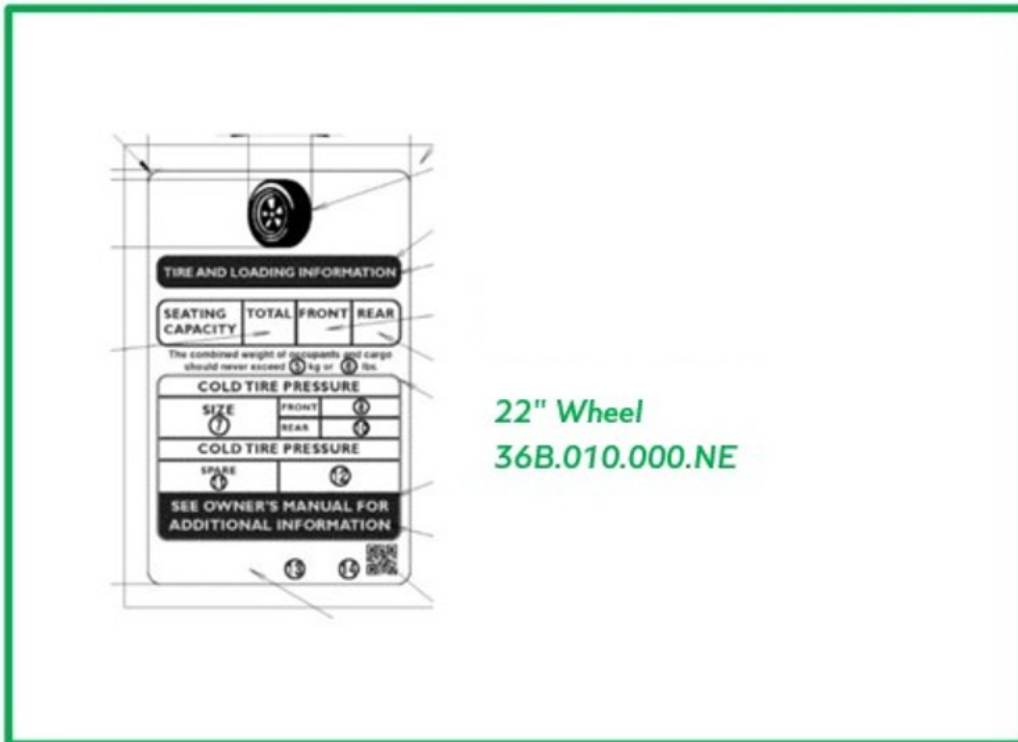
A small number of vehicles were equipped with tyre information placards that do not correspond to the wheel size installed on the vehicle. In affected cases, a 21" wheel placard was fitted to vehicles built with 22" wheels.

Figure 1. Correct label Condition

1. Check the currently fitted tyre placard on the driver's door B-pillar.
2. If the label indicates 21", proceed to replacement.

Removal of the old label requires the use of a suitable heat gun and a thin plastic spatula.

3. Using the heat gun and plastic wedge, slowly remove the original label.

4. Using a proprietary solvent and a lint free cloth, remove the left over adhesive from the body until completely clean.

6. Applying sufficient pressure, fit the new label in the same location as the previously removed label.
