**Storyteller Overland, LLC
Customer Service Department
428 Industrial Lane
Birmingham, AL 35211**

**TO: Storyteller Overland Dealers
Subject: NHTSA Recall: 26V-183**

What is the reason for this recall? Storyteller Overland is recalling certain 2024-2026 Storyteller GXV HILT vehicles. Storyteller GXV HILT vehicles may contain a door switch failure that could signal entry steps to automatically extend while the vehicle is in transit.

NHTSA 26V-183 Hilt Stairs

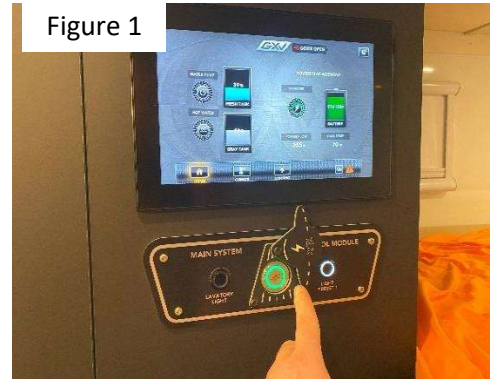
1. Ensure unit is parked with ignition turned off.
2. Turn off the electrical system in the capsule by holding down the illuminated green button until there is an audible "click". (Figure 1)
3. Locate the harness for the steps and unplug the side that is attached to the capsule (Figure 2 & 3)
4. Plug In the Supplemental Harness (R4H-02-95-001-1.1) to the now open port on the capsule (Figure 4)

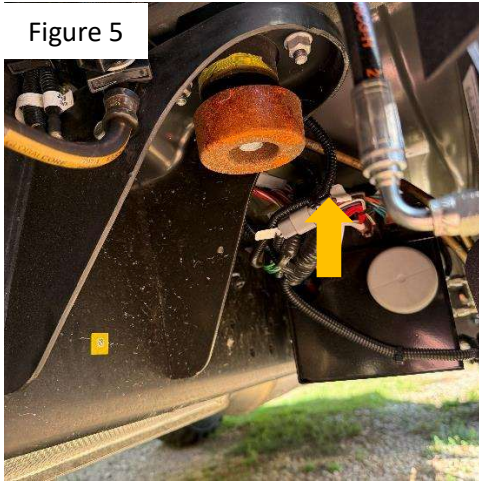
Figure 5

5. Begin fishing the wire toward the front of the vehicle replicating the path detailed in the following steps
6. Cross over the top of the liquid springs control module and secure with zip ties (Figure 5)
7. Follow the liquid springs harness forward until you reach the firewall, securing with zip ties every ~2ft (Figure 6)

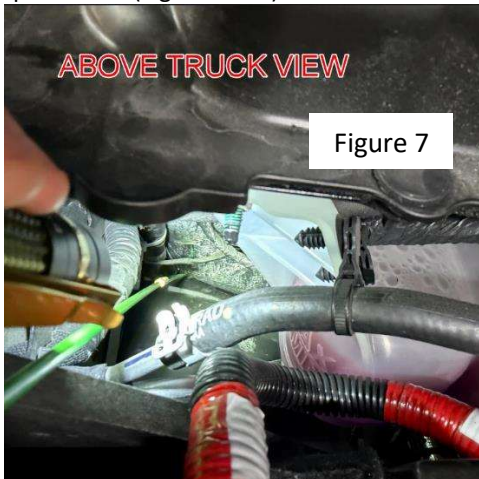
Figure 7

8. From the top of the engine compartment, pass your fish rod/tape down to underneath the vehicle in the spot shown (Figure 7 & 8)

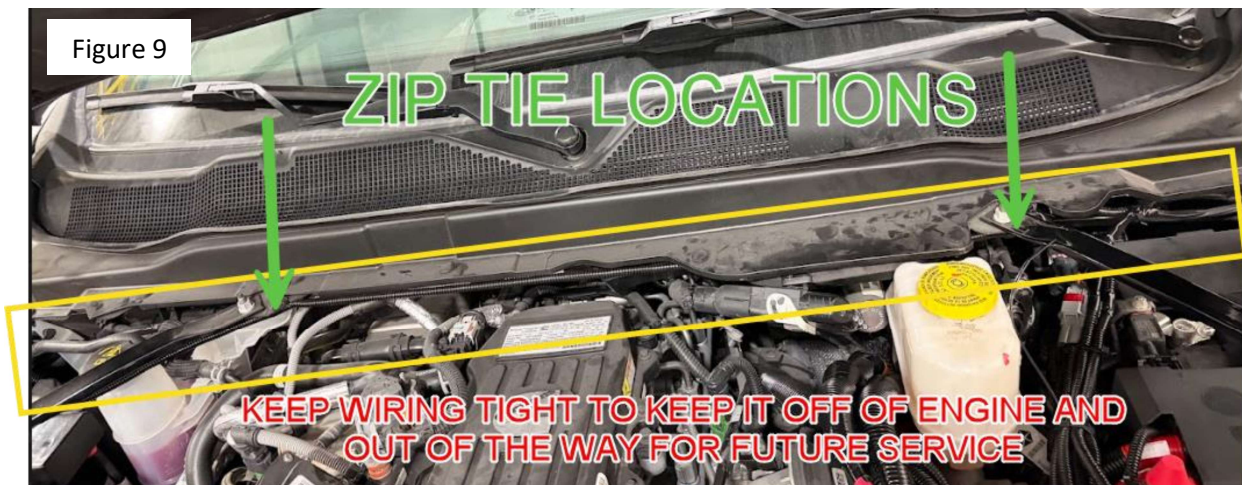
Figure 9

9. Attach wire to fish rod/tape and pull to top of engine compartment
10. Run along cowl securing with zip ties at the two cross braces (Figure 9)

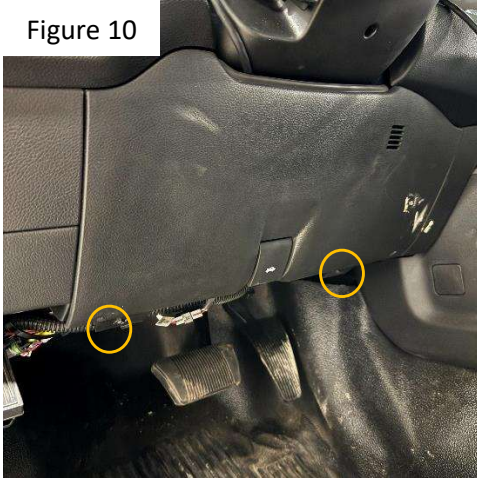
Figure 10

11. Remove the kick panel In the driver footwell using 7mm socket (Figure 10)
12. From the driver footwell, pass fish rod/tape through the grommet shown and into engine compartment. Take care to make sure the grommet stays in place. The grommet must be in place where wires pass through firewall. (Figure 11 & 12)
13. Attach wire to fish tape/rod and pull into driver footwell

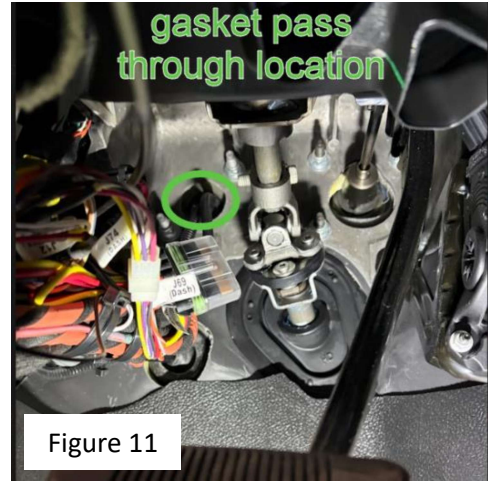
Figure 11

gasket pass
through location

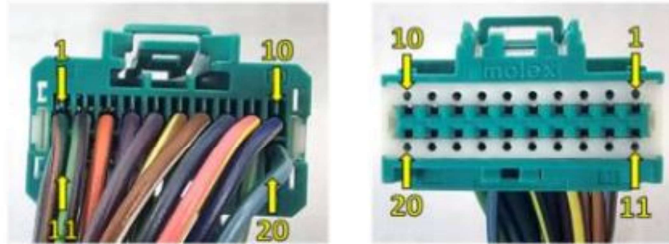
MY 25+

14. Locate the two wires shown on pictures below for the year Ram you are working on
 - a. **Model year 25+:** On VSIM Connector "C" 20 Cavity: pins 15 (reverse) and 17 (drive)
 - b. **Model Year 24 and under:** On VSIM Jumper 24 gray in-line connector: pins 12 (reverse) and 16 (drive)

GREEN 20 CAVITY VSIM CONECTOR

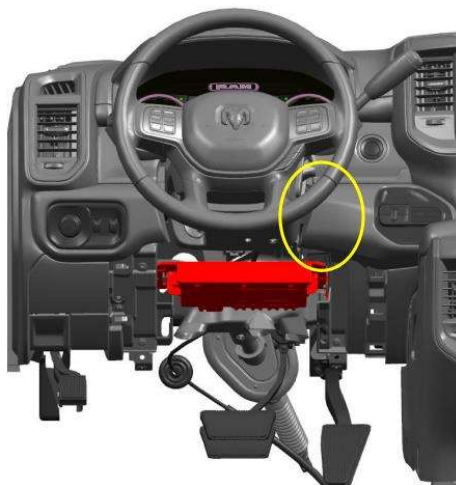
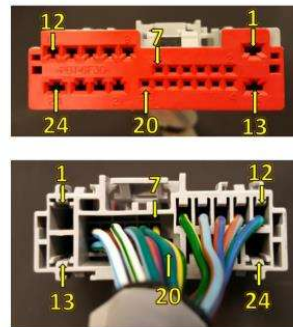
MY 24 AND BELOW

The VSIM Gray 24 Cavity In-line mating connector is located above the accelerator pedal bracket.

Gray 24 Cavity In-Line Connector
Plugs into mating connector
above accelerator pedal bracket

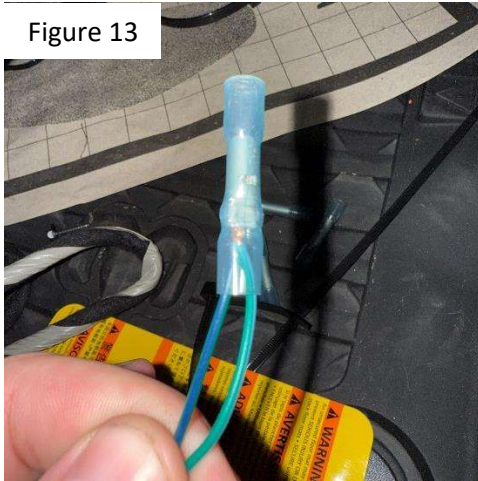
Figure 13

17. If wires were correct, take supplied butt connector, strip back both wires, Insert Into one end of the connector, and crimp (Figure 13)
18. Crimp the wire run In steps 5-12 Into the other end of connector and shrink heat shrink with heat gun

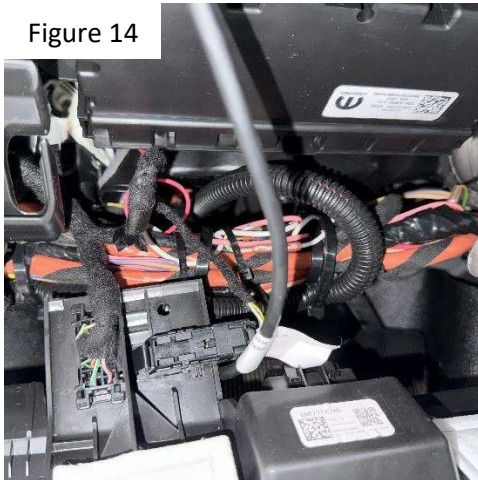
Figure 14

19. Tie up all of the wires cleanly underneath dashboard and replace kick panel (Figure 14)
20. Plug the steps connector removed In step 3 Into the supplemental harness (Figure 15)
