**Subject: NHTSA Recall: 26V- 274**

# NHTSA Recall # 26V274

## 2023 AWD MODE Coolant Routing

Rev05192026

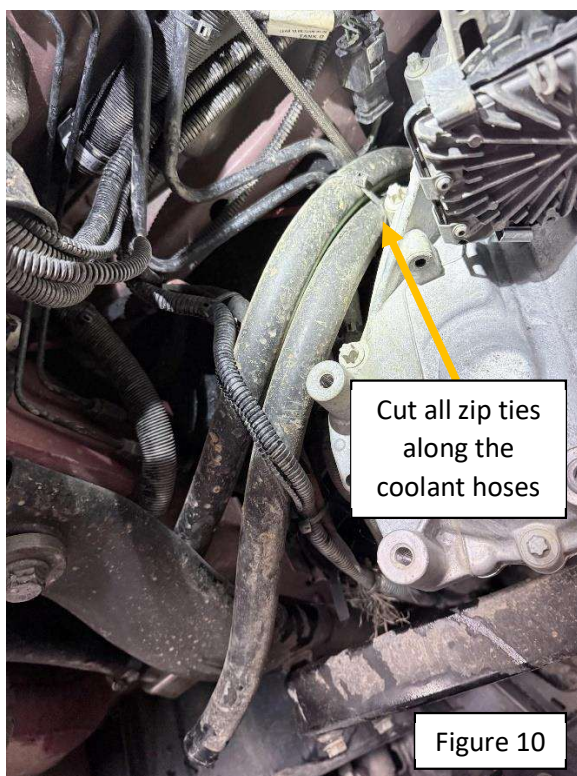
Figure 10

- d. Locate and cut/remove all the zip ties along the Rixen coolant hoses from the heat exchanger to the engine bay. See figure 10
  - e. Remove the hose clamps from engine bay side of Rixen coolant hoses
