R26AG

## **IMPORTANT SAFETY RECALL**

**SUBJECT:** R26AG: 12V Power Supply Wire Short-to-Ground

## R26AG: 12V Power Supply Wire Short-to-Ground

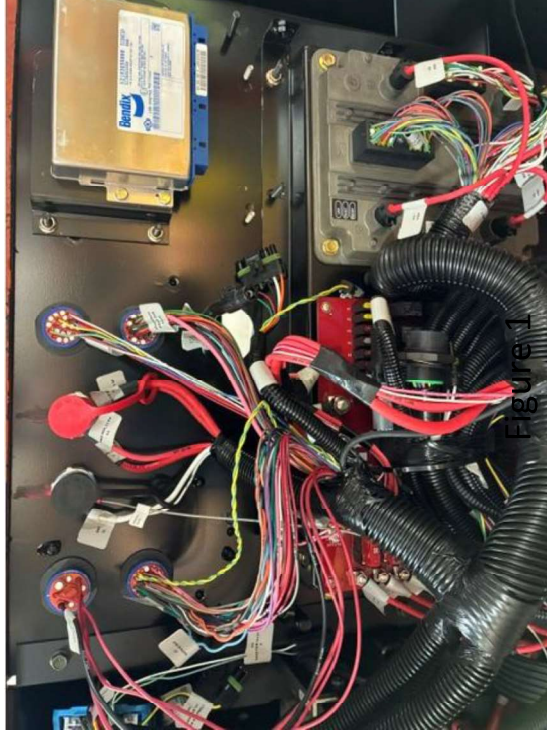
**Figure 1**

- Turn **OFF** the battery disconnect switch or remove the **positive battery cable** from the battery terminal. Secure the cable to prevent accidental contact.
- Inside the bus, remove the **plastic doghouse cover** to access the **A MUX module** and wiring harness (Figure 1).
- Locate the **12V Positive Pass-Through Stud** positioned above the PCB.
- Remove the **3/8" hex nut** from the positive pass-through stud. Refer to the **Procedure** section below for the detailed removal and installation steps.
- After completing the rework (pg. 3), install the **new ring terminal** onto the pass-through stud.
- Tighten the **3/8" hex nut to 11–15 ft-lb (15–20 Nm)**.
- Verify that the ring terminal is fully seated, the connection is secure, and the wiring is routed without strain or interference before reassembling the vehicle.

*Note: If the harness needs replacement, then apply edge trim to the known edges causing harness damage.*
